Scottish Road Research Board

EARLY LIFE PAVEMENT FAILURES

PROJECT NO. TS/TRBO/SER/2017/04/12

DATE: MARCH 2024

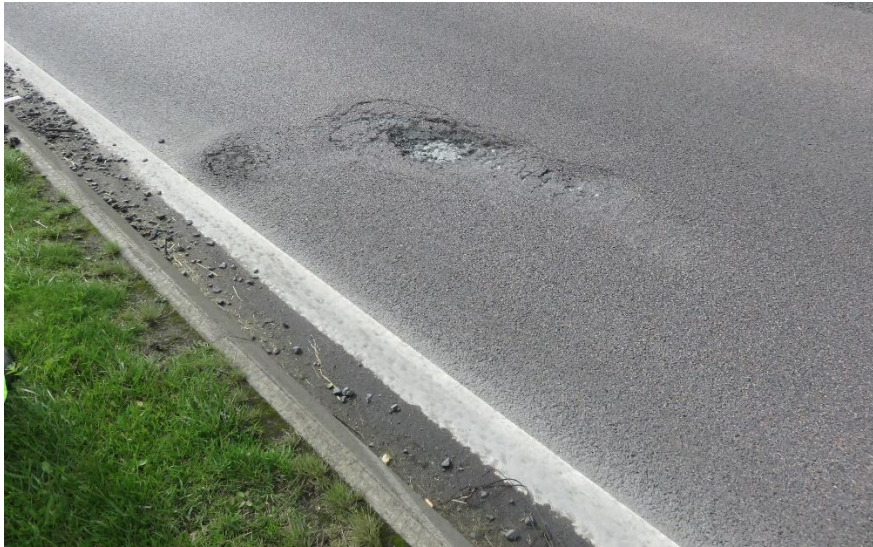
As part of the Scottish Inspection Panel survey in 2019, it was reported that several pothole defects were observed on recently completed surfacing schemes (Figure 1-1). These types of defects are not normally associated with new surfacing and it was recommended that further investigations should be undertaken to investigate whether a problem exists and what measures could be put in place to eliminate any future occurrences.

Figure 1-1 - Early life defect on one-year-old surfacing

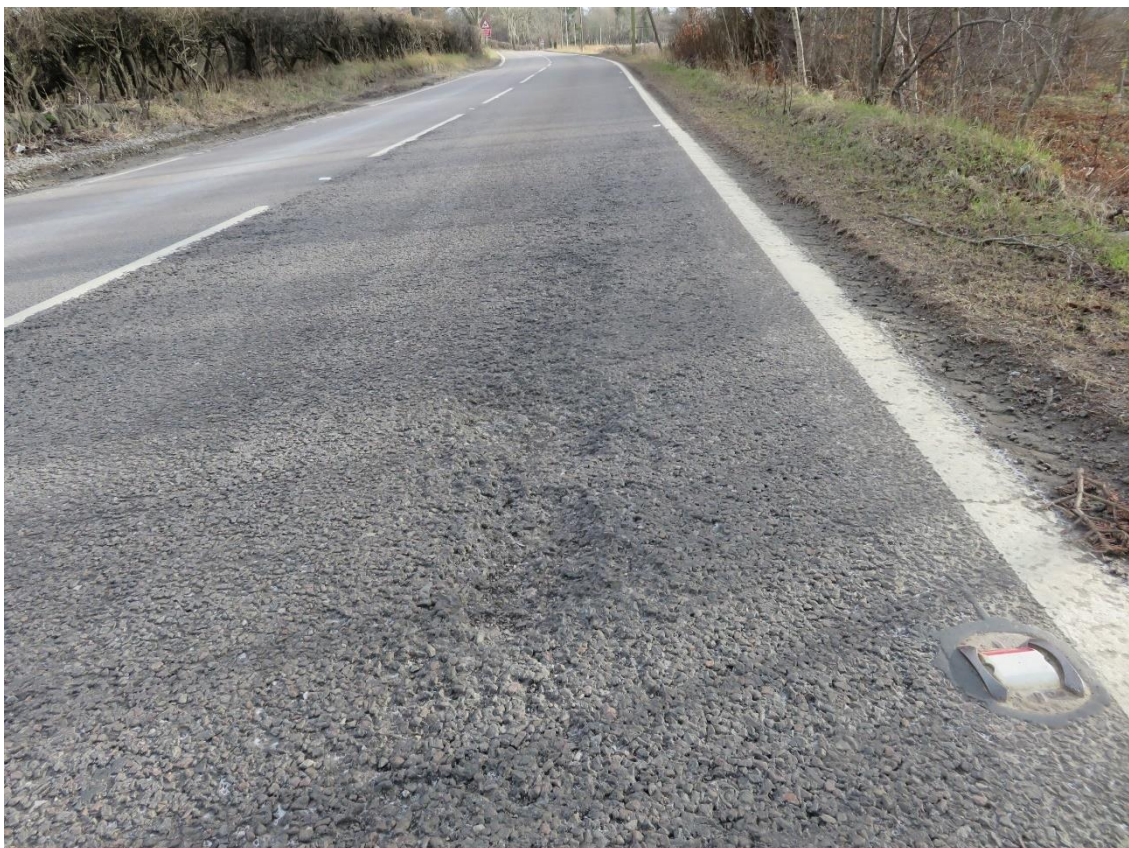
Five of the schemes visited incorporated a targeted design approach that included treating the pavement to different depths, or no treatment. In the latter case, sections of the pavement within the scheme were not treated and presumably deemed to be defect free at the time of the design. The schemes included both single and dual carriageways. Figure 3-2 shows an example of a section omitted for treatment on a single carriageway scheme. Recorded defects were typically found close to the boundary of these sections, i.e. start, end, or adjacent to longitudinal joints, but external to the treated area. The site visits also confirmed that defects recorded on three schemes were confined to bridge deck areas that had not been treated as part of the maintenance works.

Figure 3-2 - Example of section omitted for treatment

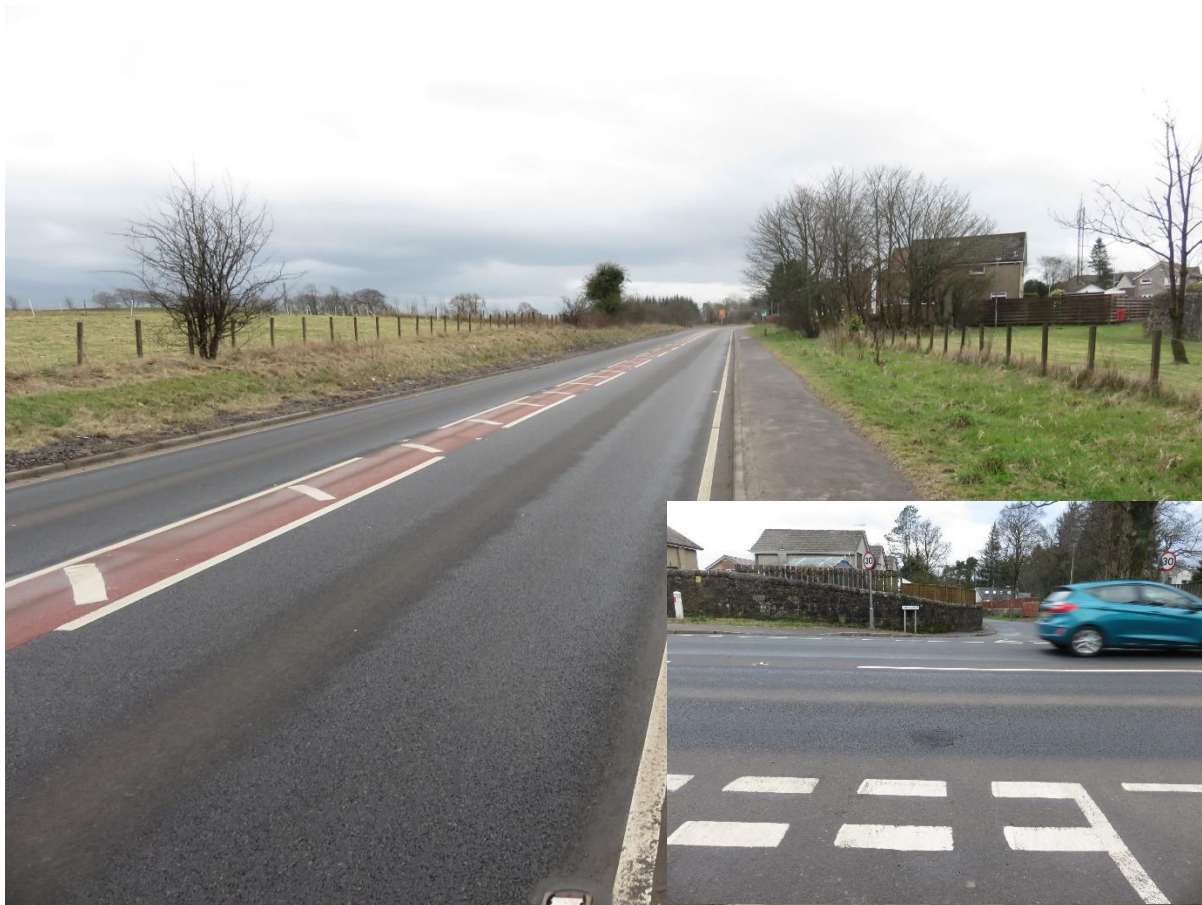
An example of this type of site is shown in Figure 3-3. The scheme on the A95 near Beith was 868 m long and only one pothole (see insert) was found within the boundary of the treated area.

Figure 3-3 - A737 Beith with single pothole (18 months old)

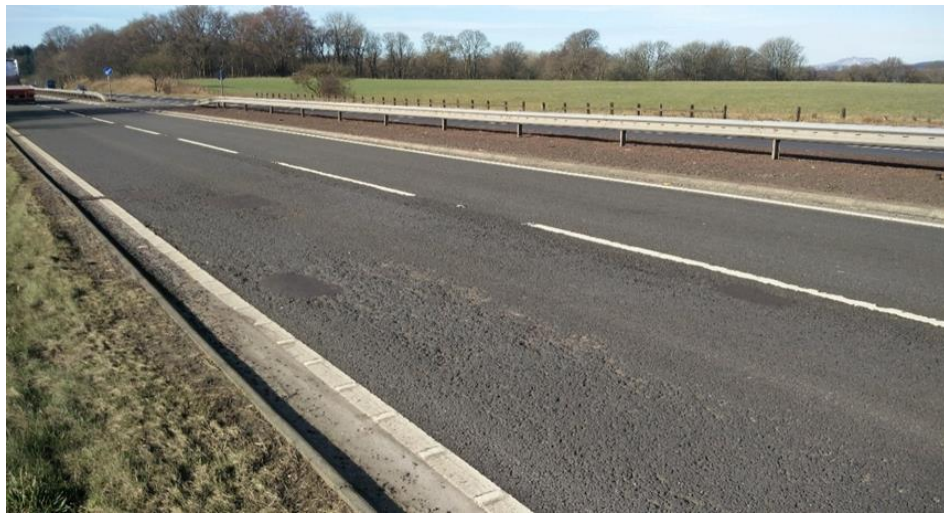
The chosen depth of an inlay is likely to be driven by visual condition surveys (VCS), extracted cores and deflection data, where available. VCS data for one of the schemes visited shows that the main driver for maintenance was surface fretting. Figure 3-4 shows the condition of the surfacing in 2016, prior to treatment in 2017, and Figure 3-5 shows an image taken in 2021, post treatment, at approximately the same location.

Figure 3-4 - VCS near A9 Dunblane in 2016, prior to treatment

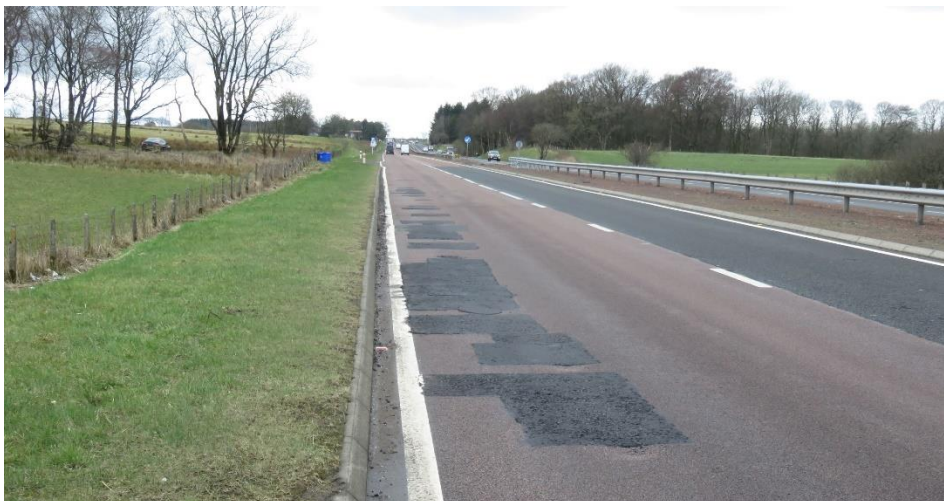
Figure 3-5 - A9 near Dunblane after treatment (2021)

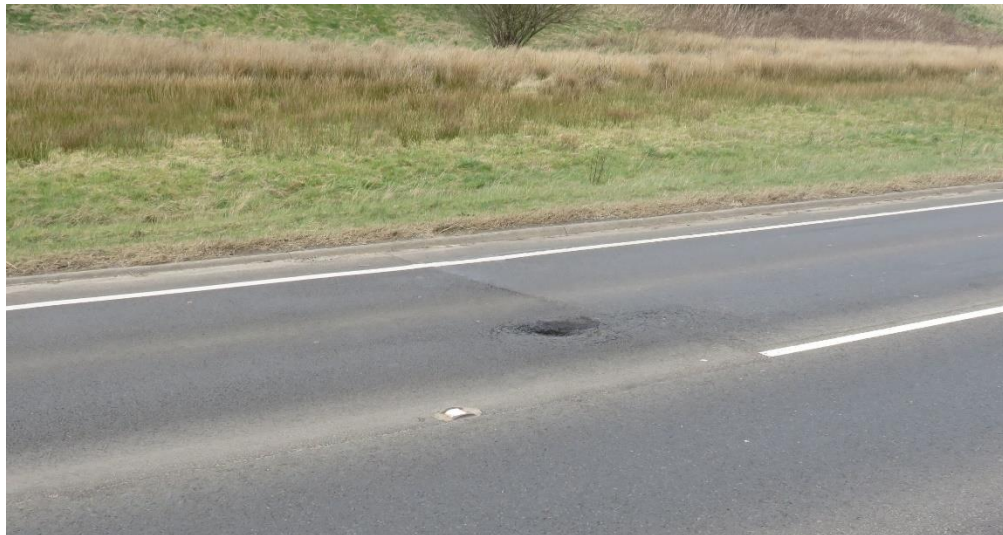
A scheme visited on the A77 near Maybole had been reported to experience widespread early life defects a few months after completion in 2017. The defects were only found where a 40mm treatment had been carried out, i.e. none of the deeper treated sections of pavement exhibited any defects. An extensive pavement investigation was carried out in 2019 that concluded that the process of milling operations and exposure to light precipitation had activated a clay mineral within the exposed layer or substrate and subsequently affected the bond to the new asphalt layer. The site visit showed that where these areas had been replaced with a deeper inlay the surfacing showed no defects. However, some small areas suspected to still contain a shallow inlay are continuing to deteriorate (Figure 3-6). Three other sites on the A77, A1 and A82 highlighted that the majority of defects were confined to areas where a shallow (40 mm) inlay had been selected.

Figure 3-6 – Defect on A77 near Drumellan Farm (2021)

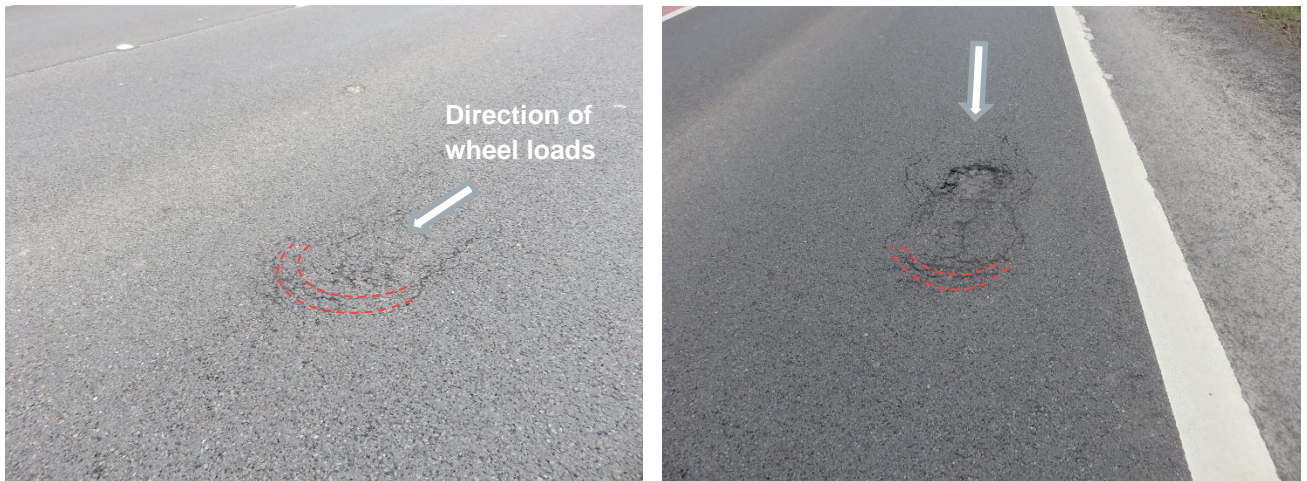
It is possible that the new 25mm thick surface course may have slid upon the weak layer below. As a result, excessive flexure in this 25 mm layer would cause the material to crack and break up. An image of the ongoing surfacing deterioration at the A1 is shown in Figure 3-7. Once deterioration commences it is difficult to ascertain the exact failure mechanism, but there are some signs of slippage cracks, represented by crescent-shaped tears, and these are highlighted in Figure 3-7 with dashed red lines. It is likely that the new surfacing material is continuing to move or slide under wheel loads owing to a lack of bond and support from the underlying HRA.

Figure 3-7 - Development of defects following thin inlay

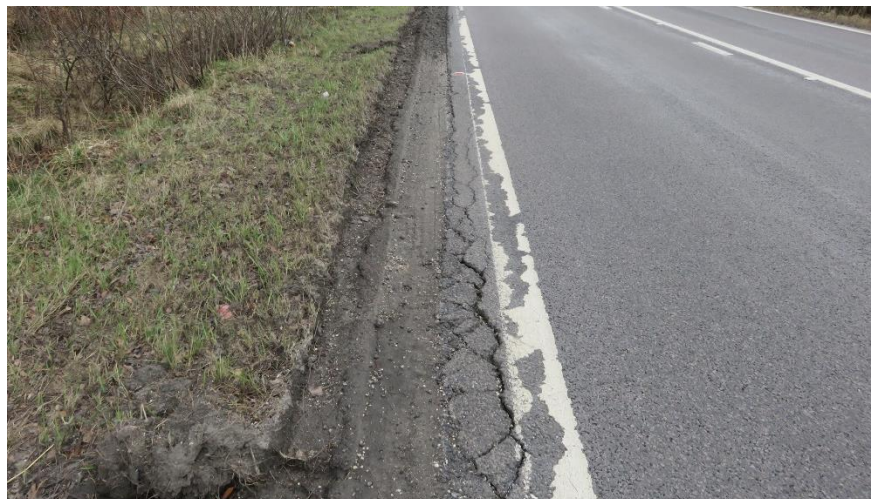
Defects at two of the sites visited were predominantly related to edge deterioration. Figure 3-8 and Figure 3-9 show examples of edge deterioration on the A95 and A82, respectively. Heavy goods vehicle (HGV) tyre marks could be seen clearly at both locations.

Figure 3-8 - HGV edge overrun on A95

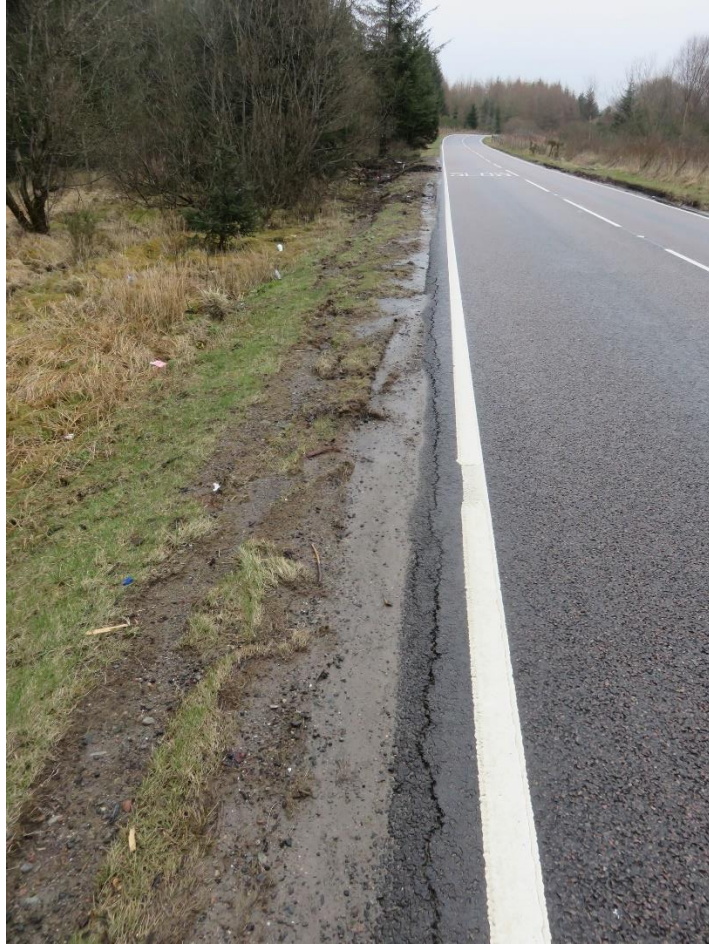
Figure 3-9 - HGV overrun on A82

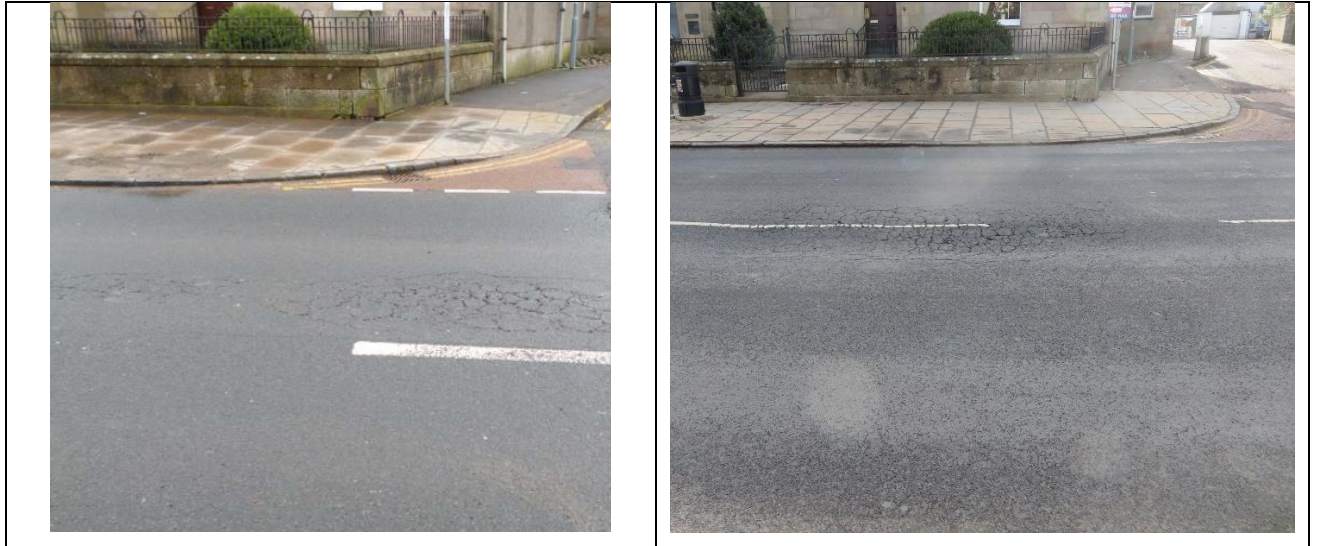
'alligator' cracking which is related to inadequate structural support. In this instance the reason for failure is most likely due to a loss of subbase or subgrade support, or the presence of water. The presence of water under a pavement will generally cause the underlying materials to become weak.

Figure 3-10 - Structural rutting before treatment (left, 2018) and after treatment (right, 2021)

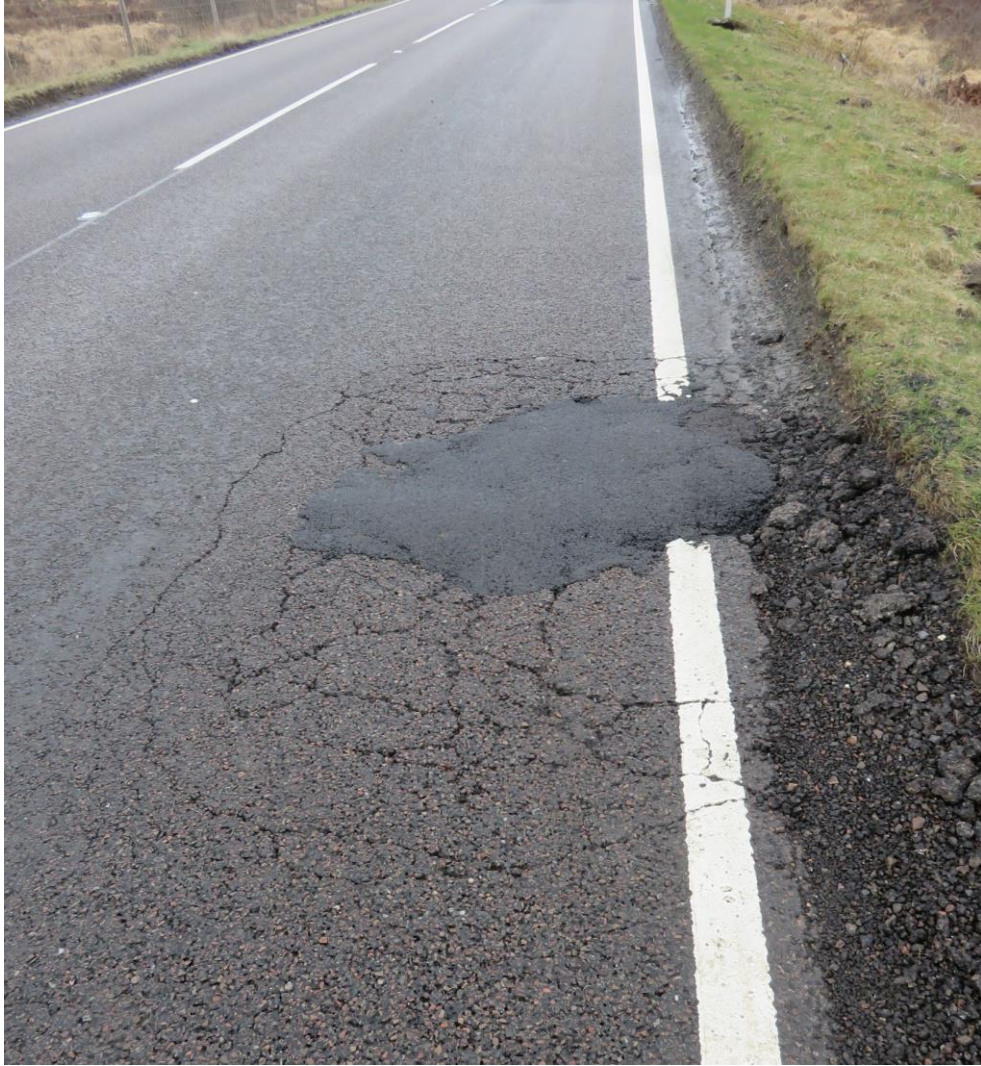
At the time of the visit several defects were noted which were confined to the outer edge of the pavement and could have been related to the edge of the lower concrete slab. However, some of the defects were observed to be of a structural nature (see Figure 4-2). This road is a rural single carriageway with an average width of 6.1m and limited drainage. It is recognised that these types of road are not uncommon on the Scottish network and it is possible that some pavements perform better than others owing to the presence of natural free draining and favourable ground conditions. Nonetheless, it is recommended that where excessive vehicle overrun and damage is identified at the design stage, then road widening and improved drainage must be considered. Notwithstanding the adoption of this advice, it should be expected that the life span of these type of roads will be shorter than would otherwise be the case and hence the appearance of early life defects will continue to occur.

Figure 4-2 - Structural failure noted on A82 at 2.5 years old

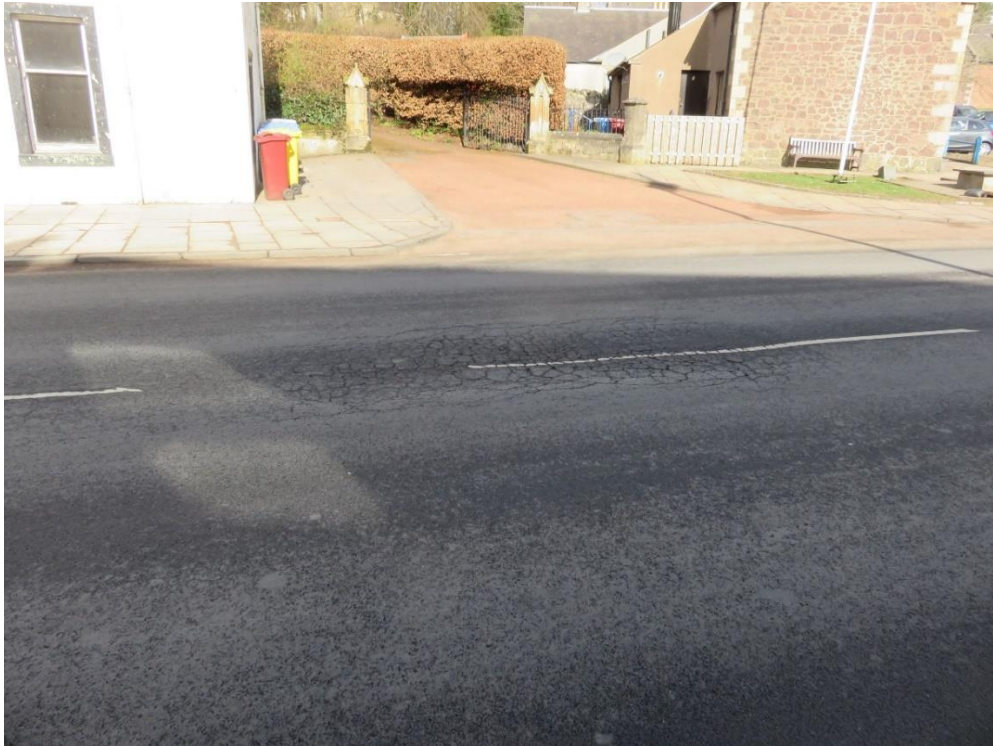
Carrying out structural maintenance on a road pavement that has failed owing to a high density of utility apparatus, reinstatements and street furniture is challenging. There is a high likelihood that many of the surface defects encountered in an urban environment are due to failure of material below the bound layers of the pavement. One site visited as part of this study (Figure 4-3 and Figure 4-4) suggests that full reconstruction in some sections may be the only solution. Full reconstruction requires the replacement of all the bound layers and may extend into the foundation. It is likely that subbase defects, such as low CBRs, contamination, etc, mean that the subbase may need to be replaced.

Figure 4-3 - Structural failure on A702 after 22 months

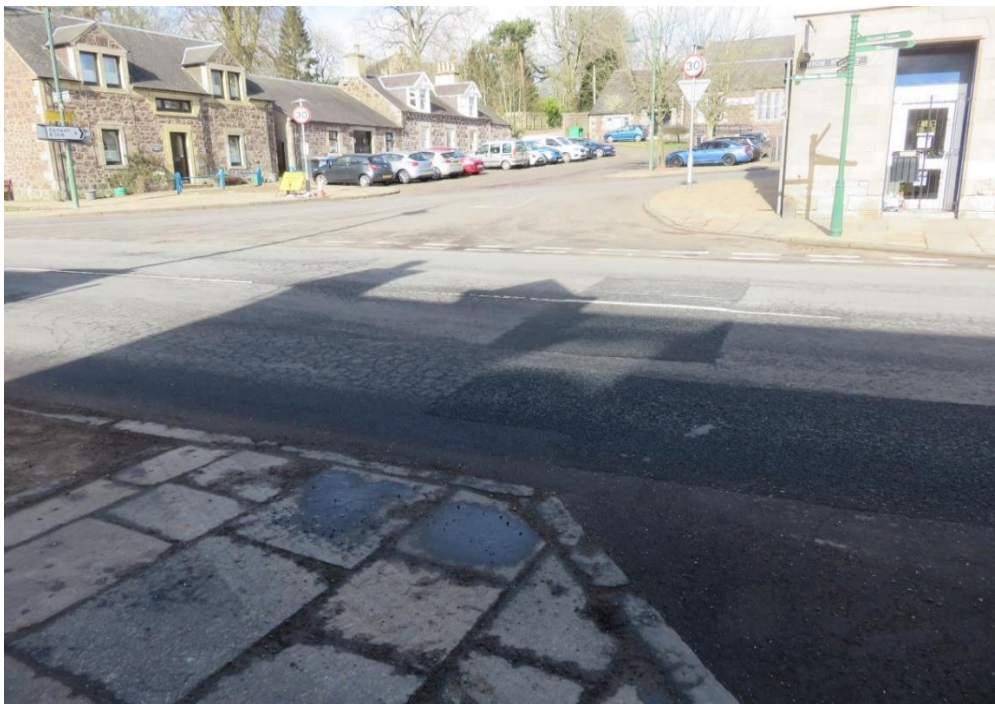
Figure 4-4 - Alligator cracking and remedial treatment at A702

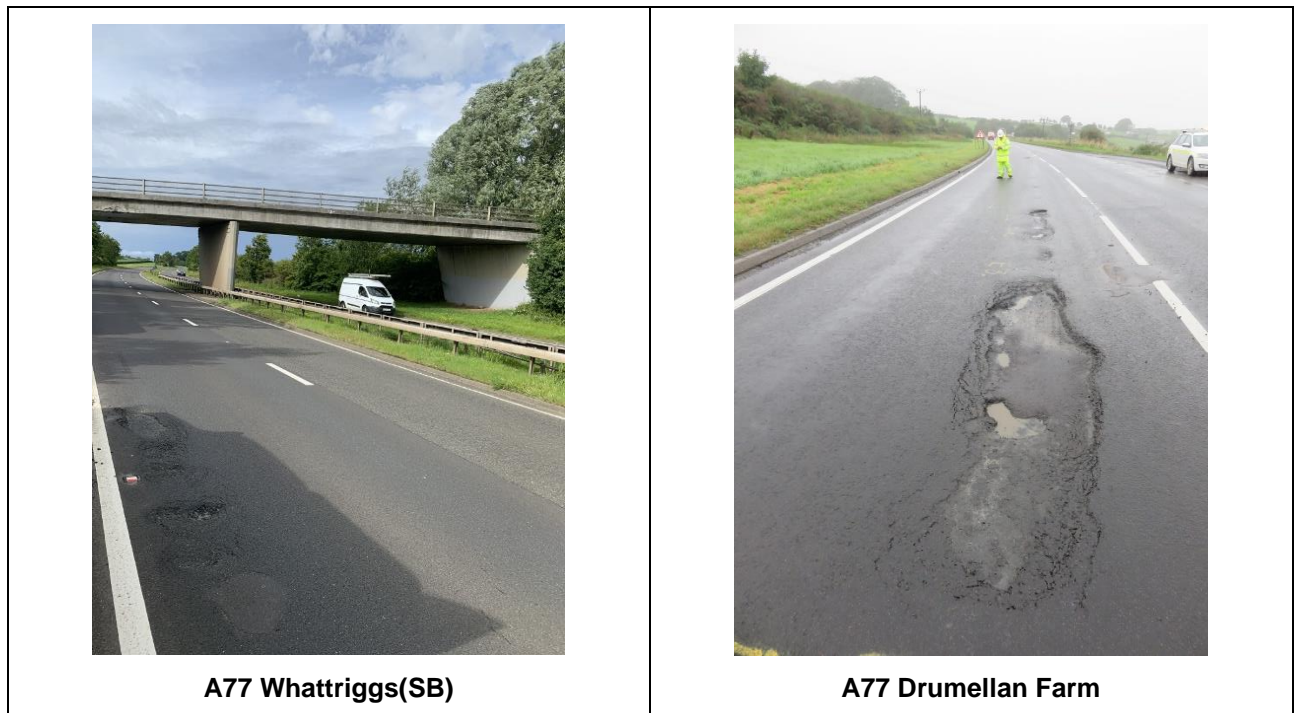
A defect register, listing 28 schemes, was submitted by the SW representative. The list contained information on the sites and some of the defects that had been recorded between 2015 and 2019. Fourteen of the scheme identifiers were coded '0300' signifying that the work was carried out as part of routine maintenance. The other 14 schemes were coded '0100' which means they were part of a structural maintenance programme. A decision was made to concentrate on the latter sites as these schemes require to be designed and were likely to provide more relevant information to the study. Some images of the early life failures are shown in Figure A-1.

Figure A-1 - Images of early life failures in the SW

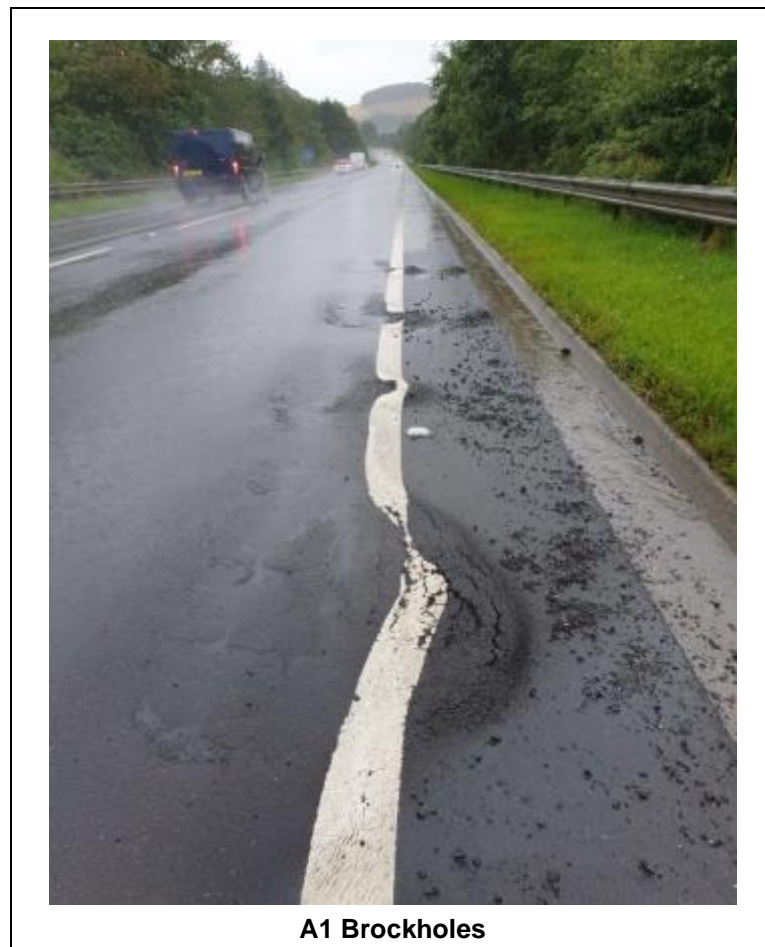
Figure A-2 - Early life defect in the SE

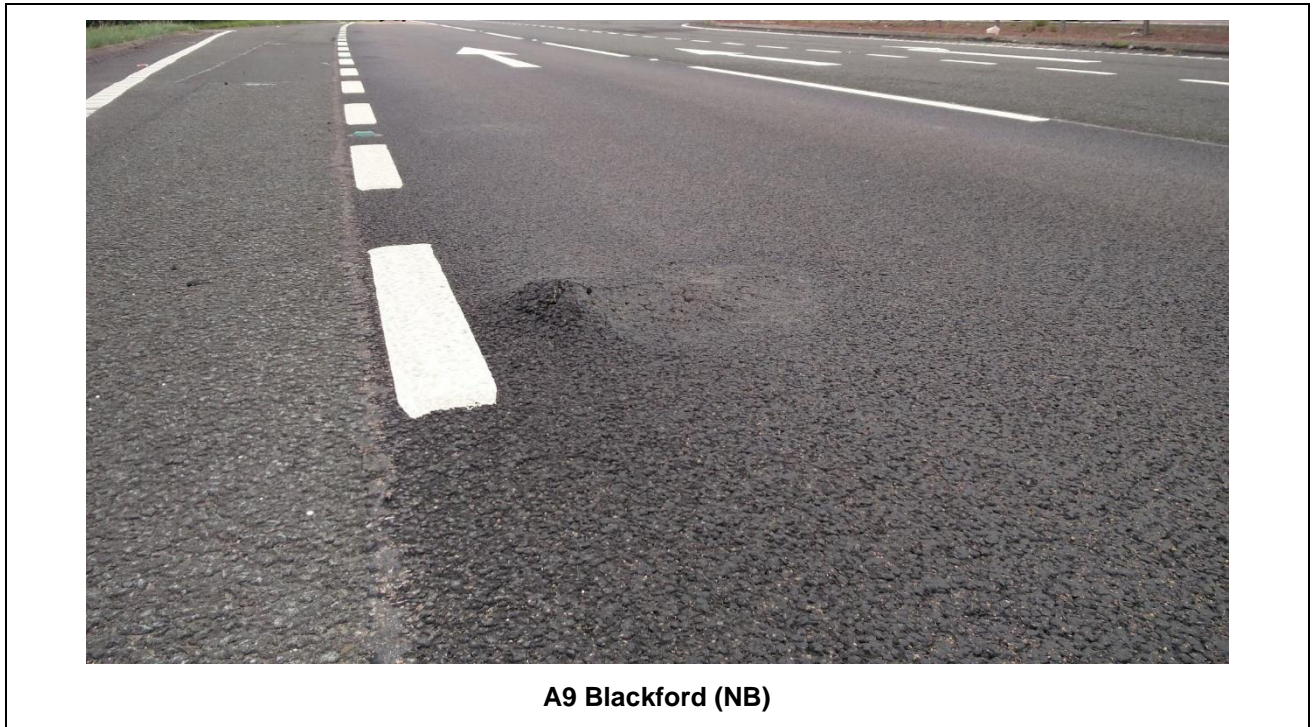
Figure A-3 - Early life defect in the NE

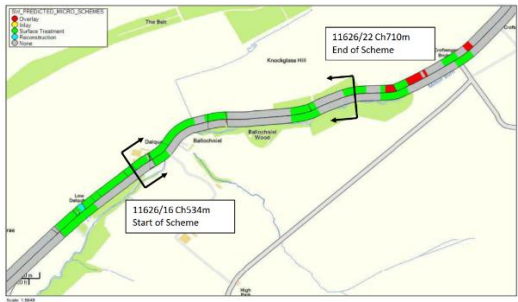
<ul style="list-style-type: none"> Walk-over, check current status 	<p>A77 - South of Kirkoswald Road Type: D2; length 846m; completed in October 2019.</p> <p>This scheme was supplied by the OC, highlighting a large pothole with cracking in the vicinity and water within the hole. The description and location appear to correspond with the defect at chainage 217 found as part of this investigation. The treatment, from analysis of the VCS and cores appears to be reasonable, but there is no client review within IRIS to ascertain any concerns or conflicts arising from the review process.</p>
20	17/SW/0103/005

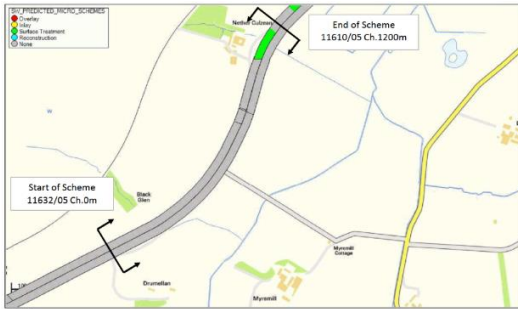
<ul style="list-style-type: none"> Walk-over, check current status 	<p>A77 – Drumellan Farm. Road Type: S2; length 1200 m; completed in May 2017.</p> <p>93 defects on this scheme have been well documented with further coring and laboratory testing to ascertain the route problem. The treatment proposed by the OC appears to have been reasonable, with a 40mm inlay implemented through the majority of the scheme with targeted 200m inlays dictated by the VCS and core reports. IR highlighted issues with the existing binder course, possibly suffering from moisture ingress when exposed following planing operations. The presence of clay was found in the binder course. Construction failures were restricted to sections that had received a 40mm inlay.</p>

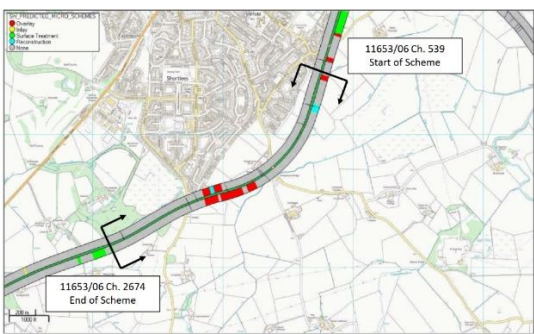
<ul style="list-style-type: none"> Drive-over, check current status Closer inspection to be carried out at Laybys (one located at beginning of job) Defects/repairs located near overbridge 	<p>A77 (SB) - South of Kilmarnock. Road Type: D2; length 2135 m; completed in September 2019.</p> <p>Scheme supplied by OC. Eleven defects include potholes, fretting and chip loss. Street View (Sept 2020) shows variation in surface texture between CL1 & CL2 with the former looking very open compared to CL2. Scheme includes 40 mm to 220 mm structural inlays.</p>

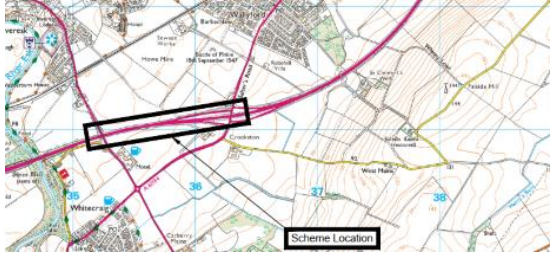
<ul style="list-style-type: none"> • Drive over to check there are no defects • Appears to be a referencing issue with defects. • Eyeball aggregate size. 	<p>A1(SB) - approx. 2.5 miles E of Musselburgh Road Type: D2; length 1280 m; completed in Nov 2018</p> <p>The six defects recorded as part of this work do not appear to tie in with the information supplied by the OC. This may simply be reporting errors by the inspection team. Some of the deeper treatments consisted of ½ lane inlays, with some concerns regarding the location of construction joints below the wheel tracks. Original design specified a 14mm TS2010. However, according to the MSD, a 10mm TS2010 surface was laid on site.</p>
12	20/SE/0103/23

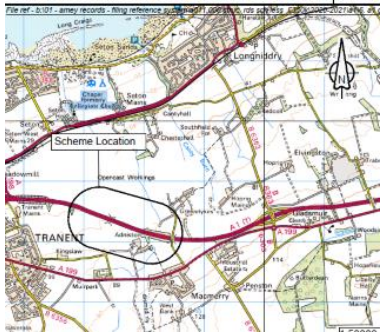
<ul style="list-style-type: none"> • Drive over to check status. • Isolated defects clearly visible on Street View (Sep 2020). 	<p>A1 (NB) – nr. Macmerry Road Type: D2; length 1509 m; completed in August 2019.</p> <p>One defect/small area identified within the scheme extents. Since the initial search in July 2020, there has been a further defect recorded in November 2020 at chainage 1337 – described as 2 potholing patch repairs of 8m x 1m and 4m x 1m in size.</p>

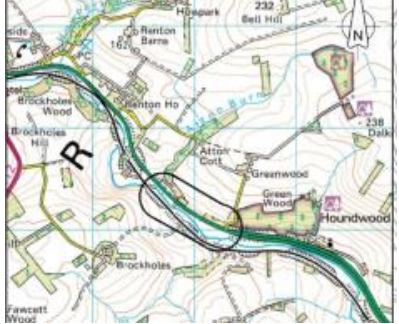
<ul style="list-style-type: none"> • Walk-over, check current status • Check to see if deeper constructed section is free of defects. [NB. Approx. Ch 70 to 220m from the northern side of the scheme] 	<p>A1 - Nr. Houndwood Road Type: S2; length 1,069 m; completed in April 2018.</p> <p>Fifteen defects recorded. An inlay of 25 mm thick, 6 mm TS2010 was carried out. In addition, 150 m length of a deeper 100mm localised inlay of 25mm surface course and 75 mm AC20 was used in CL1 only. The OC had proposed a further 100mm inlay in CR1 over the same section length but this was removed from the design. A report on the failures was compiled by the OC. There have also been another five Cat 1 defects repaired since the initial search in July 2020.</p>

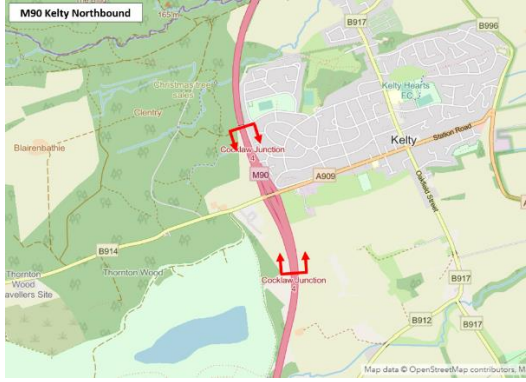
<ul style="list-style-type: none"> • Drive-over, check current status 	<p>M90 (NB) - Jct 4 & West of Kelly. Road Type: D2; length 1115 m; completed in November 2016.</p> <p>7 defects recorded. The maintenance driver was cracking along the hard shoulder, open joints and fretting. The OC proposed a 120mm inlay including a reinforcement grid in CL1. All of the defects recorded since resurfacing occurred within a 40-metre section of CL1 or the left edge of the C/way. There is a possibility that the fretting defects noted from chainage 128 onwards could be outside the scheme extents and are not early life defects.</p>
3	17/NE/0103/015

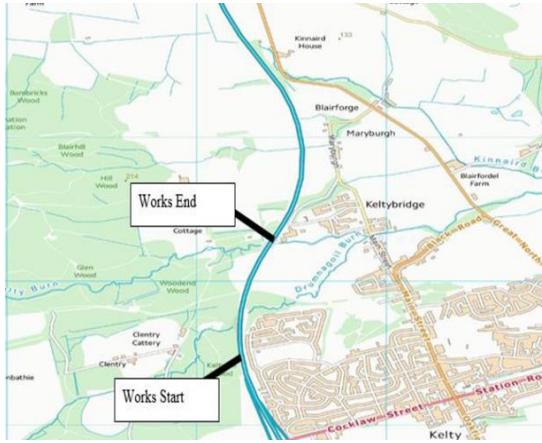
<ul style="list-style-type: none"> • Drive-over, check current status • Starts from job above and finishes just beyond bridge deck. 	<p>M90 - Jct 4 to 5 N of Cowdenbeath. Road Type: D2H; length 1,000 m; completed in November 2018</p> <p>All four defects happened from chainage 967 to 974, prior to the bridge deck (ch.988-1018). There are some inconsistencies at this location as the MSD indicates that the bridge deck was resurfaced along with the remainder of the site. However, images from Google earth (October 2020) show that perhaps the deck was not resurfaced and that the defect chainage may be inaccurate and the defects occurred on the bridge deck.</p>

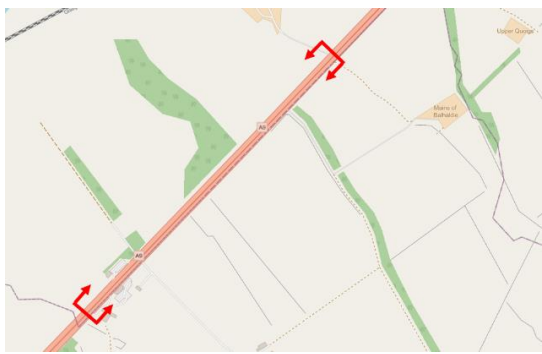
<ul style="list-style-type: none"> • Drive-over, check current status • Closer inspection to be carried out at Layby (one located near beginning of job) 	<p>A9 (SB) - NE of Dunblane Road Type: D2; length 1,040 m; completed in April 2017.</p> <p>20 defects reported and main maintenance driver was fretting and potholes. The treatment consisted of 40 & 60mm targeted Inlays. Eighteen of the 20 defects since resurfacing occurred within a 51m section of CL1 (Ch 1318 to 1369). Nearest core (1 of 14) to this area (Ch 1381) was recorded as broken to a depth of 95mm. The remaining 13 cores were all in relatively sound condition.</p>

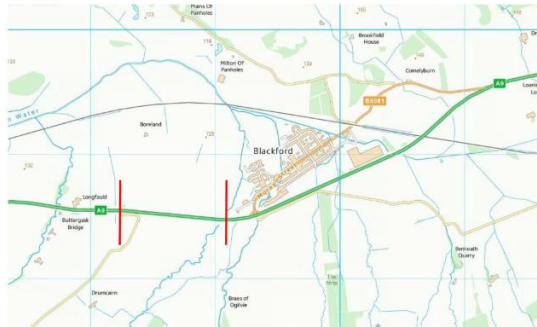
<ul style="list-style-type: none"> Walk-over, check current status of remedial repairs Parking at start of job 	<p>A9 (NB) - Sherrifsmuir to Blackford Road Type: D2; length 840 m; completed in April 2017.</p> <p>10 defects recorded. Maintenance driver for this scheme was fretting. PI found no structural issues. OC had proposed a surface course replacement and not disputed during the review process. All defects recorded since resurfacing occurred on a 17 m section of CL1 (Ch 1520 to 1537). Further core investigation (October 2017) revealed that the binder layer had deteriorated, and was attributed to the presence of clay in binder that broke down during planing operations. A remedial intervention replaced both the surface course and binder course. Street view (2019) show no defects in remedials.</p>

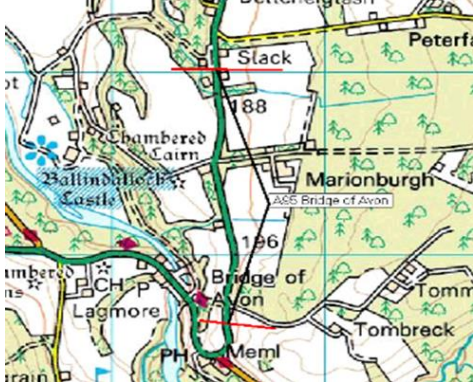
<ul style="list-style-type: none"> *Not inspected owing to Covid restrictions. Street View (Nov 2020) shows repairs to road edge that are not thought to relate to reinstatement, i.e. damage due to vehicle over-run. 	<p>A95 - Ballindalloch Road Type: S2; length 1375 m; completed in July 2018.</p> <p>8 defects recorded. Maintenance driver was to include repair of longitudinal reinstatement. Images from VCS (2017) show cracking, crazing and rutting in the vicinity of this reinstatement. The 8 defects recorded since resurfacing occurred within two 16 m sections (Ch 636 to 652) and 100 m section from (Ch 965 to 1065). If the chainage of the defects is accurate then there is the possibility that they have happened where the treatment depth was limited to 45mm of TS2010. There is also a possibility that the Gas line restricted the pavement investigation, although this is not mentioned in the SOI or review process. There has also been a further 11 defects recorded at this location since the initial search in July 2020. NB Initial SOI states section of A95 is an evolved road with limited drainage.</p>

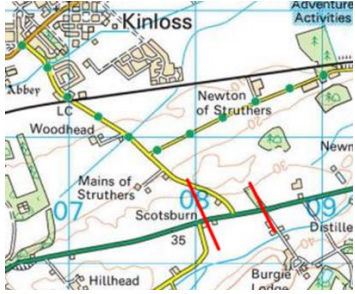
<ul style="list-style-type: none"> *Not surveyed owing to Covid restrictions. 	<p>A96 - Forres to Elgin, adjacent to the Kinloss military base junction. Road Type: S2; length 248 m; completed in September 2019.</p> <p>2 defects recorded. Treatment consisted of 150mm, with the exception of the turning lane, that received a 45mm Inlay of TS2010. Two areas of fretting reported in March 20.</p>

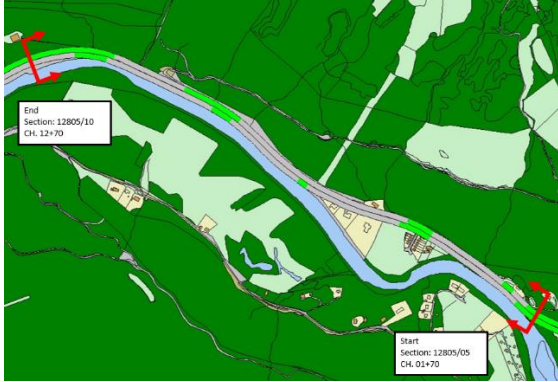
<ul style="list-style-type: none"> Footway available for part of the scheme. 	<p>A887 - west of Invermoriston Road Type: S2; 1732 m; completed May 2018.</p> <p>37 defects recorded. The MSD form details show that a combination of 6mm CI942 and 0/10 mm TS2010 was laid at the site. The 6mm CI942 from ch.0-194 was implemented in February 2018 while the remainder of the site was resurfaced with TS2010 (10mm) in May 2018. There is no obvious reason for the fretting defects found on this site</p>
8	18/NW/0103/095

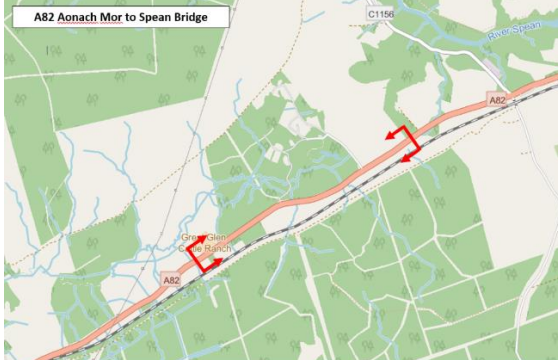
<ul style="list-style-type: none"> Not surveyed owing to Covid restrictions. Drive-over, check current status closer inspection to be carried out from side roads 	<p>A82 - south of Spean Bridge Road Type: S2; length 1,457 m; completed in September 2018.</p> <p>2 defects recorded. The treatment consisted of a 150 mm inlay: 50mm AC20 Dense Binder course was laid on planed surface followed by a pavement reinforcement geogrid with a further 60 mm of AC20 Dense Binder course and a 40mm CI942 10m surfacing. From the SOI review process, this treatment was devised to address a deteriorated composite pavement construction. The VCS indicated the presence of transverse cracking, edge cracking, potholes, fretting and crazing. The TS review noted that edge cracking might be a result of a different construction at the edges.</p>

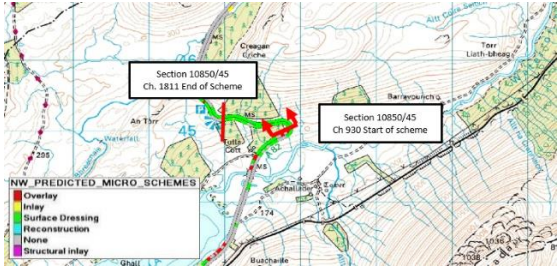
<ul style="list-style-type: none"> Park at Loch Tulla viewpoint & walk down Visited during SIP19 (edge defects?) 	<p>A82 - North of Bridge of Orchy Road Type: S2; 881m; completed in May 2017.</p> <p>5 defects recorded. The OC had originally proposed an inlay consisting of 80 mm binder and 40mm CI942. Altered during the review process to an overlay due to concerns about the lower layers and leaving them in place. All 10 cores showed disintegration or were broken in the lower layers. Design was changed to an inlay/overlay 70; planing depth of 50mm and overlaying 80mm AC20 and 40mm CI942 (10mm). There were 5 defects found within the extents, one of the defects was described as "Failed resurfacing" by the inspector.</p>

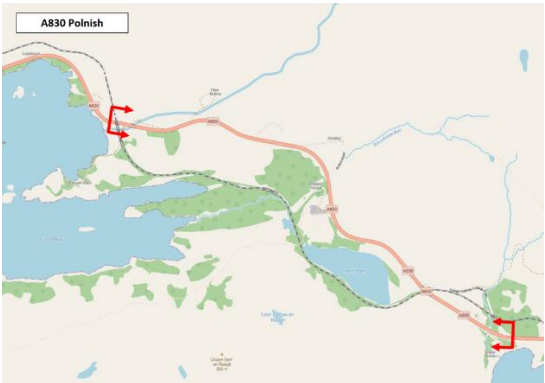
<ul style="list-style-type: none"> • Drive over to check current status • Various side road for closer inspection. 	<p>A830 T- Loch Beag to Loch Ailort Road Type: S2; 3,280 m; completed in August 2016.</p> <p>40 defects recorded. The treatment consisted of a mix of 40mm and 100mm targeted patches over a 3km stretch of the A830. Defects listed include cracking, fretting and potholes, although due to the nature of the scheme and allowing for discrepancies in defect position reporting, there is some difficulty in determining the exact number of defects - 40 originally identified, reduced to 25 after further review. There were no issues noted during the review process.</p>
<p>9</p>	<p>17/NW/0103/133</p>

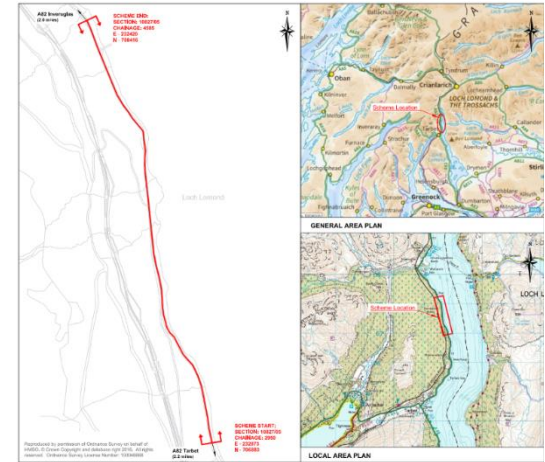
<ul style="list-style-type: none"> • Drive over to check current status 	<p>A82 - Tarbet and Inveruglas Road Type: S2; length 1,635 m; completed in September 2018.</p> <p>60 defects recorded. Treatment consisted of 40 6 mm CI942 & 70mm of AC20 Binder. There is limited scope to make any conclusions on this section: missing several documents, including the TS review, VCS and Core report. However, using the MSD construction information and IRIS chainage locations of the defects, it can be seen that 49 of the 60 defects have occurred out with the sections that received a deeper treatment. It was also noted on the SOI that drainage had historically been an issue at this location.</p>

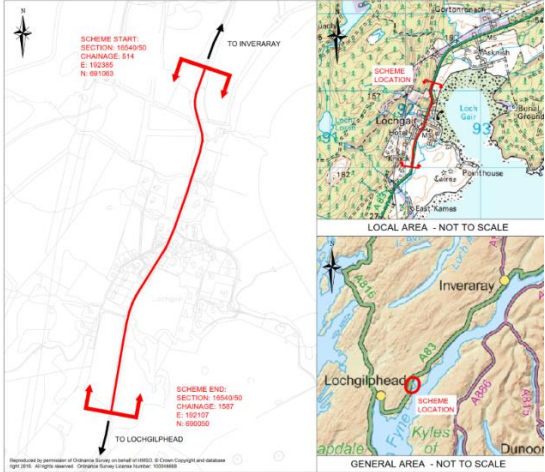
<ul style="list-style-type: none"> • *Not surveyed owing to Covid restrictions. 	<p>A83 - Lochgair / Loch Fyne. Road Type: urban S2; length 1,073m; completed in January 2017.</p> <p>16 defects recorded. The initial treatment proposed by the OC was 60mm of EME2 Binder and 40mm of 14 mm CI942. The design was amended during the review process with the client proposing a 10mm CI942 and AC20 Binder due to compaction concerns regarding EME2. The defects found as part of the Early Life Failure investigations include edge cracking, fretting, depressions and potholes. There is no obvious reason for the fretting defects found on this site</p>
