## Appendix B: Road Drainage and the Water Environment – Baseline Conditions

**A9 Dualling Programme: Pass of Birnam to Tay Crossing  
Environmental Baseline Report  
Appendix B: Road Drainage and the Water Environment  
Baseline Conditions**

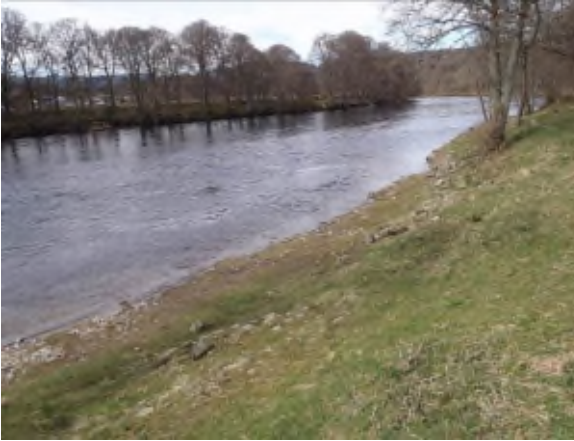
WF6 (River Tay) – view upstream towards Dunkeld and Birnam.
	Fluvial geomorphology	WFD hydromorphology status: Moderate (2013). Meandering planform with islands. Historical change: erosion and deposition, island development. Riparian buffer: 40m trees. Structures: two bridge structures (A9 and A923). Pebble and cobble bed, predominantly smooth flow, some large riffles, 80m-90m wide.	
	Water quality/supply	WFD overall chemical status: Pass (2013). WFD overall water quality status: Good (2013). Existing pressures: point source pollution from sewage disposal; morphological alterations preventing fish passage (dams/weirs); and alien species (Australian swamp stonecrop – <i>Crassula helmsii</i> ). Drinking water abstractions, abstractions for hydropower. Potential additional pollutant sources: diffuse rural sources, road drainage.

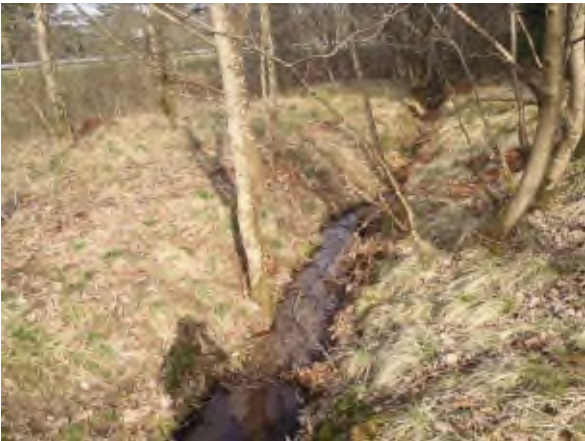
<p>WF2 – View downstream towards existing A9 culvert inlet.</p>
	Fluvial geomorphology	WFD hydromorphology status: not classified. Slightly sinuous planform. No riparian buffer. Historical change: No change in planform since 1867, culverted under the existing A9 between 1959 and 1981. Structures: culverted under Highland Main Line railway and the existing A9. Silt bed, 0.5m wide, some variations in flow.

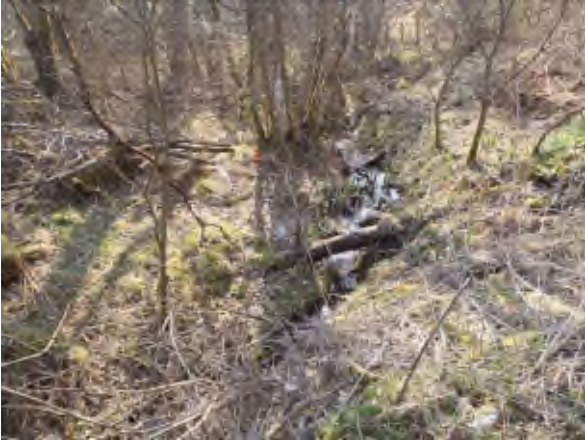
<p>WF5 – downstream view from B867 towards A9.</p>
	Fluvial geomorphology	WFD hydromorphology status: not classified. Straight planform. Silt bed, limited flow variation, 0.4m wide.	
	Water quality/supply	WFD overall chemical and water quality status: not classified. Mapped by OS (1:25,000 scale) as a discontinuous linear feature terminating north of the B867. However, it was noted that a dry channel exists to the north leading to the embankment of the existing A9. Potential pollutant sources: diffuse rural sources, road and rail drainage.

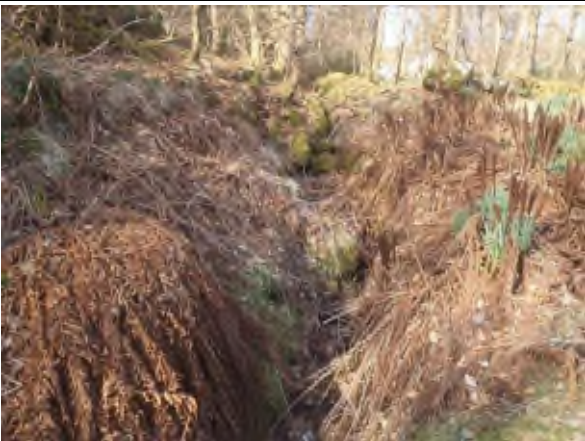
<p>WF186 – upstream view from Birnam Glen access road.</p>
	Fluvial geomorphology	WFD hydromorphology status: not classified. Straight planform.	
	Water quality/supply	WFD overall chemical and water quality status: not classified. Potential pollutant sources: diffuse rural sources.	
	Dilution and removal of waste products	Low flow, likely to be ephemeral.	
	Biodiversity	WFD overall ecological status: not classified. Fisheries status: not classified.	
WF8 (Inchewan Burn)  5.77km <sup>2</sup> catchment  Surrounding land use: development, woodland, plantation, moorland.	Hydrology and flood risk	SEPA Flood Maps show direct flood risk to the surrounding properties in Birnam.

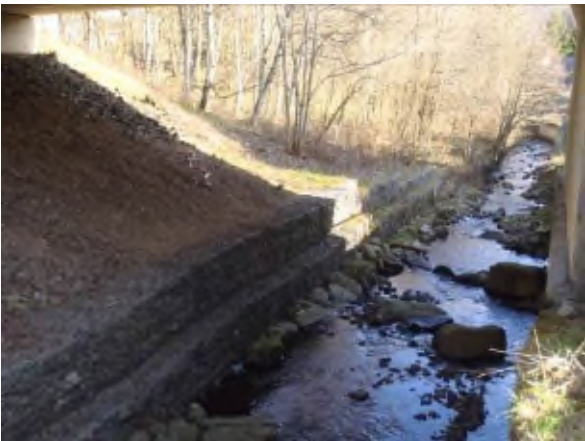
<p>WF8 (Inchewan Burn) – downstream view of restored section underneath A9 overbridge.</p>

Fluvial geomorphology	WFD hydromorphology status: not classified. Sinuous planform. Riparian buffer: 10m-20m trees. Historical change: erosion and deposition, meander migration, straightened near the existing A9. Structures: bridge crossing under the existing A9 and Highland Main Line railway, culverted under local access routes. Upstream section includes a dynamic bedrock cascade. Downstream section: gravel and cobble bed, 3m wide, step-pool sequence.	
	Water quality/supply	WFD overall chemical and water quality status: not classified. Potential pollutant sources: diffuse rural sources and urban, road and rail drainage.	
	Dilution and removal of waste products	Low to medium flow with falls and weirs upstream of the existing A9. Low to medium pollution dilution/dispersal capacity.	
	Biodiversity	WFD overall ecological status: not classified. Fisheries status: not classified. Historic man-made barriers to fish passage under existing A9 now removed after river restoration works in 2007 (River Restoration Centre, 2013). Considered to be salmonid waters in its lower reaches; upper sections have falls, which are likely to block fish

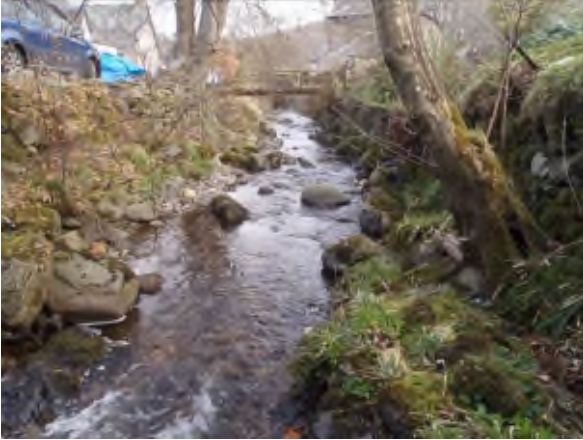
<p data-bbox="1541 783 2121 810">WF8 (Inchewan Burn) – downstream view in Birnam.</p>
WF187  0.06km <sup>2</sup> catchment  Surrounding land-use: woodland/ agriculture.	Hydrology and flood risk  Fluvial geomorphology  Water quality/supply  Dilution and removal of waste products  Biodiversity	No flood risk has been identified for this water feature using either the SEPA Flood Maps or OS map.  WFD hydromorphology status: not classified. Road drain, limited features.  WFD overall chemical and water quality status: not classified. Possible pollutant sources: rail drainage.  Low flow, likely to be ephemeral.  WFD overall ecological status: not classified. Fisheries status: not classified.	No photo (not accessed).
WF9  0.75km <sup>2</sup> catchment  Surrounding land use: development, grassland, plantation, woodland.	Hydrology and flood risk  Fluvial geomorphology  Water quality/supply	No flood risk has been identified for this water feature using either the SEPA Flood Maps or OS map.  WFD hydromorphology status: not classified. Straight planform field drain. Structures: culverted under the existing A9 and local access routes. Silt bed, smooth flow, 1.2m wide, vertical earth banks.  WFD overall chemical and water quality status: not classified. Possible additional pollutant sources: diffuse rural sources, and urban, rail and road drainage.

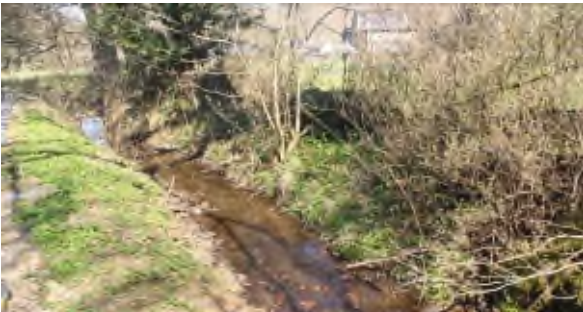
Water Feature ID (water body name)	Attribute	Description	Photographs
	Dilution and removal of waste products	Low to medium flow, low to medium pollutant dilution/dispersal capacity.	WF9 – downstream view from existing A9 culvert outlet towards River Braan.
	Biodiversity	WFD overall ecological status: not classified. Fisheries status: not classified.	
WF11 (River Braan)  211km <sup>2</sup> catchment  Surrounding land use: woodland, plantation, moorland, development, agriculture.	Hydrology and flood risk	SEPA Flood Maps show direct flood risk to properties at Inver and campsite.

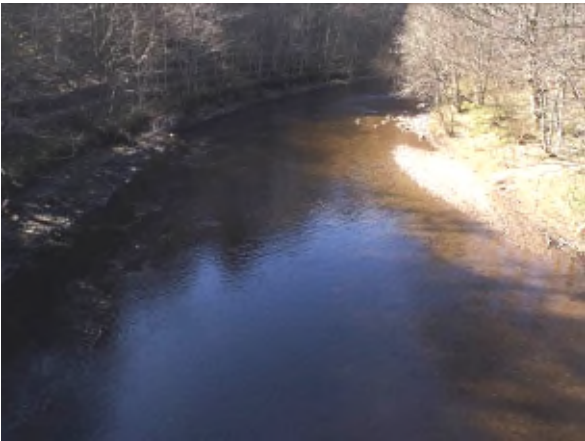
WF11 (River Braan) – view upstream from footbridge, immediately upstream of A9 bridge crossing.
	Fluvial geomorphology	WFD hydromorphology status: High (2013). Historical change: island development, deposition and erosion. Riparian buffer: 20m-30m trees. Structures: a number of bridge crossings, including the existing A9. Pebble and cobble bed, numerous boulders, 10m-12m wide.

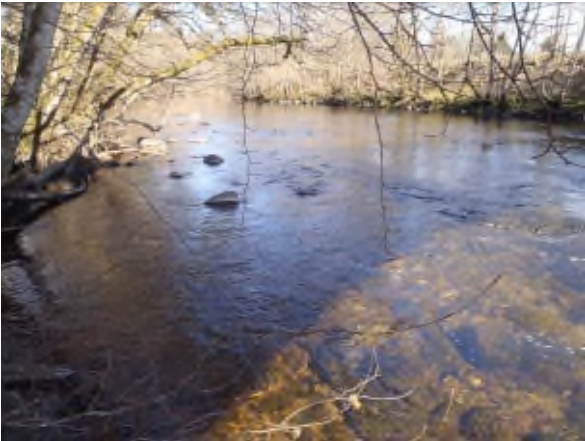
Water Feature ID (water body name)	Attribute	Description	Photographs
			WF11 (River Braan) – view downstream from railway bridge.
WF12 (Mill Lade/Mill Stream)	Hydrology and flood risk	SEPA Flood Maps show direct flood risk to properties at Inver and campsite.

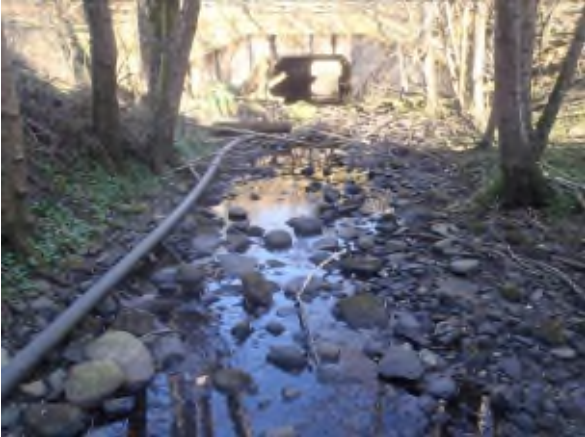
<p>WF12 (Mill Lade/Mill Stream) – view downstream towards existing A9 culvert inlet.</p>

0.02km <sup>2</sup> catchment	Fluvial geomorphology	WFD hydromorphology status: not classified. Meandering planform between River Braan and River Tay. Structures: culverted under the existing A9 and local access route. Gravel and cobble bed, 1.5m-2m wide, incised, bank reinforcement.	
Surrounding land use: development, residential/recreational (caravan park).	Water quality/supply	WFD overall chemical and water quality status: not classified. Potential pollutant sources: road drainage.	
	Dilution and removal of waste products	Low flow, low pollution dilution/dispersal capacity.	
	Biodiversity	WFD overall ecological status: not classified. Fisheries status: not classified.	
WF13	Hydrology and flood risk	No flood risk has been identified for this water feature using either the SEPA Flood Maps or OS map.

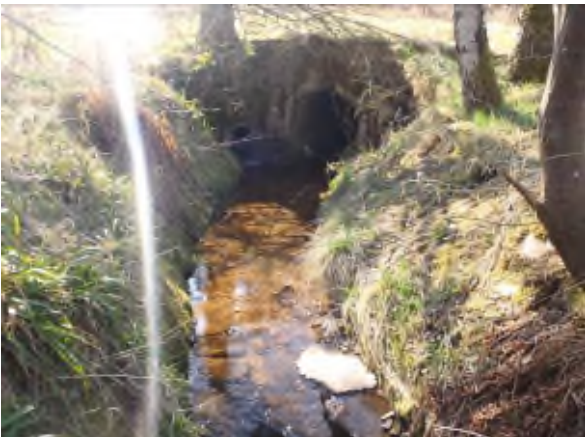
<p>WF13 – view upstream towards existing A9 culvert outlet.</p>

1.33km <sup>2</sup> catchment	Fluvial geomorphology	WFD hydromorphology status: not classified. Historical change: erosion and deposition, meander migration. Structures: culverted under the existing A9, Highland Main Line railway and local access routes. Gravel and sand bed, riffles, approximately 0.7m wide.	
Surrounding land use: woodland, moorland.	Water quality/supply	WFD overall chemical and water quality status: not classified. Potential pollutant sources: diffuse rural sources, road and rail drainage.	
	Dilution and removal of waste products	Low flow, low pollution dilution/dispersal capacity.	
	Biodiversity	WFD overall chemical status: not classified. Fisheries status: not classified.

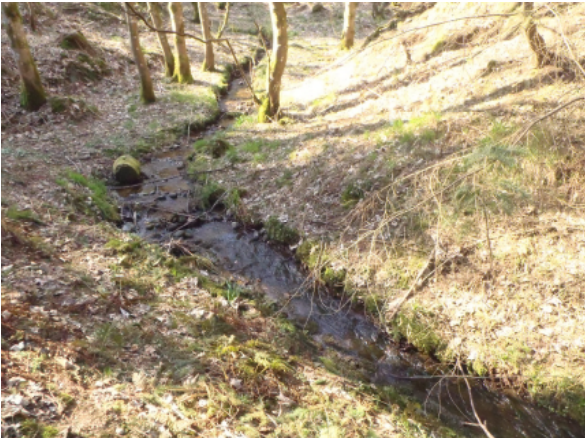
<p>WF14 – view upstream towards arch structure under Highland Main Line railway.</p>
	Fluvial geomorphology	WFD hydromorphology status: not classified. Predominantly sinuous planform. Historical change: erosion and deposition, meander migration. Structures: bridge crossing under the existing A9 (Tay Bridge) and culverted under B898 road, Highland Main Line railway and local access routes. Gravel and sand bed, riffle-pool sequence, approximately 1m wide.	
	Water quality/supply	WFD overall chemical and water quality status: not classified. Potential pollutant sources: diffuse rural sources, road and rail drainage.	
	Dilution and removal of waste products	Low flow, low pollution dilution/dispersal capacity.

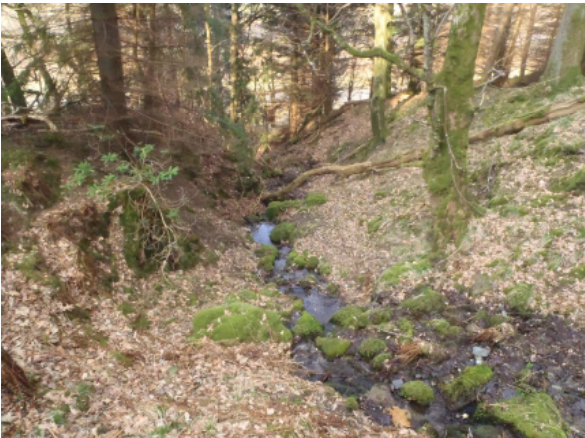
<p>WF16 – view downstream towards A9.</p>
	Fluvial geomorphology	WFD hydromorphology status: not classified. Predominantly sinuous planform. Structures: culverted under the existing A9, General Wade's Military Road and forest tracks. Gravel and cobble bed, step-pool sequence, approximately 0.8m-1m wide.	
	Water quality/supply	WFD overall chemical and water quality status: not classified. Potential pollutant sources: diffuse rural sources.	
	Dilution and removal of waste products	Low flow, low pollution dilution/dispersal capacity.	
	Biodiversity	WFD overall ecological status: not classified. Fisheries status: not classified.
