A83 Rest and Be Thankful

LTS EIAR VOLUME 4, APPENDIX 19.3 - ROAD DRAINAGE AND
THE WATER ENVIRONMENT BASELINE

A83AAB-AWJ-EAC-LTS_GEN-RP-LE-000294

A19-3.Road Drainage and the Water Environment Baseline

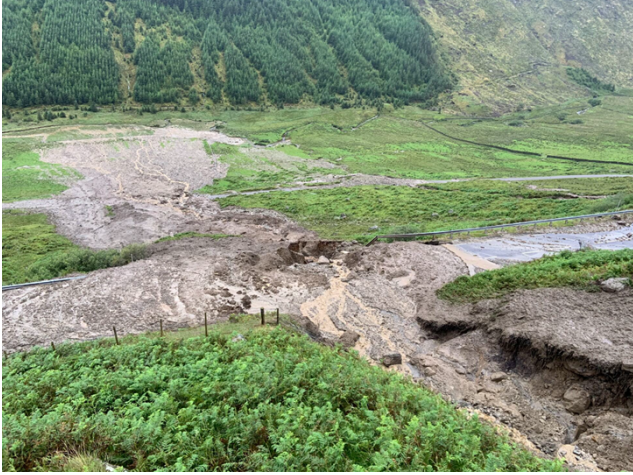
Plate A19.3.19 – Example of channel and overland flow crossing the A83 and OMR to the base of Glen Croe

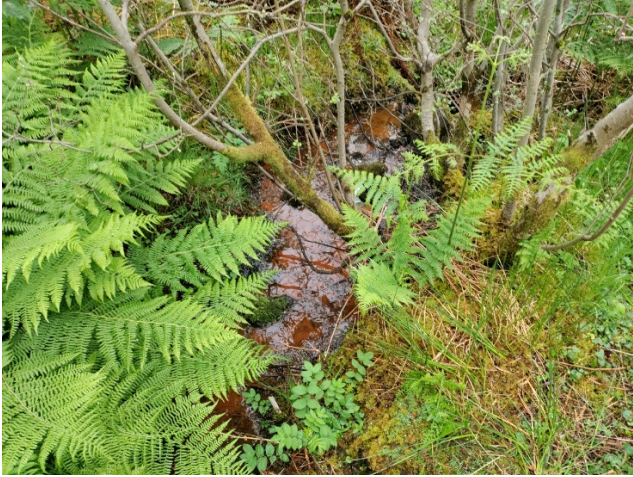
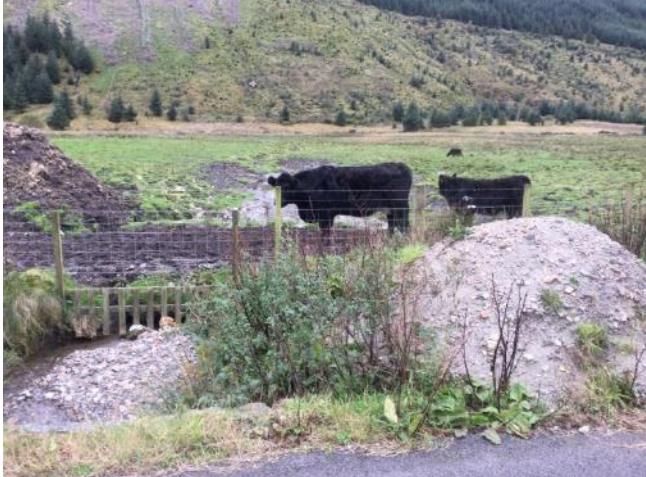
<p>Description: A83_ML_016_000 and A83_ML_017_000 have a confluence approximately 120 m upstream of the OMR and 86 m downslope from the A83. The watercourse is very steep, with gradients of 20 to 90% in the upper 110 m of the reach and the morphology is generally step-pool sequences. The gradient reduces to approximately 60 to 20% for the next 110 m with morphology transitioning from step-pools to plane bed sequence as the gradient decreases in the base of Glen Croe. This watercourse has not experienced significant scour erosion resulting from debris flow events. Significant fines and gravel aggradation on the bed is observed upstream and downstream of the OMR where bed slopes are moderate and flows constricted by two culverts in short succession.</p> <p>Processes: The existing culvert can only convey fluvial flows lower than a 20-year event. Very little flow was observed exiting the culvert under the A83, even during a wet period</p>

(May 2024). On the same visit, flow was observed to be bypassing the inlet, flowing south adjacent to the A83 towards the Croe Water/Cobbler Bridge, though it was not possible to trace the ultimate destination of this flow. The upper and middle reaches of the watercourses are primarily transporting sediment with some minor erosion. On the lower gradients, is a riffle-pool to plane-bed channel morphology with significant fines and gravel deposition (as attested by the sediment pile in the right figure).

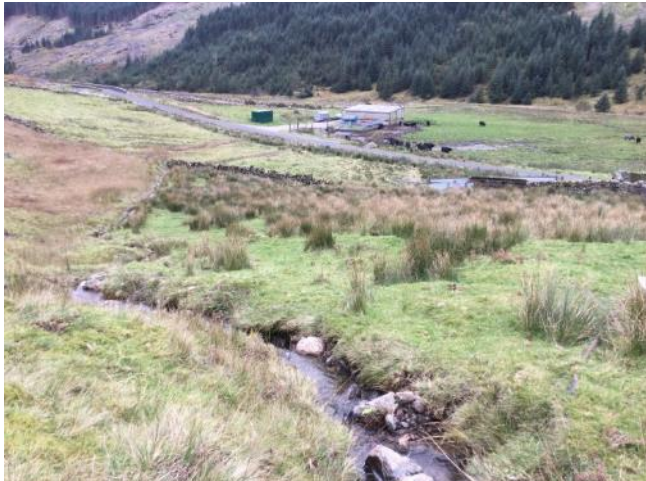
<p>Description: The A83 outlet comprises an apron of placed, flat, boulders for approximately 2-3 m, with a 2 m drop to a heavily scoured channel (2/3 m deep). There is little evidence of bank erosion suggesting that the dense vegetation cover may be influencing bank stability at this location. The watercourse exhibits a very steep gradient, ranging from 0% to 100% in the upper 50 m of the reach and increasing to approximately 350% in the next 50 m downstream from the A83 culvert outlet, where channel morphology features are predominantly cascades. Beyond this point, the gradient reduces to about 23% throughout the remaining reach with channel morphology transitioning to a step-pool sequence. This watercourse has not experienced significant scour and erosion resulting from debris flow</p>

events. Significant fines and gravel aggradation on the bed is observed upstream and downstream of the OMR where bed slopes are moderate and flows constricted by two culverts in short succession. The bankfull width measures 2.0 m in the upper reach and narrows to 1.2 m closer to the OMR.

Processes: Though the channel immediately downstream of the A83 culvert outlet is heavily scoured (left hand picture above) no evidence of active scour was observed. The surveyed section, downstream from the confluence with the A83_ML_016_000, shows gravel aggradation. The upper reach, depicted in the left figure, features a step-pool sequence with no significant scour of the bed and banks. Conversely, the lower reach transitions to a riffle-pool and plane-bed channel with substantial gravel deposition around the OMR culvert.

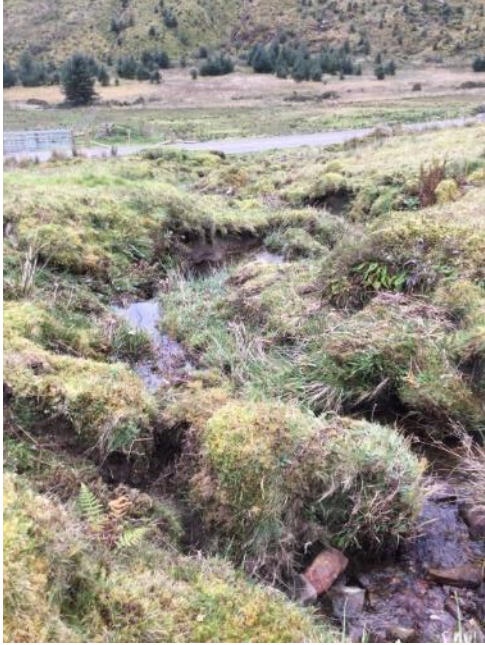
<p>Description: The watercourse exhibits a moderately steep gradient, with an average of 10% in the upper 70 m of the reach. Immediately downstream of the A83 culvert the gradient reaches 126%. Beyond this point, the gradient reduces to an average of 17% throughout the remaining reach. The morphology of the upper and lower reaches primarily features step-pool sequences. No significant scour erosion from debris flow events are observed, however, cattle poaching and collapsing banks were prevalent upslope of the OMR. Significant accumulation of sediment in the channel bed of gravel grain sizes and finer is present immediately upstream and downstream of the OMR, where slopes are more moderate, and flow constricted by the culverts.</p> <p>Processes: The current A83 culvert can accommodate fluvial flows up to a 2-year event, suggesting that impacts on flows can occur during relatively frequent flood events. Excessive scour erosion was not observed at the culvert outlet. The upper reach (right photo) features a step-pool sequence with moderate scour of the bed and banks. Similarly, the lower reach(left photo) has evidence of confinement but less scour and a more substantial sediment accumulation.</p> <p>Sediment: Field-collected sediment samples indicate that the lower reach contains coarser sediments compared to the upper reach. In the upper reach, approximately 95% of the</p>

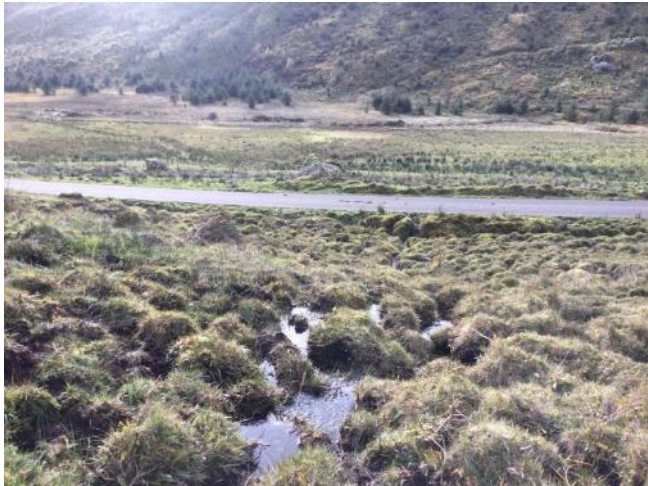
<p>Description: The channel morphology upslope of the OMR is heavily influenced by cattle poaching resulting in a channel that is not well-defined with water flowing between clumps of mud and grass. The reach below the OMR displays a plane-bed morphology. Downstream of the A83 culvert the average channel gradient is 30% (up to 73%) which declines with distance downstream. Despite these steep gradients and peaks of slope below the culvert outlet, no significant scour erosion from debris or fluvial flow events have been observed.</p>

Significant fines and gravel aggradation on the bed is observed upstream and downstream of the OMR where bed slope is moderate and flow is constricted by the culvert.

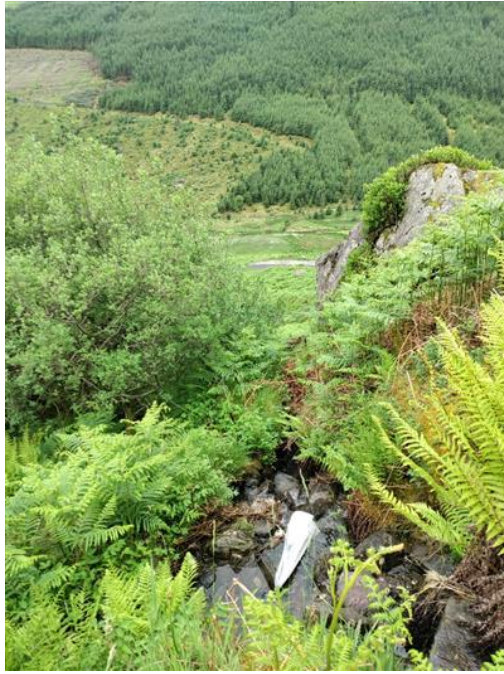
<p>Description: The A83_ML_021_000, a Major watercourse, converges with the A83_ML_020_000, Minor B, watercourse approx. 17 m downslope of the A83 and approx. 14 m down from the A83_ML_021_000 culvert outlet. The first 10 m of the channel from the A83 culvert outlet are built on concrete step cascades which are 700 mm long x 200 mm high, for approximately the first 6m, which then steepen to 200 mm long x 200 mm high (1:1) for a further 4 to 5 m. The remainder of the watercourse is as described for A83_ML_020_000.</p> <p>Processes: As discussed above, the upper section immediately below the A83 features an engineered cascade before it then drops in to a natural channel where there is evidence of historic scour. The remainder of the watercourse is as described for A83_ML_020_000.</p> <p>Sediment: Field-collected sediment samples from downstream of the confluence with the A83_ML_021_000 indicate that the lower reach contains coarser sediments compared to the upper reach. In the upper reach, approximately 95% (D_{95}) of the sediment in the channels is</p>

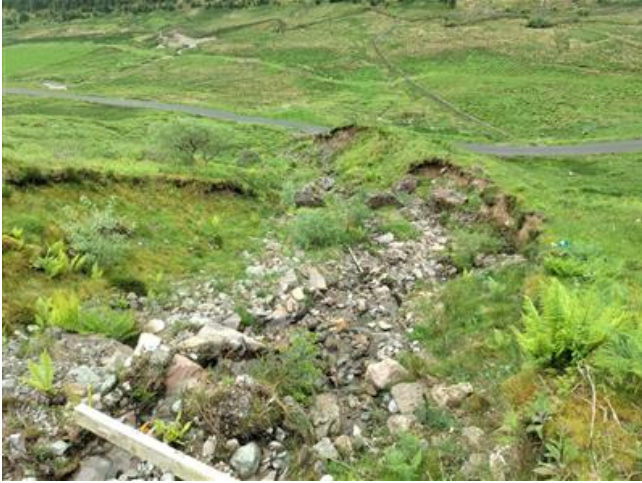
<p>Description: The watercourse has a catchpit and three landslide/rock fall barriers immediately upstream of the A83. The upstream catchpit is a combined catchpit linking this watercourse with A83_ML_024_000 and A83_ML_026_000. Downstream of the A83, the average channel gradient is approximately 39% (0.39m/m) with peaks up to 87% (0.87 m/m) throughout the remaining reach to the OMR. The morphology of the upper reach, to the OMR, primarily features a cascade/step-pool sequence, whereas the reach below the OMR comprises a plane-bed/step-pool channel. Significant fines and gravel aggradation on the bed is observed upstream and downstream of the OMR where bed slopes are moderate and flows constricted by a culvert.</p> <p>Processes: The A83 culvert can convey fluvial flows up to a 30-year event. The channel between the A83 and OMR is significantly over widened and deepened due to debris flow events (evident in both photos). The upper reach, depicted in the right figure, features cascade/step-pool sequences. The lower reach has evidence of confinement but with a more gravel-bed channel morphology, typical of lower gradients.</p> <p>Sediment: Field-collected sediment samples from reaches above and below the OMR contain sediments with comparable size profiles. In the upper reach, approximately 95% of the sediment in the channels is smaller than 77.0 mm, whereas in the lower reach, 95% (D_{95})</p>

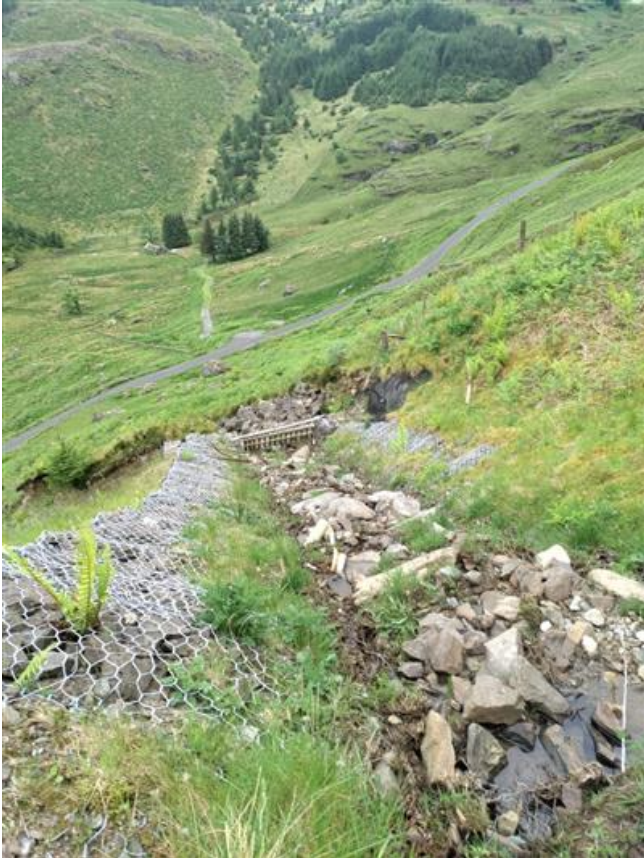
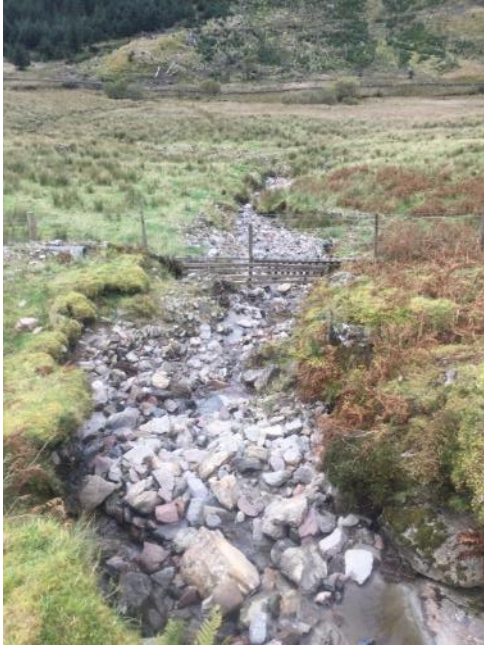
Description: The watercourse has a catchpit and landslide/rock fall barriers immediately upstream of the A83. The upstream catchpit is a combined catchpit linking this watercourse with A83_ML_024_000 and A83_ML_025_000. The watercourse exhibits a steep gradient, with an average of 55% (up to 121%) upstream of the A83 and 45% downstream (up to 126%). The peaks in the channel bed gradient are immediately upstream and downstream of the A83 culvert; gabion/reno mattress type protection has been installed over a ~10 m reach, protecting the bed and banks downstream of the culvert. Within the base of the mattress there is a geotextile to trap fines. There are gabions at the top of the reach offering some support to the slopes around and above the culvert outlet. The mesh within the channel is failing. Downstream of this reach there is a section of that is lined with a geotextile that has been soil nailed to provide further protection with large boulders placed on top. Immediately downstream of this reach a rockfall fence has been installed across the channel and filled with large boulder material to provide scour protection, however, this has caused erosion and widening of the channel upstream and downstream of the fence. Following this, the morphology of the cascade and step-pool sequence. Significant cobble and boulder aggradation on the bed is observed upstream and downstream of the OMR where bed slopes are moderate and flows constricted by two culverts in short succession.

Processes: As discussed above the upper reach of the watercourse is heavily modified due to historic erosion and scour. A number of measures have been constructed which have been partially successful, though there is evidence of corrosion and breaks with the mattress mesh and erosion around the larger boulder material. The lower reach, downstream of the OMR, shows a less steep morphology. The upper reach, depicted in the left figure, features a cascade sequence with severe scour of the bed and banks. Similarly, the lower reach, shown in the right figure, has evidence of confinement but is more subtle and the substrate is slightly finer.

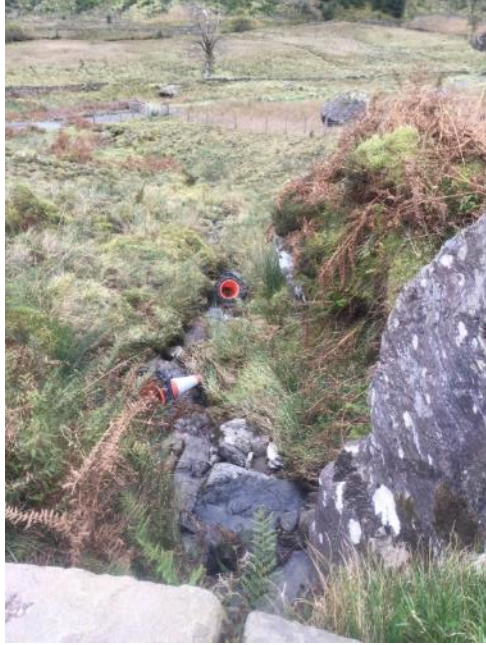
<p>Description: The watercourse exhibits a very steep gradient, with an average of 38% (up to 100%). Although there are some peaks downstream from the culvert, there is an overall decline in channel steepness. The morphology of the upper and lower reaches primarily features a cascade sequence which transition to step pools as the gradient reduces.</p> <p>Processes: The current culvert can accommodate fluvial flows up to a 2-year event. The channel is very incised and in some locations there is active erosion, though on the whole, the channel is stable and well vegetated. The upper reach, depicted in the right figure, features a cascade sequence with severe scour of the bed and banks. Generally, the gradient reduces with distance from the A83 culvert and the morphology transitions to step pool sequences (Step measurements: 1.20 m w, 1.18 m h. Spacing 1.20 m l, 0.90 m l, 3 steps then a longer pool. Longer pool at the base of the cascade = 1.35 m l depth: 0.40m h 0.50m h 0.20m h. (Upstream- downstream) key boulder diameter = 0.29 m, 0.20 m and 0.30 m).</p> <p>Sediment: Field-collected sediment samples indicate that the lower reach contains finer sediments compared to the upper reach. In the upper reach, approximately 95% (D₉₅) of the sediment is smaller than 87.4 mm, whereas, in the lower reach, 95% is smaller than 61.6 mm. The median particle size (D₅₀) is 12.2 mm in the upper reach and 10.8 mm in the</p>

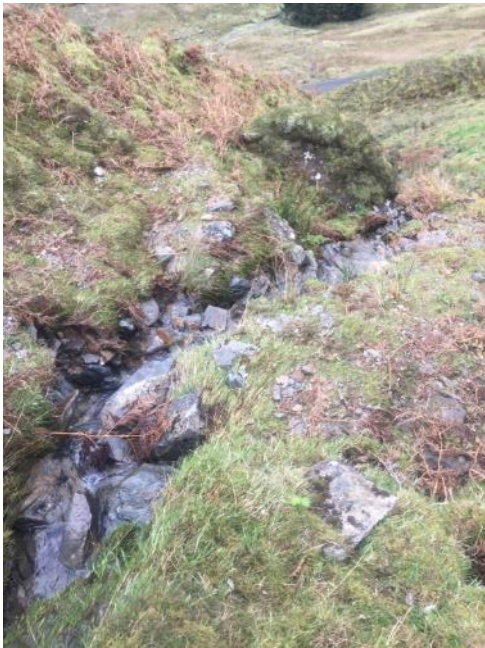
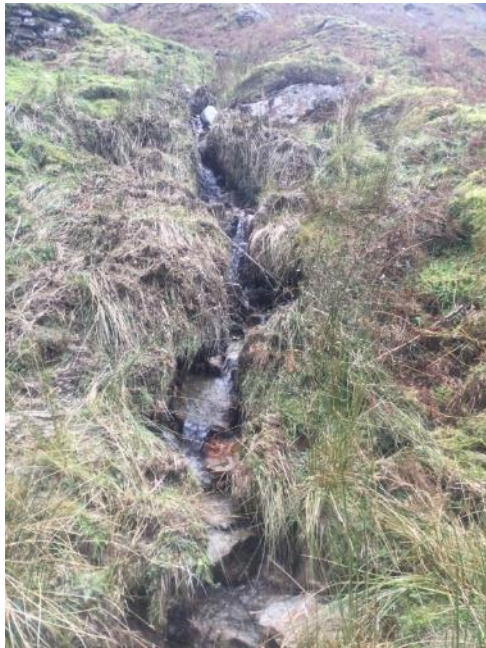
<p>Description: The A83 culvert outfalls to a concrete cascade, which is in good condition and provides a solid base to a well vegetated channel. The watercourse exhibits a very steep gradient, with an average of 39% (up to 121%) in the upper reach, and 35% (up to 86%) in the lower reach. Although there are some peaks downstream from the culvert, there is an overall decline in channel steepness. The morphology of the upper and lower reaches primarily features a cascade to step-pool sequence.</p>

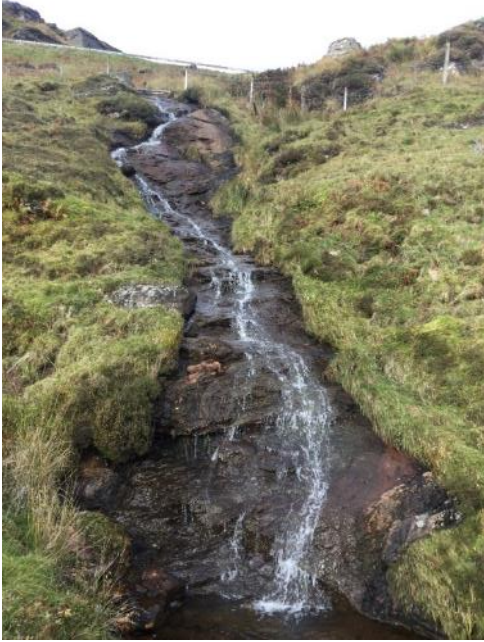
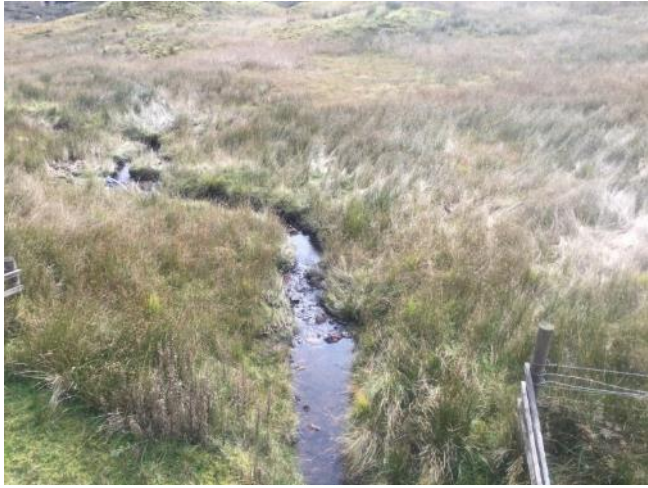
<p>Description: A concrete culvert beneath the A83 discharges to a bedrock cascade. The watercourse exhibits very steep gradients, with an average of 52% (0.516 m/m) and peaks up to 173% in the reach above the OMR culvert, and 23% (peaks up to 212%) in the reach below the OMR. The reach upstream of the OMR comprises of a bedrock channel. The reach below the OMR primarily features step-pool sequences. Other than the culverts, the watercourse is natural and is not experiencing excessive scour/ erosion.</p>

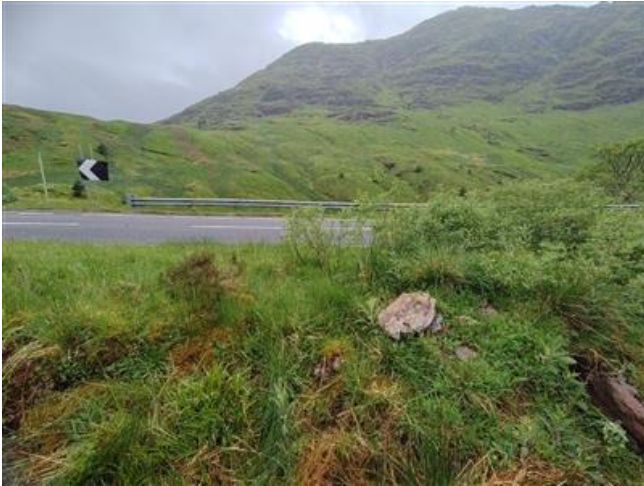
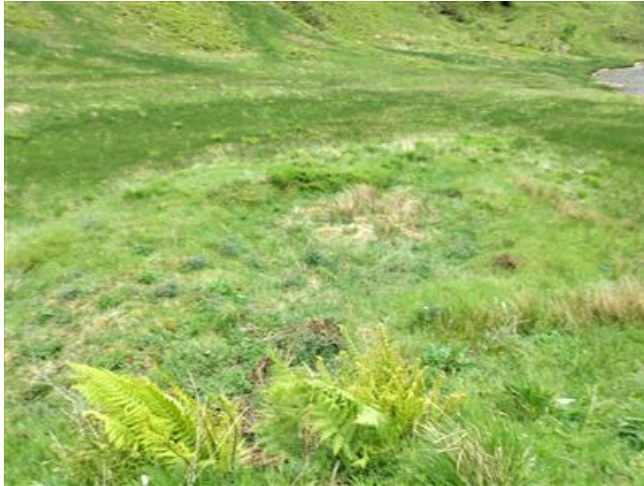
<p>Description: The A83 culvert inlet is located within an ill-defined drainage channel that runs in parallel to the A83. It was not possible to locate the inlet during a site visit due to the vegetation and detritus within the drainage ditch. The buildup of in channel vegetation is highly likely to be impacting the efficiency of the conveyance of flows into the culvert. The culvert outlet was observed to have collapsed. Flow was not seen; however, it could be heard bypassing the pipe at the downstream extent of the culvert. Downslope of the A83 the land is frequently very wet and drains to the western extent of Loch Restil. No 'in channel' sediment to characterise as upslope and downslope are vegetated extensively.</p>

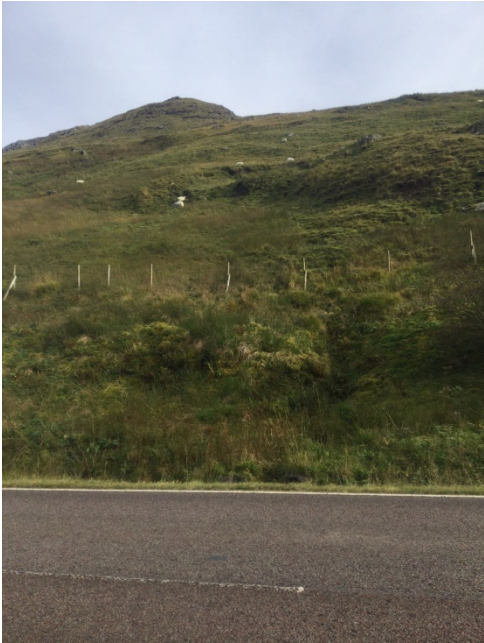
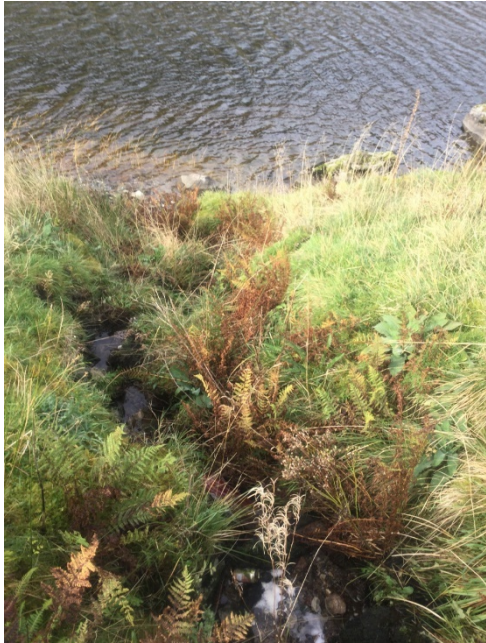
<p>Description: The upstream channel is ill-defined and the A83 culvert inlet is located within a heavily vegetated drainage channel. The culvert outlet is located approximately 7 m from, and 3 m above, the shore of Loch Restil. The downstream channel consists of natural step-pools sequence that is eroding the fines and cobbles that make-up the bed and banks.</p>

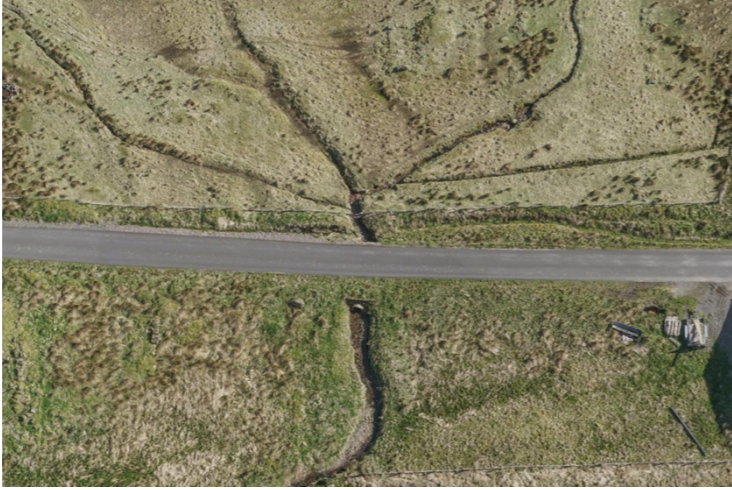
<p>There is no significant build-up upstream of or within the culvert. There is no evidence of erosion downstream of the culvert, however the modelled exit velocity is high and d/s scour protection is recommended. The culvert is being extended upslope which requires the 4 upstream watercourses to be realigned. Three of these are relatively minor drainage ditches which direct overland flows, generated within the field to the culvert. These three watercourses will have a keystone (250-300mm), bed checks, buried flush with the bed every 3-4 m to prevent headward cutting. The fourth channel will have step-pool features installed at 1.5 m spacing. Step constructed from boulder (sourced locally), consisting of a 450 mm keystone tied into the bed, with c.300 mm boulders used to form a crest, upstream and 150 mm proud of the keystone. Smaller boulders/cobbles placed behind the crest to raise upstream water level and form low flow notch.</p> <p>Electric fishing surveys conducted in August 2023 recorded 3 brown trout in a 100 m² section below the OMR (preliminary data - age class / length not currently known). Upstream of the OMR the watercourse is likely ephemeral and unsuitable for fish. The watercourse is not suitable for otters.</p>

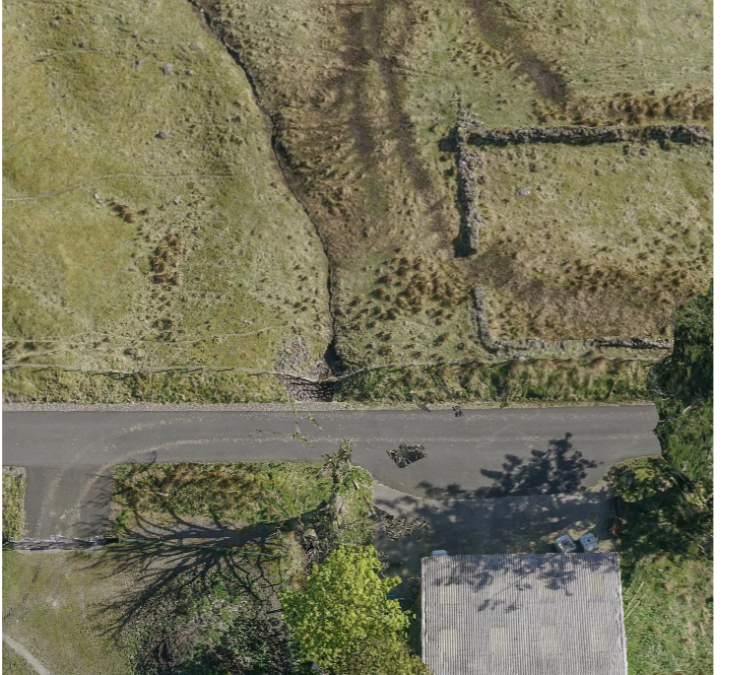
<p>There is a significant build-up of sediment at the upstream extent of the culvert affecting approximately 80% of the cross-sectional area. The channel gradient at this culvert is comparatively shallow (0.9%) compared to some of the others. There is no evidence of downstream scour/erosion, therefore no requirement for protection measures. The culvert is being extended by 6.11 m in the upslope direction, requiring the upslope channel to be vertically realigned at up to 30% gradient over 15 m. To achieve this a 2 m wide step pool sequence is proposed, consisting of 0.45 m steps at 0.9 m intervals, with a low flow notch created by lowering the central keystones of the steps. A 3 m long by 2 m wide sedimentation area is included for at the upstream of the culvert for ongoing maintenance to maintain the culvert capacity.</p> <p>The watercourse is unsuitable for fish and otters.</p>

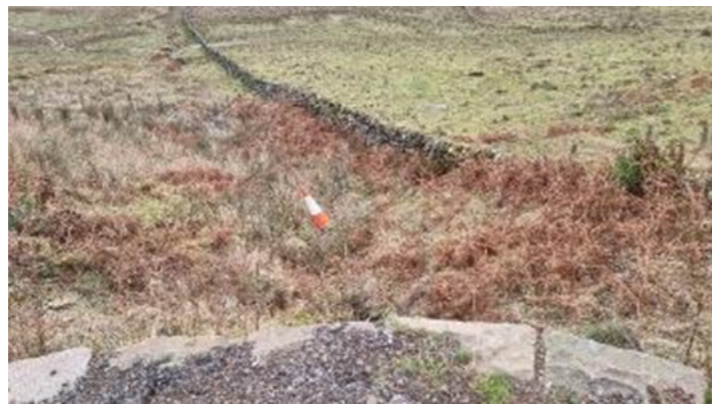
<p>There do not seem to be any issues with channel erosion or sediment deposition at either the upstream or downstream end of the culvert. The culvert is not being replaced so there does not seem to be a need for an upstream catchpit or downstream erosion protection.</p> <p>The watercourse is unsuitable for fish and otters.</p>

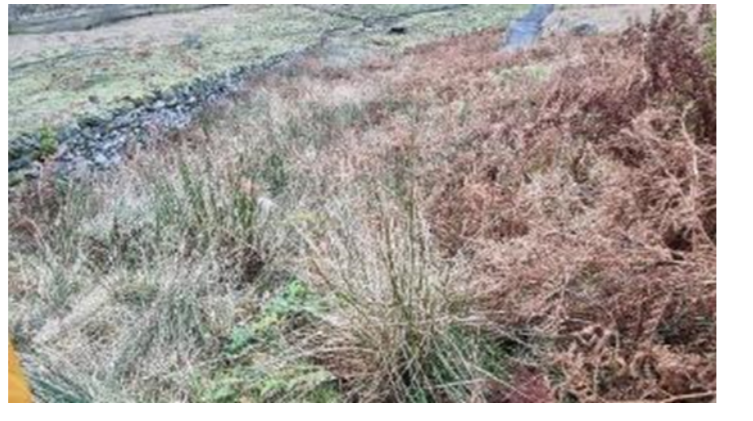
<p>The channel appears to be well vegetated both upstream and downstream of the culvert and there are no obvious signs of erosion or deposition. However, the downstream channel gradient is very steep and the disturbance involved in installing twin barrel culverts will make it worth installing some larger cobbles/small boulders for 2/3 m downstream to protect the bed from erosion.</p> <p>The watercourse is unsuitable for fish and otters.</p>
A83_ML_032_B01 (OMR_32)

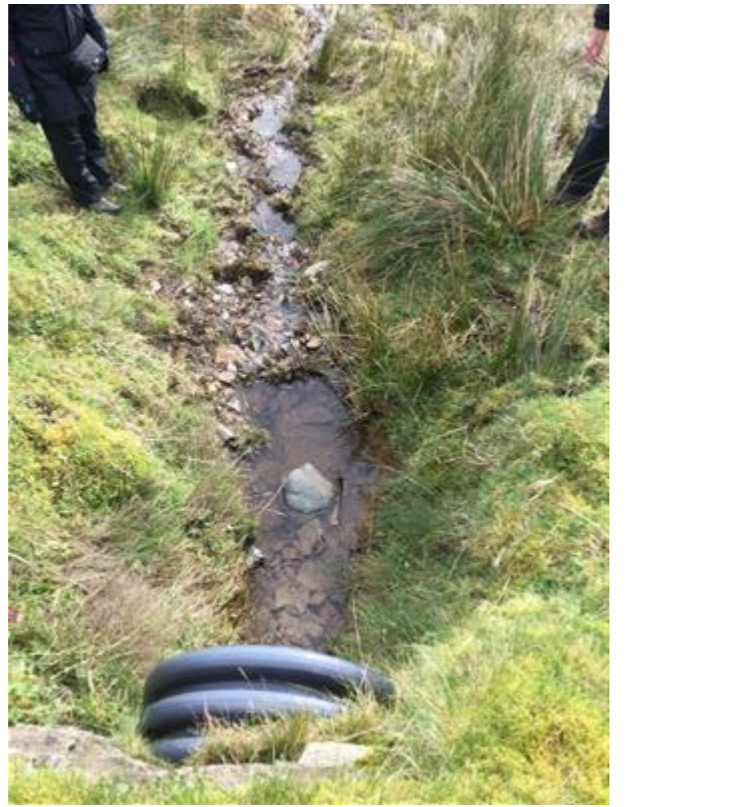
<p>This culvert is not being changed. Based on the aerial imagery there appears to be limited/no erosion downstream of the culvert and limited erosion/deposition of material upstream of the culvert. Therefore, the recommendation is that no catchpit or erosion protection measures are required.</p> <p>The watercourse is unsuitable for fish and otters.</p>

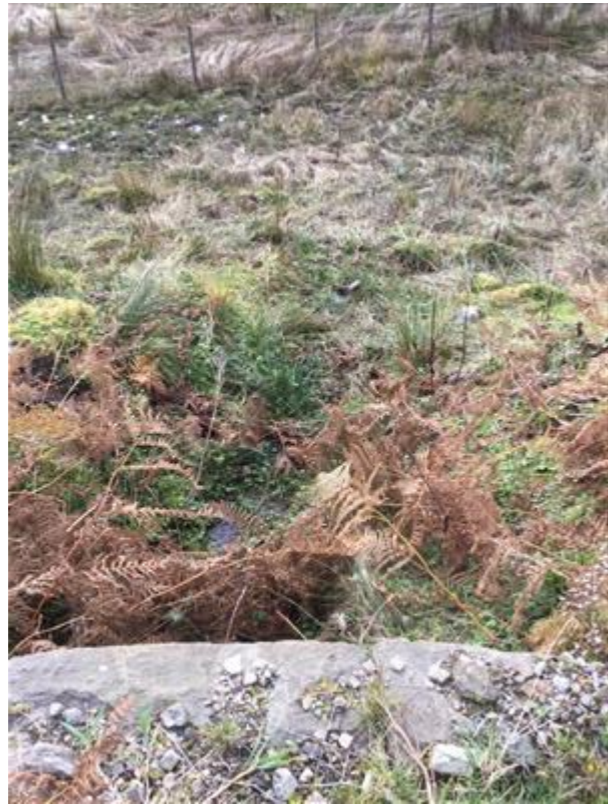
<p> Culvert OMR_33 is located within an artificial drainage channel, which is connected to the north to watercourse A83_ML_033_000 and culvert OMR_34. Large material looks to have been placed at the culvert entrance, potentially in an effort to act as a filter and stop material building up within the culvert. The culvert barrel looks to be largely free from material build up and there is no obvious downstream scour seen in the photos or aerial imagery. On this basis, as no changes are being made to the culvert there does not seem to be an additional requirement for an upstream catchpit or downstream erosion protection. </p> <p> The watercourse is unsuitable for fish and otters. </p>
