# Water course report for the proposed Maybole By-pass

## Electrofishing and invertebrate survey

**September 2012**

Ayrshire Rivers Trust

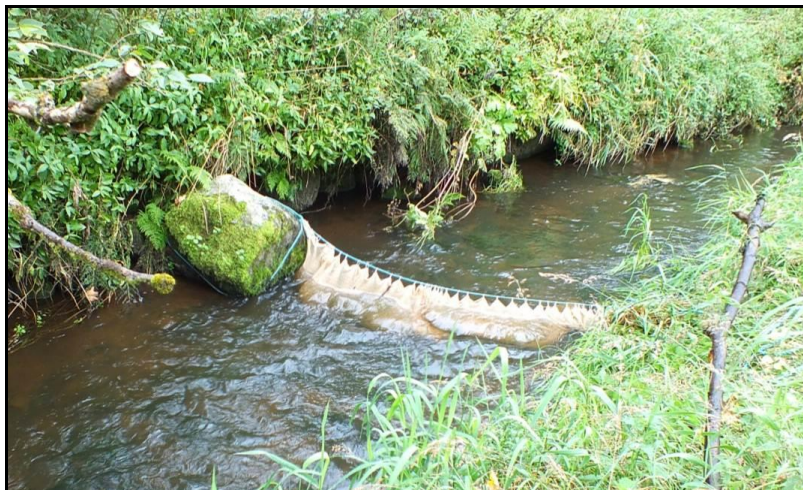
**Figure 2:**

*Upstream stop net in place during the fully quantitative electrofishing survey of the Barlewan Burn site*

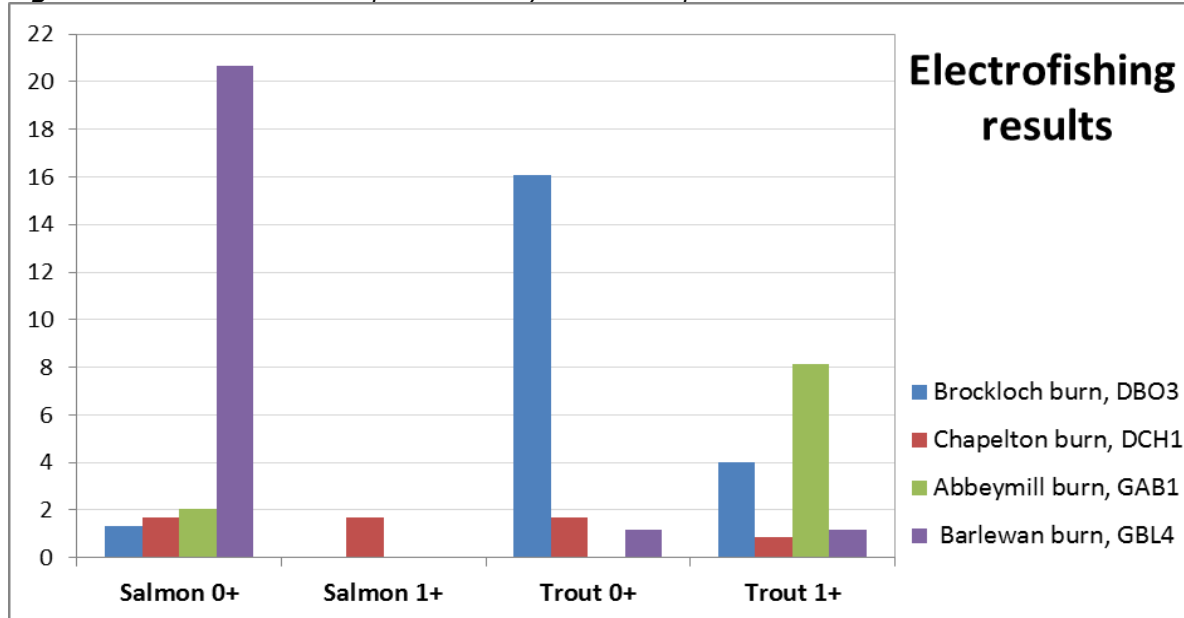
**Figure 4:** Salmonid results separated into year classes per 100 m<sup>2</sup>

Salmon, Brown trout and Eel were recorded at four sites (DB03, DCH1, GAB1, GBL4). Stoneloach (*Barbatula barbatula*) and Three-Spined Stickleback (*Gasterosteus aculeatus*) were recorded at three sites (DCH1, GAB1 and GBL4). Minnows (*Phoxinus phoxinus*) were only recorded at GBL4. At three sites (DBG1, DUN 1 and GUN 2), no fish were found. The reasons why three surveys failed to produce any fish are detailed in the discussion section below.

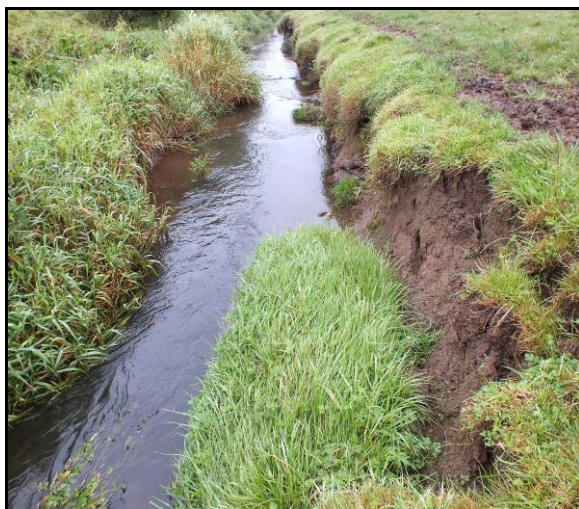
**Figure 12:**

Bank erosion and siltation in the Chapelton Burn as a result of over grazing and poor land management

The Chapelton Burn was historically an important spawning burn for salmon and trout but intensive agriculture and morphological alterations aimed at improving land drainage have led to habitat degradation and reduced availability of spawning substrates. Siltation and enrichment are the main issues both of which are associated with livestock accessing the watercourse and degrading the banks. Upstream, extensive land drainage also contributes to siltation. Downstream of the site, riparian fencing has been installed along both banks for a considerable distance and this is having beneficial effects on the habitat and morphology of the burn although siltation from upstream continues to be a major problem.

The poor quality of instream habitat is the main limiting factor at the site and this is consistent with most areas of the Chapelton Burn. Undercut banks, marginal and draped vegetation provides good fish cover in places however the stream bed was so degraded that spawning opportunities are extremely limited and certainly the most limiting factor in the salmonid population. To a certain extent, the condition of the habitat at DCH1 and elsewhere on Chapelton Burn may limit recruitment upstream on the Brockloch Burn as few migratory fish will enter such degraded system in search of suitable spawning locations.

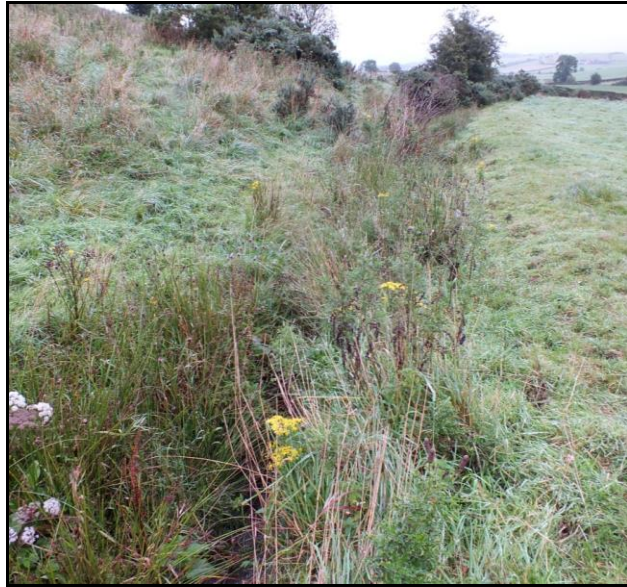
**Figure 14:** Black Glen Burn (DBG1), downstream the A77 road. This burn was suitable for neither electrofishing nor invertebrate sampling

The Black Glen Burn site was surveyed downstream of the A77. On inspection, it was immediately obvious that it was impossible to electro fish the burn due to its small scale and low flows. Similarly kick sampling was impossible. No fish or invertebrates were recorded.

Despite recent rainfall, the burn contained very little water and may dry up completely during fair weather.

Cattle have access to the burn and the banks and bed were poached and in places covered with faeces. Surface water run off from the A77 trunk road was suspected of contributing not only to the meagre flow but also to pollution within the burn. The water was opaque and dark grey in colour.

The Black Glen Burn is assumed to be of no value to fish at the survey location. The burn flows into the Chapelton Burn which in turn discharges to the River Doon and therefore has the potential to contribute to pollution and siltation in sensitive areas for fish and macro invertebrates especially during high rainfall conditions when road run off may be elevated.

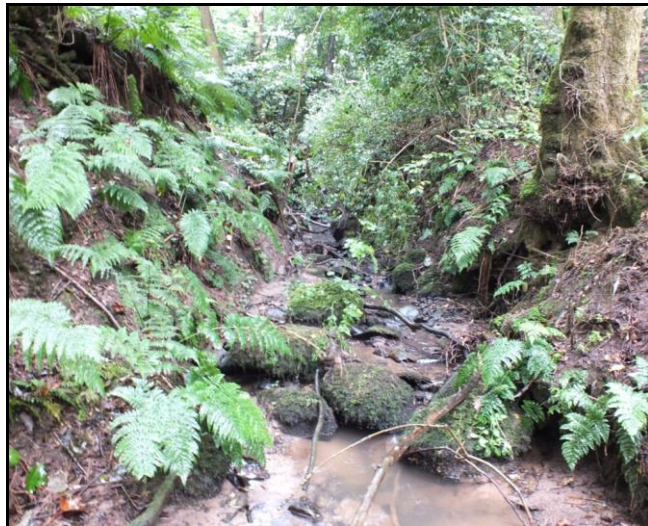
**Figure 16:** Unnamed Burn at Nether Culzean (DUN1) downstream of the railway

The survey location DUN1 was a short distance downstream of the railway in a steep sided and heavily wooded glen. The gradient was high and there were several falls that were assumed to be impassable to fish. Woody debris frequently blocked the burn causing bank erosion in places. Despite recent rainfall, there was limited flow on the day of survey.

Electrofishing failed to find any fish within the site and the survey was limited to a single run. It seems unlikely that salmonids survive in this location as pollution of the burn was obvious.

A short distance upstream of the site the burn was culverted and impassable to migratory species. Upstream of the railway the burn was little more than a field ditch and grazing stock had unrestricted access to the watercourse leading to organic enrichment. Due to the small catchment area of the burn, it may be expected to dry up completely in the upper reaches during periods of fair weather.

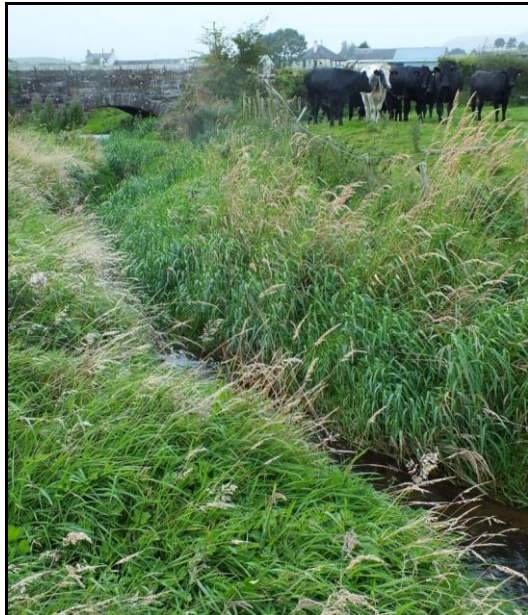
**Figure 18:** Abbeymill Burn (GAB1) downstream the road bridge to the south of Maybole

The burn habitat was of high quality with substrates suitable for spawning purposes for both trout and salmon. Siltation was evident but this doesn't appear to be limiting. The burn was fenced along the left bank and both banks were stable and well vegetated. Marginal and overhanging plants provide excellent cover for fish. Undercutting along both banks offers further areas of refuge.

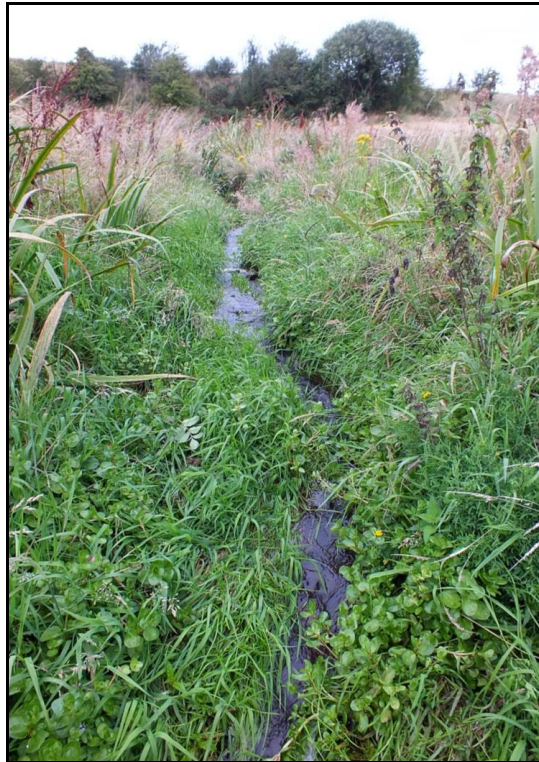
**Figure 21:** Unnamed Burn (GUN2) to the west of Maybole downstream the A77 road

The site at GUN1 was immediately downstream of the A77 to the west of Maybole. The burn flows through agricultural land that has high level of grazing pressure before it joins with the Abbeymill Burn and then the Barlewan Burn which flows into the Water of Girvan.

The burn has been subjected to considerable morphological alterations in the upper reaches including straightening and the installation of several culverts. The downstream limit of this site was a perched culvert that may allow passage of fish at certain flows. The upper

Despite the habitat providing ample cover for fish, electrofishing failed to produce any species. Absence of fish in this area is most likely due to barriers that prevent migration such as the perched culverts mentioned earlier.

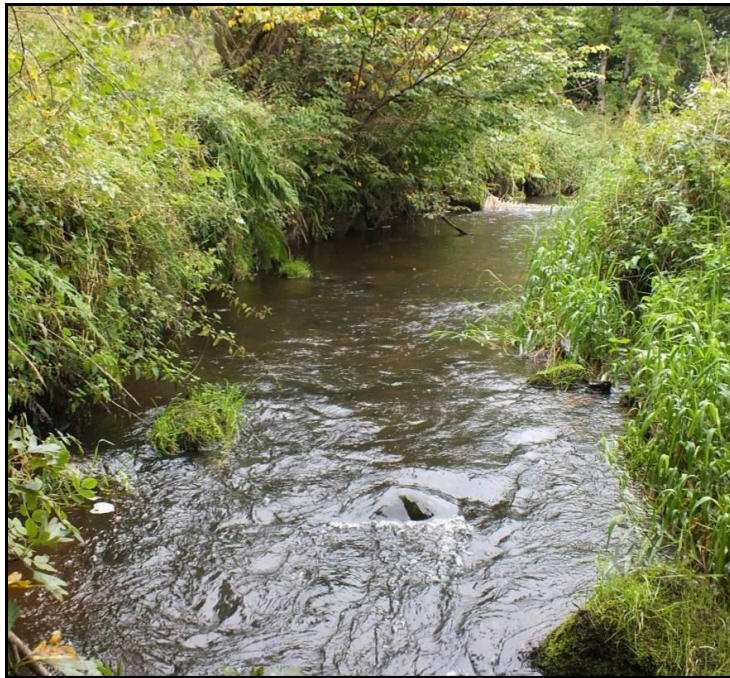
**Figure 23:**

*Electrofishing site in the Barlewan Burn (GBL4) behind Glenview near the B7023*

Habitat at GBL4 was typical of this burn in the survey area. Bank modifications have been performed in the past and much of the right bank face was constructed from boulders. Fish cover between the boulders was excellent. Instream cover was good but in some areas bedrock dominated the stream bed. Marginal vegetation provided additional cover for fish.
