# A77 Maybole Bypass

## Noise Measurement Site Survey

Document reference: 25000182-ENV-NMSS-001.

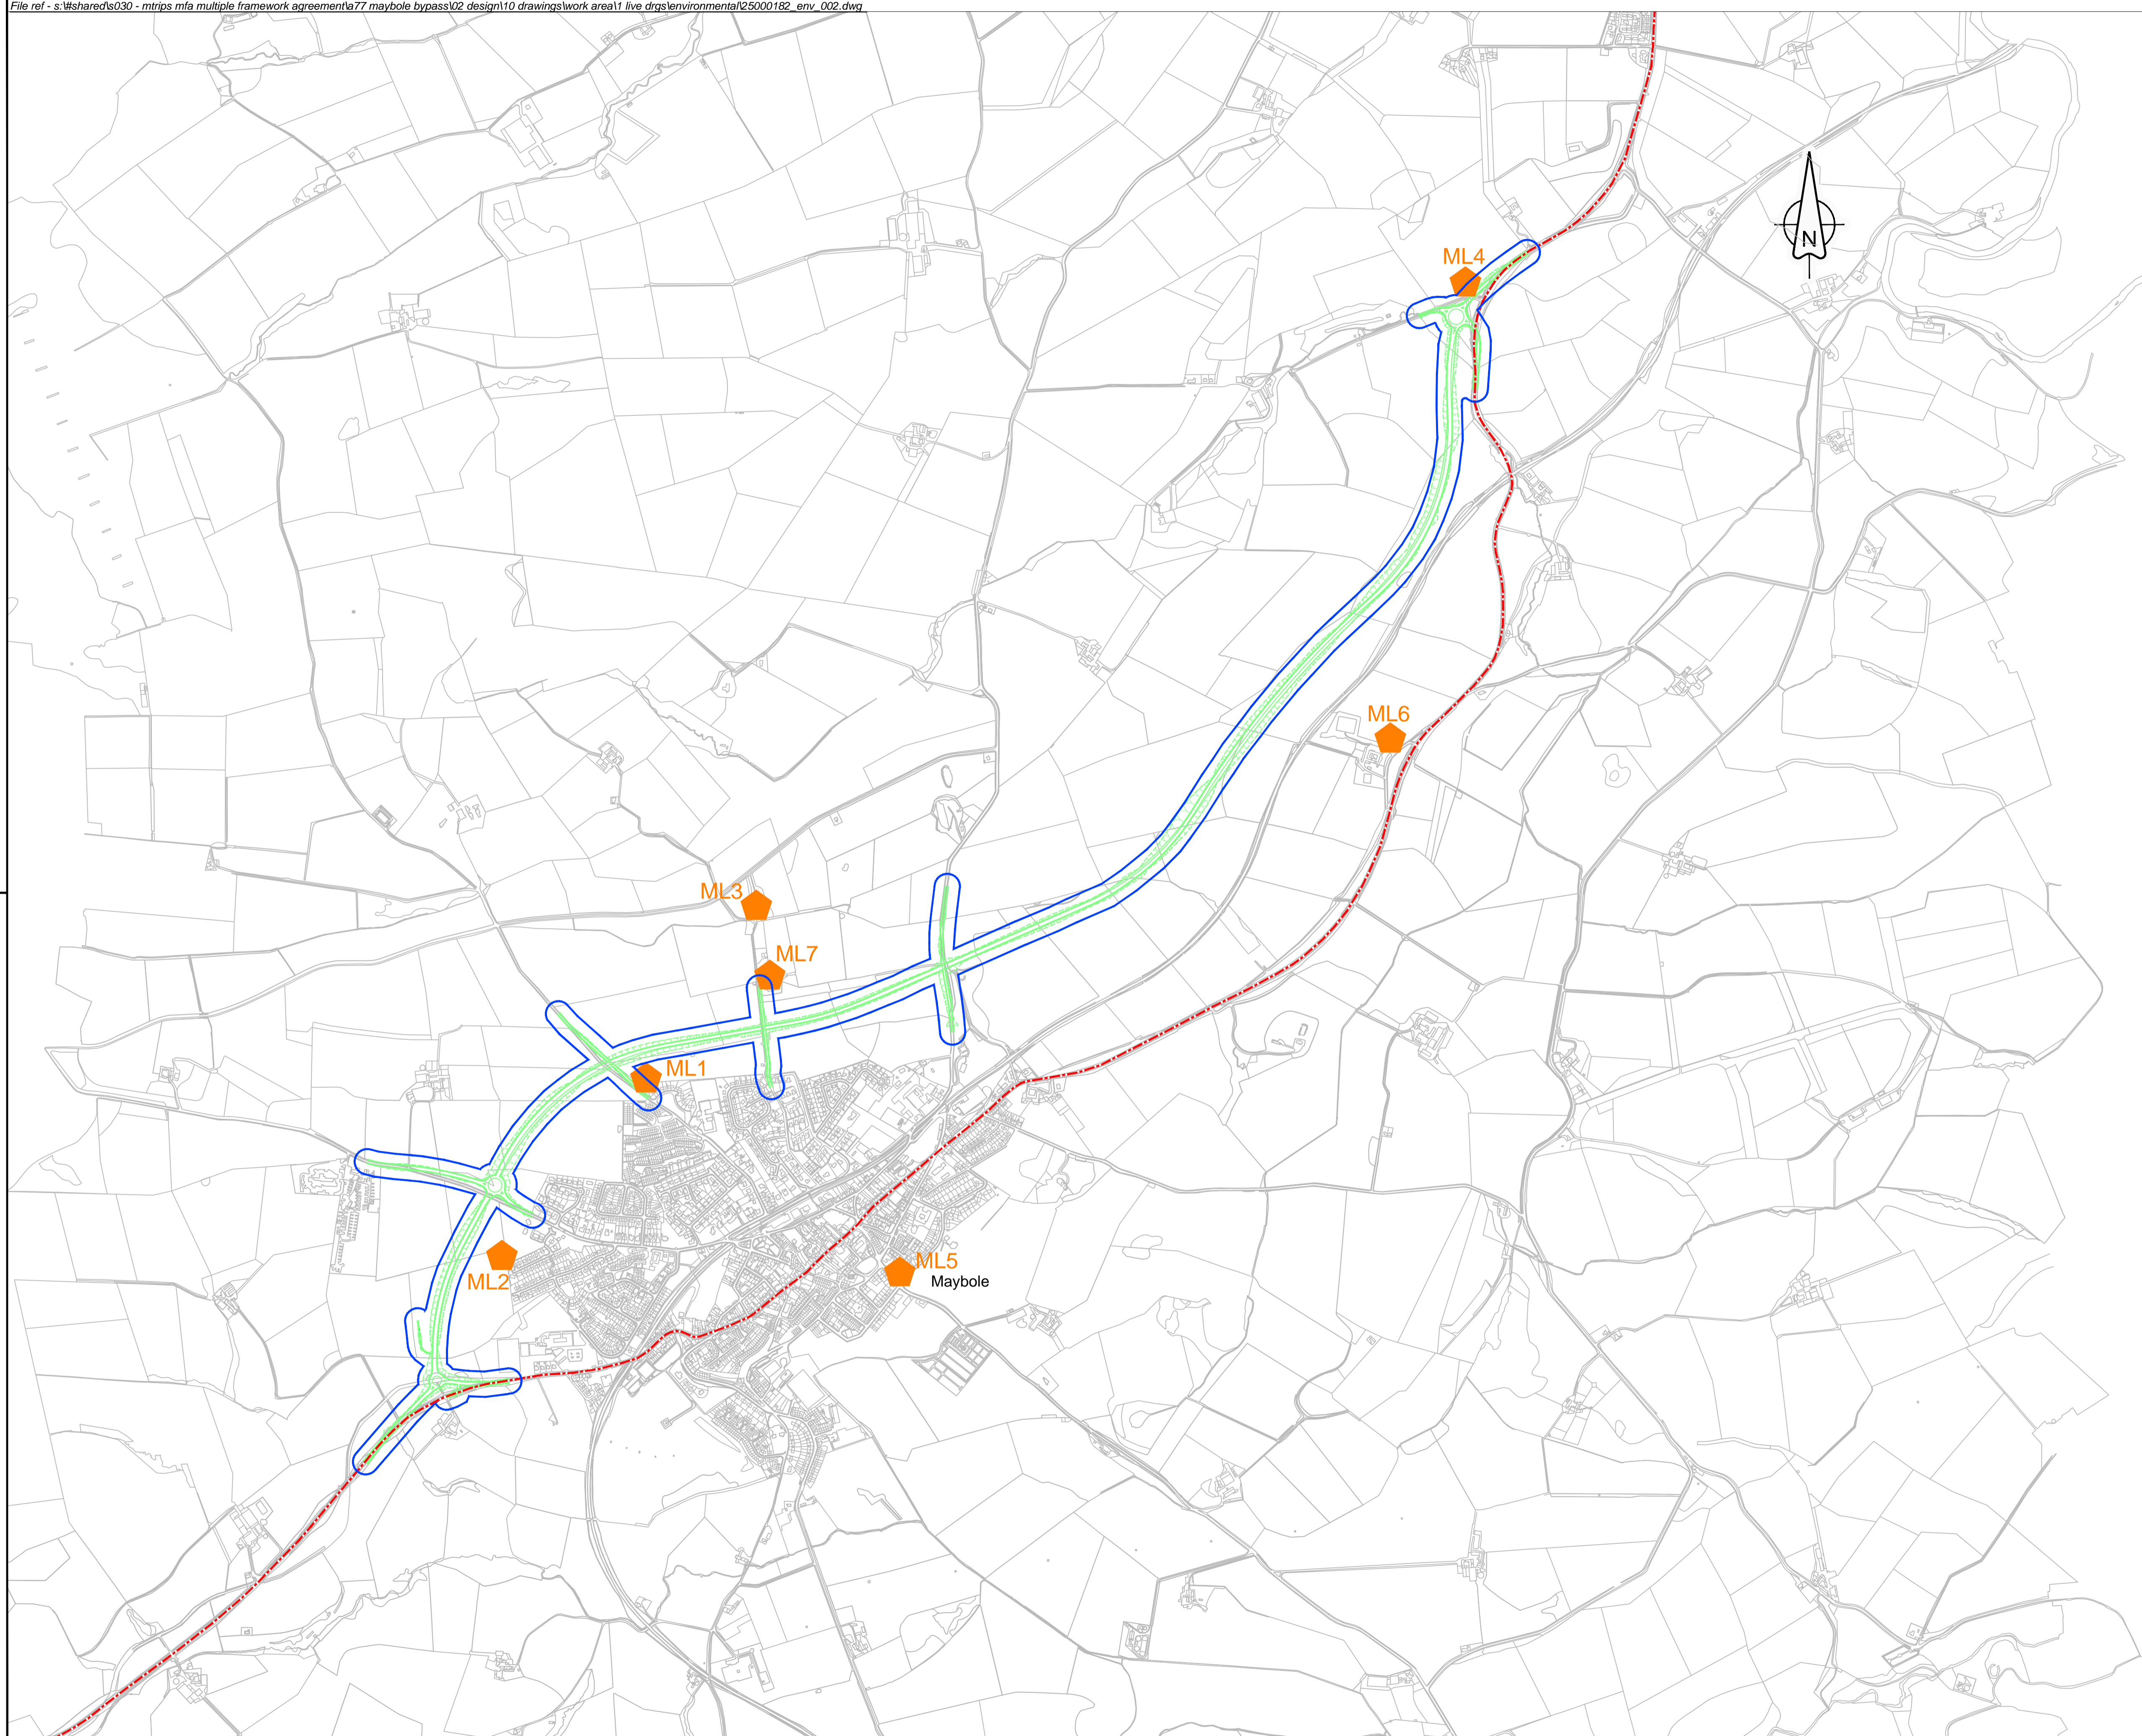
Drawing No  
**25000182/ENV/002**

- ML1 Gardenrose Path
- ML2 Burns Drive
- ML3 Cargliston House
- ML4 Low Grange Cottages
- ML5 16 Crosshill Road
- ML6 Netherculzean Farm
- ML7 Kirklandhill Farm

- Existing A77
- Proposed A77 Alignment
- 40 metre buffer

Drawing Title  
**Environmental Noise Survey Locations**

- 2.2.1. Measurement locations are illustrated within Drawing 25000182/ENV/002, Appendix A and detailed below.
