# Road Markings Durability & Adherence on TS2010 Surfacing

Phase 2: Site Trial

Transport Scotland, Scottish Road Research Board

22 August 2016

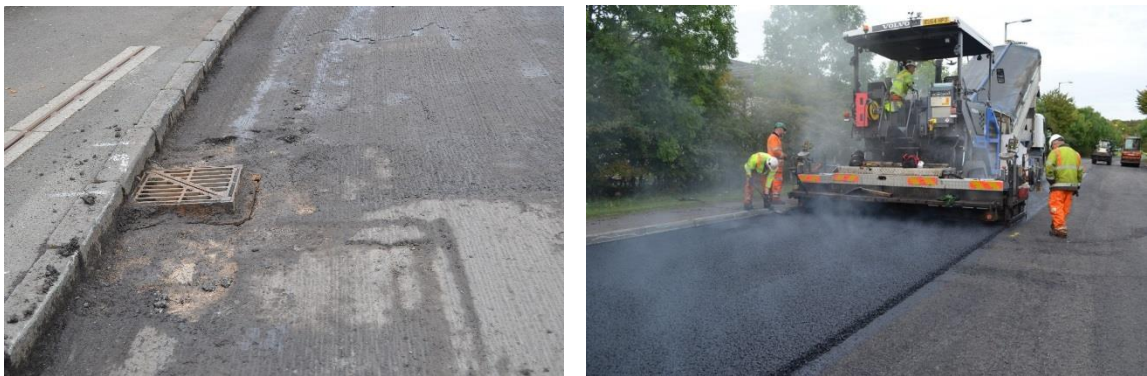
**Figure 2-1** Asphalt laying operation (left - milled surface, right – laying of surface course)

- Operating companies (Scotland Transerv for A75 and A77, and Amey for M80) coordinated and informed the contracting teams during the construction of the trial sections. The works involved milling a total of 150mm of an aged binder and surface courses prior to laying 120mm AC20 Binder Course followed by 30mm of the TS2010 surface course.

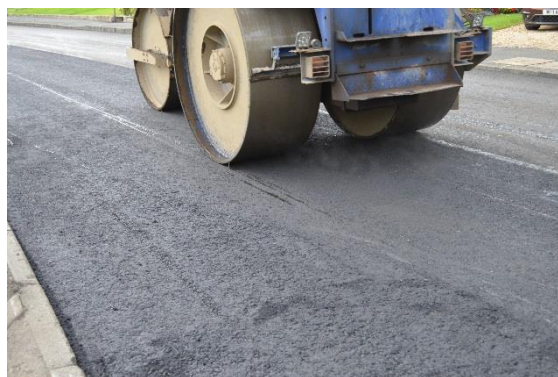
**Figure 2-2** Asphalt compaction

- The surface course was compacted by an articulated tandem steel drum roller (9 tonne).

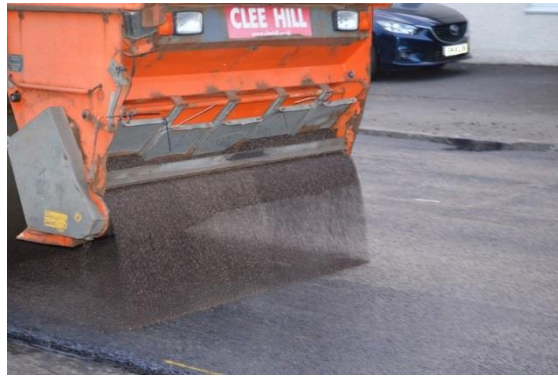
**Figure 2-3 Surface gritting application from steel drum roller**

- While the surface was still hot, grit was applied from hoppers attached to rollers after the asphalt had been laid and after the initial break down compaction had been completed.

- The roller with hopper applied the desired rate of grit on the respective trial sections followed by another roller which compacted the surface course.

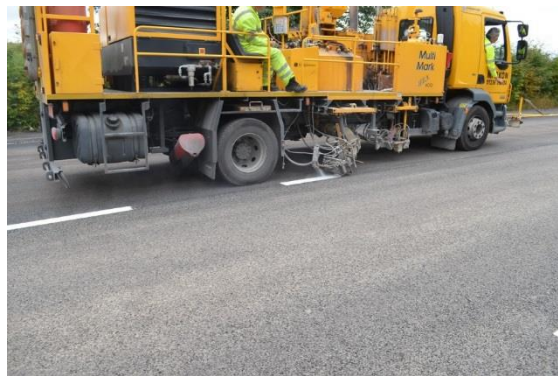
**Figure 2-4 Sweeping and hot air blowing prior to marking application**

- When the surface course material reached ambient temperature, any surplus grit was removed by sweeping and blowing hot air prior to the application of road markings and before the road is opened to traffic.
- During the trial installations the weather remained dry during both the day and night works.

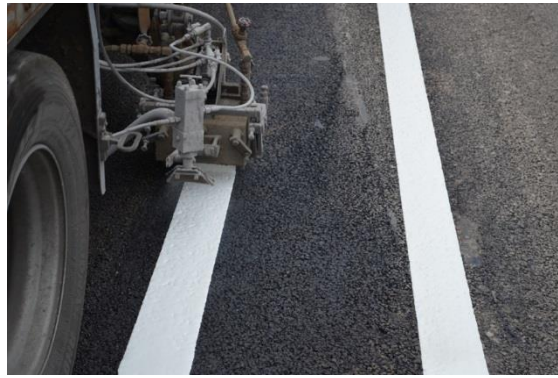
**Figure 2-5 Road Marking application**

- Thermostatic paint was used for the road markings with the laying temperature of the paint kept between 200-220°C before installation.

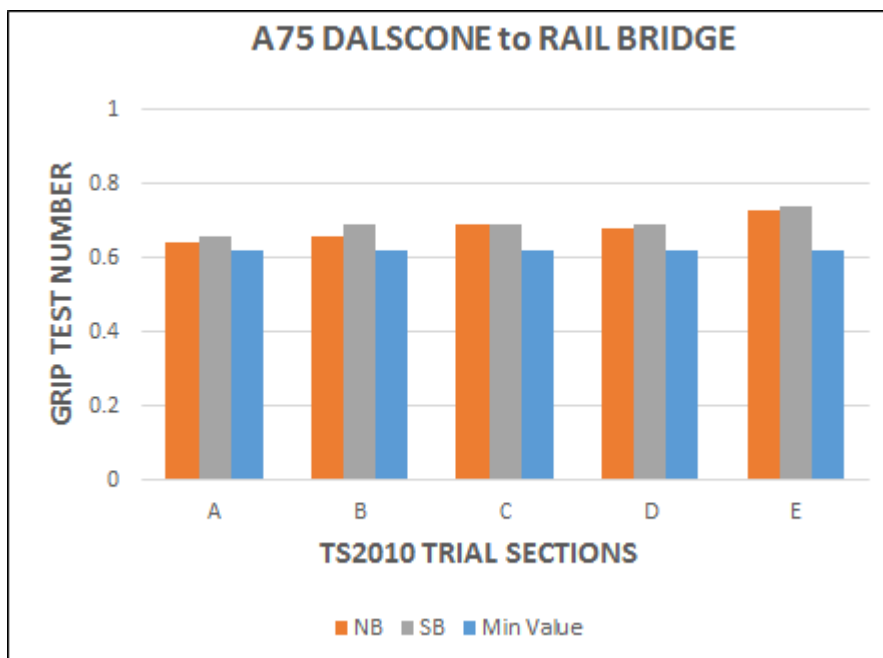
**Figure 3-2 Grip Tester Results - A75**

From the results shown in Figure 3-2, all of the sections indicate grip numbers exceeding the minimum required. The results indicate a maximum value of 0.74 (section E) and a minimum value of 0.64 (section A).

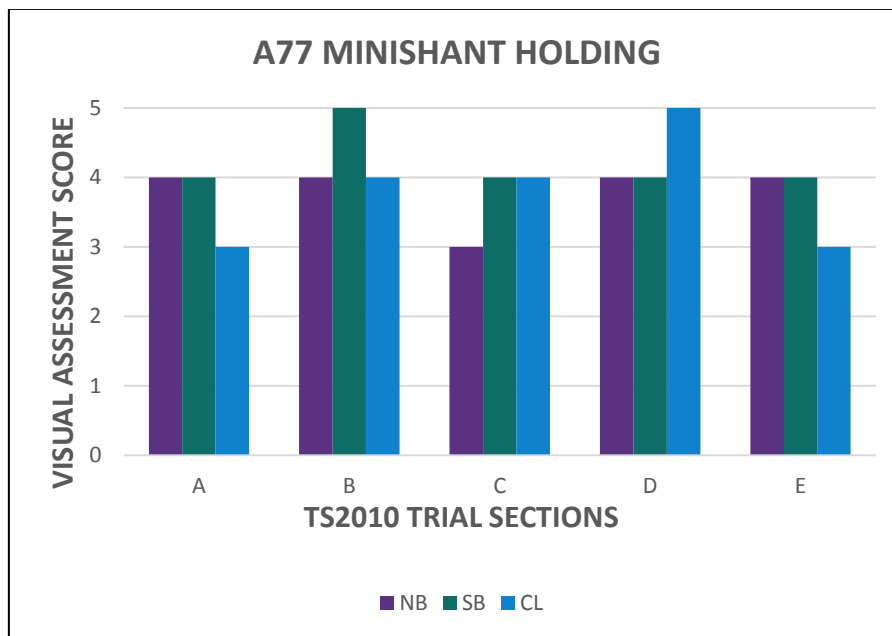
**Figure 3-3 Visual Assessment Scores - A77**

The results shown in Figure 3-3, were taken after approximately 4 months of trafficking. The control Section A, indicated an average score of 4 (very little wear) for both the NB and SB edge lines, whereas the centre line has a visual condition score of 3 (marginal – some visible wear).

The NB edge line of Section C had a lower score of 3 (marginal – some visible wear) compared to the control section. All of the other sections have similar scores compared to the control section A.

The SB edge line of Section B has a visual condition score of 5 (no wear) compared to the control section. The other sections all have similar scores compared to the control Section A.

The centreline for Section D has a visual score of 5 (no wear) and outperforms the scores from the other sections. Section E's centre line score of 3 (marginal – some visible wear) was the lowest of the alternatives, however was similar to that that of the control section.

Overall the control Section A and Section E have similar visual condition scores for the centre line of 3 (marginal – some visible wear) with Section D having the highest centre line score. All of the sections have similar visual condition scores of 4 (very little wear) with the exception of the NB edge line for Section C which has a visual assessment score of 3 (marginal – some visible wear). At the time of the assessment the differences in the visual assessment scores are viewed to be marginal, with no clear definitive alternative method standing out above the rest.

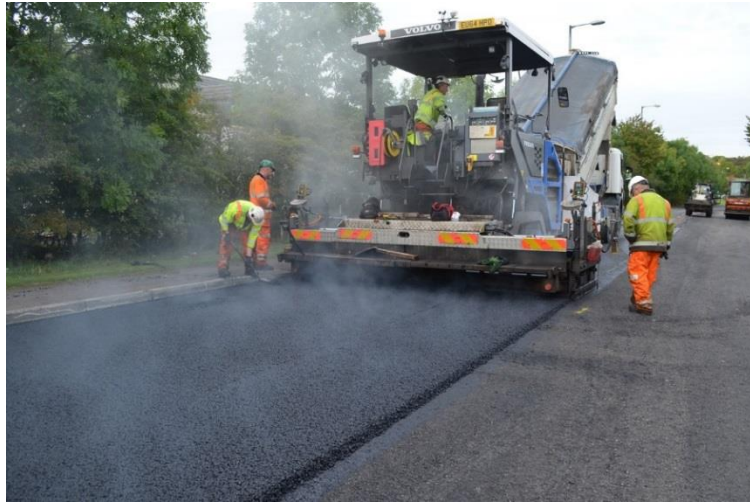
Figure C-1 Construction of asphalt surfacing (TS2010)

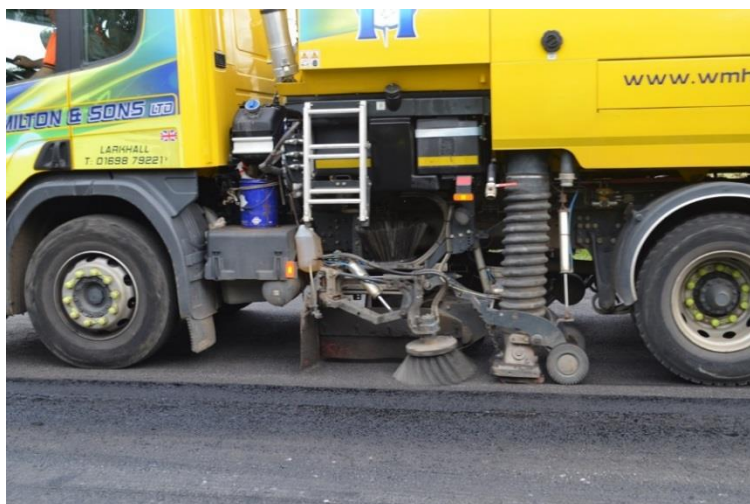
Figure C-3 Sweeping of the longitudinal joint

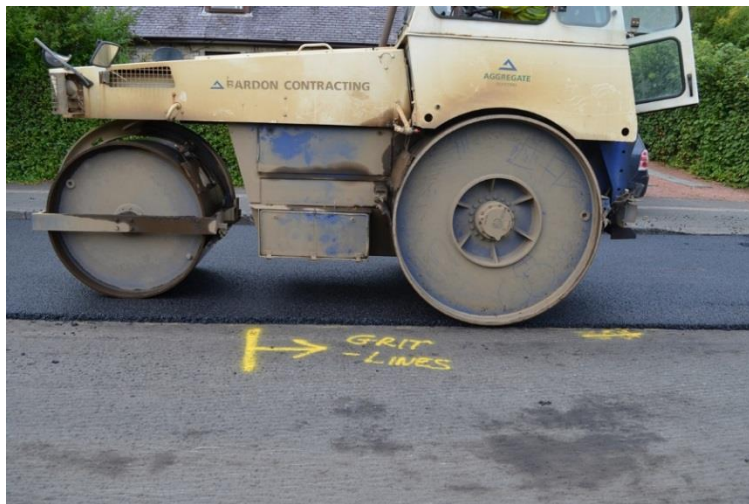
**Figure C-4**    **Compaction of surface course by Aggregate Industries**

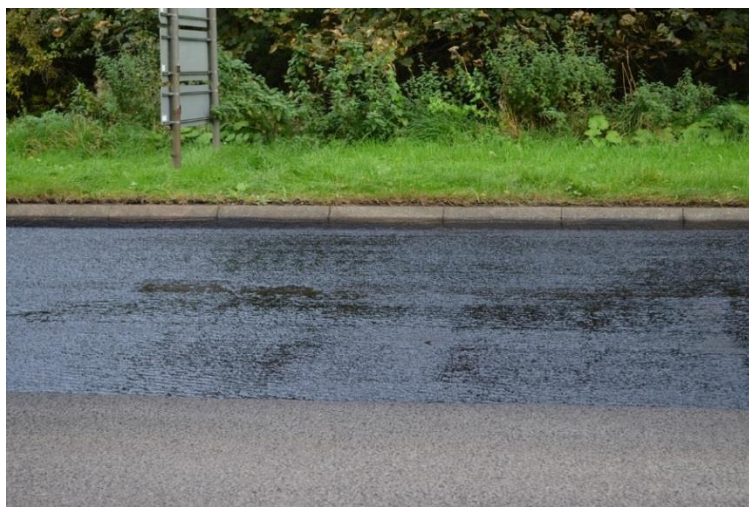
**Figure C-5**    **Tack coat prior to surfacing**

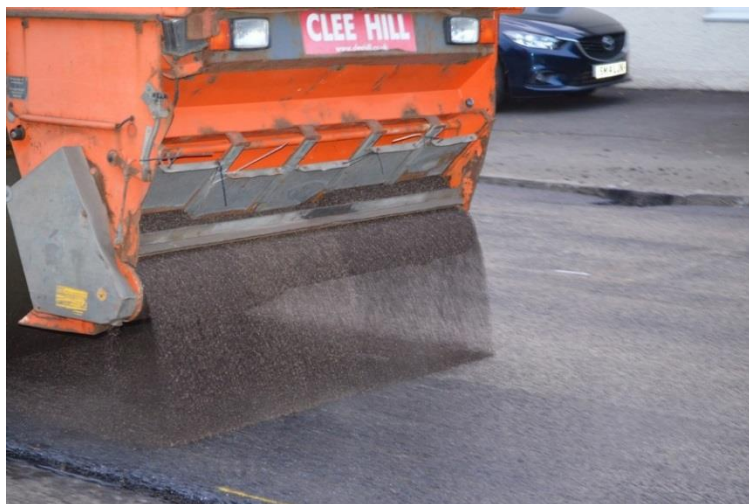
**Figure C-6**    **Gritting prior to line marking**

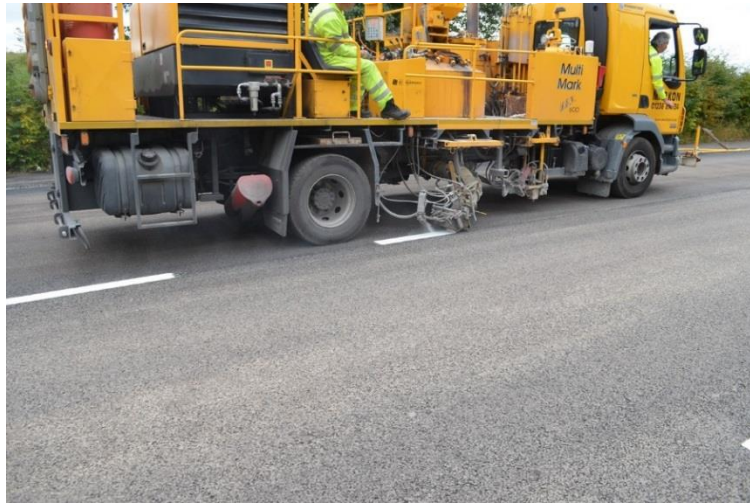
**Figure C-7** Drying/Blowing prior to line marking application

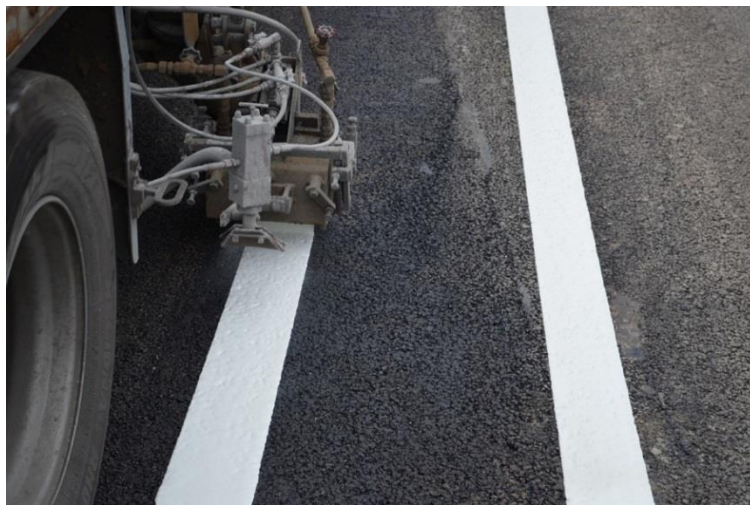
**Figure C-8** Line marking application
