A9 Dualling Programme Pass of Birnam to Glen Garry – Stage 3 Scotland

Archaeological Geophysical Survey

AOC Project No: 51736

Date: May 2017

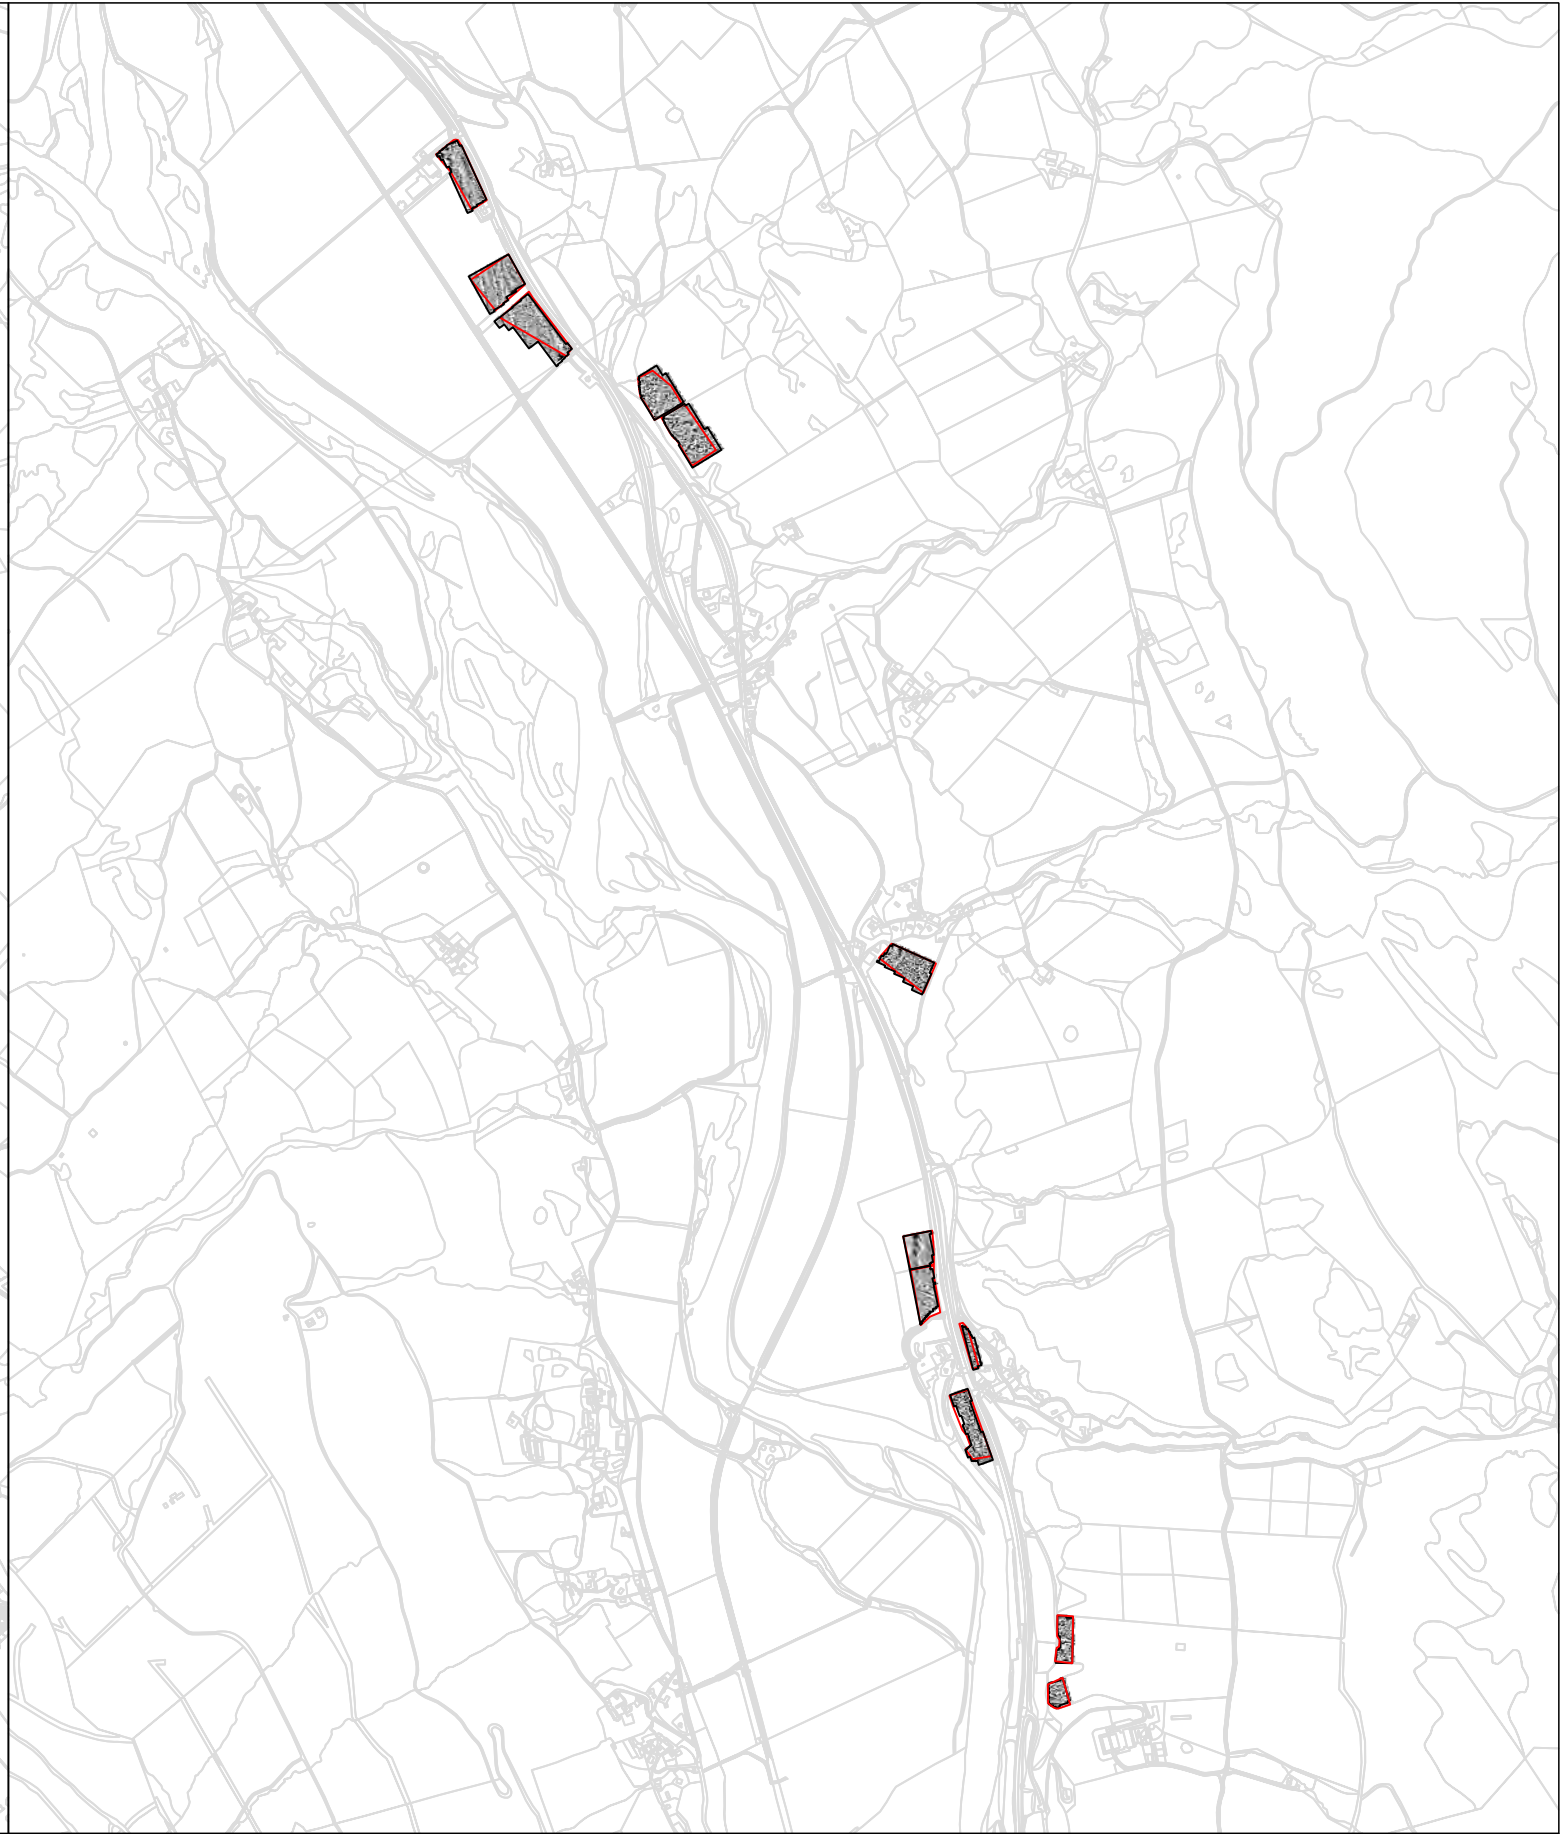
Figure
2

Location of survey areas - Parcels 1 - 9

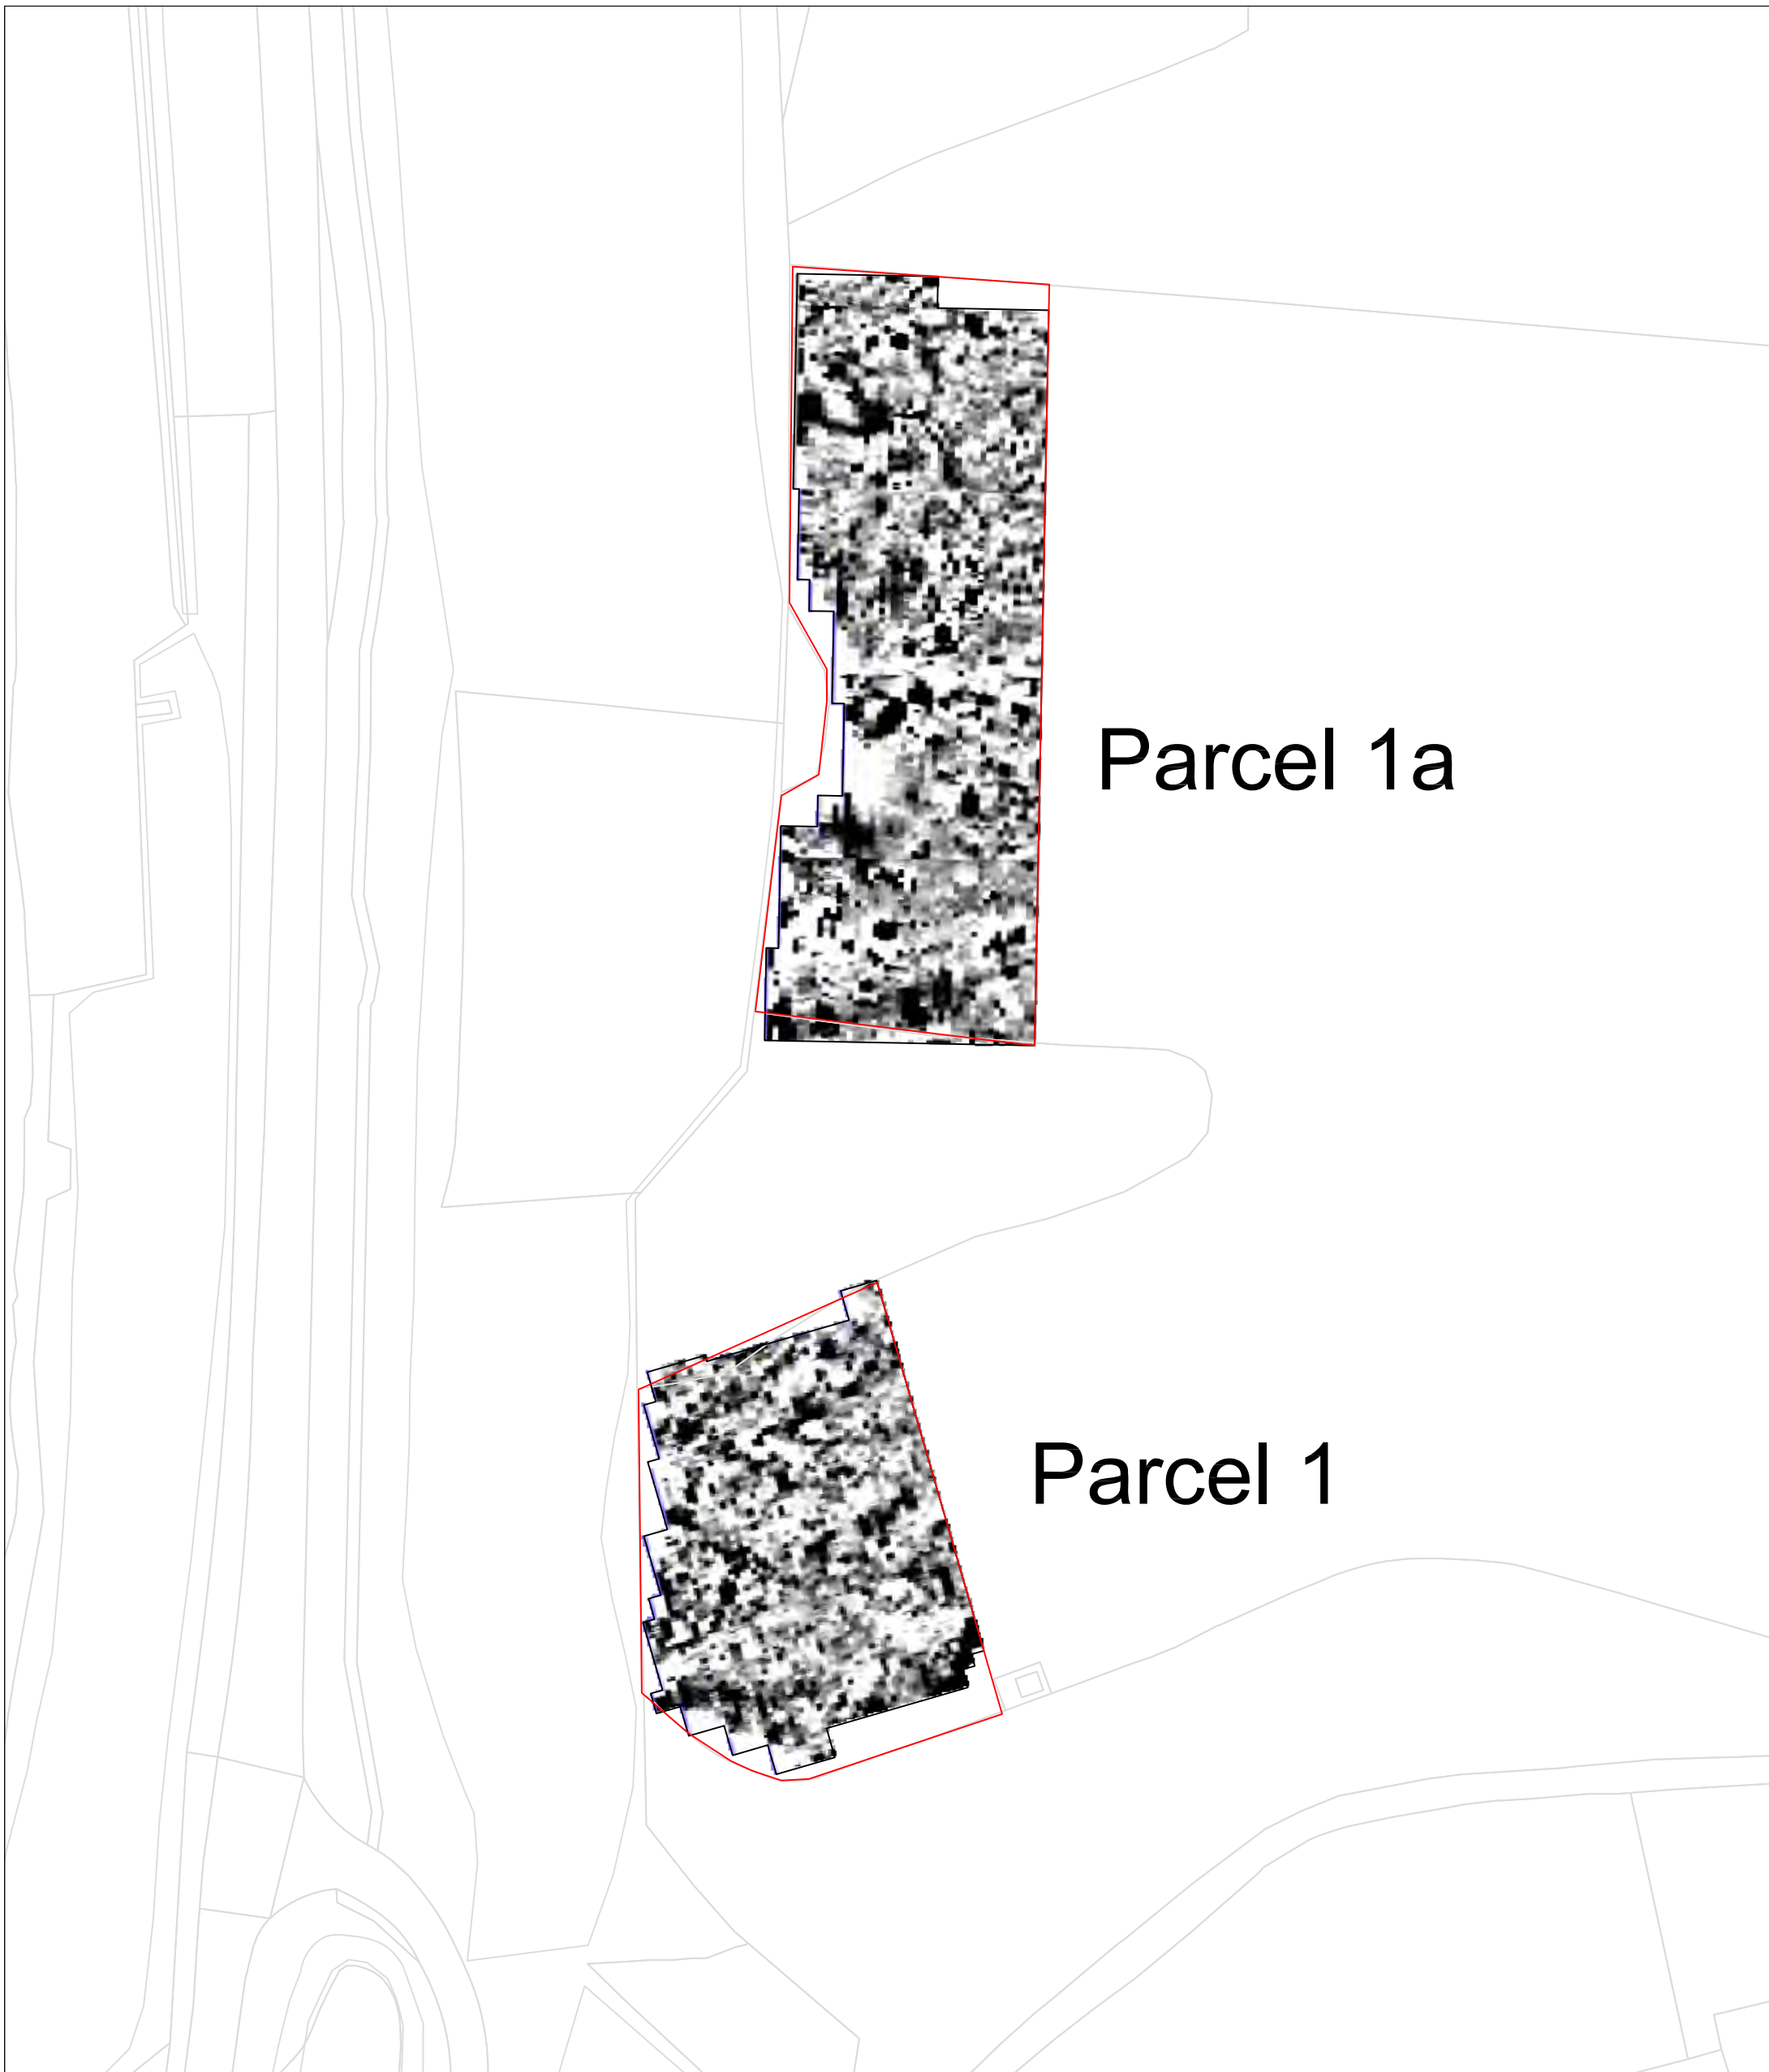
Figure 3: Minimally processed gradiometer survey results - greyscale plot - Parcels 1 and 1a

Parcel 1 and 1a (0.34ha and 0.50ha) – Figures 3 - 5**Archaeology**

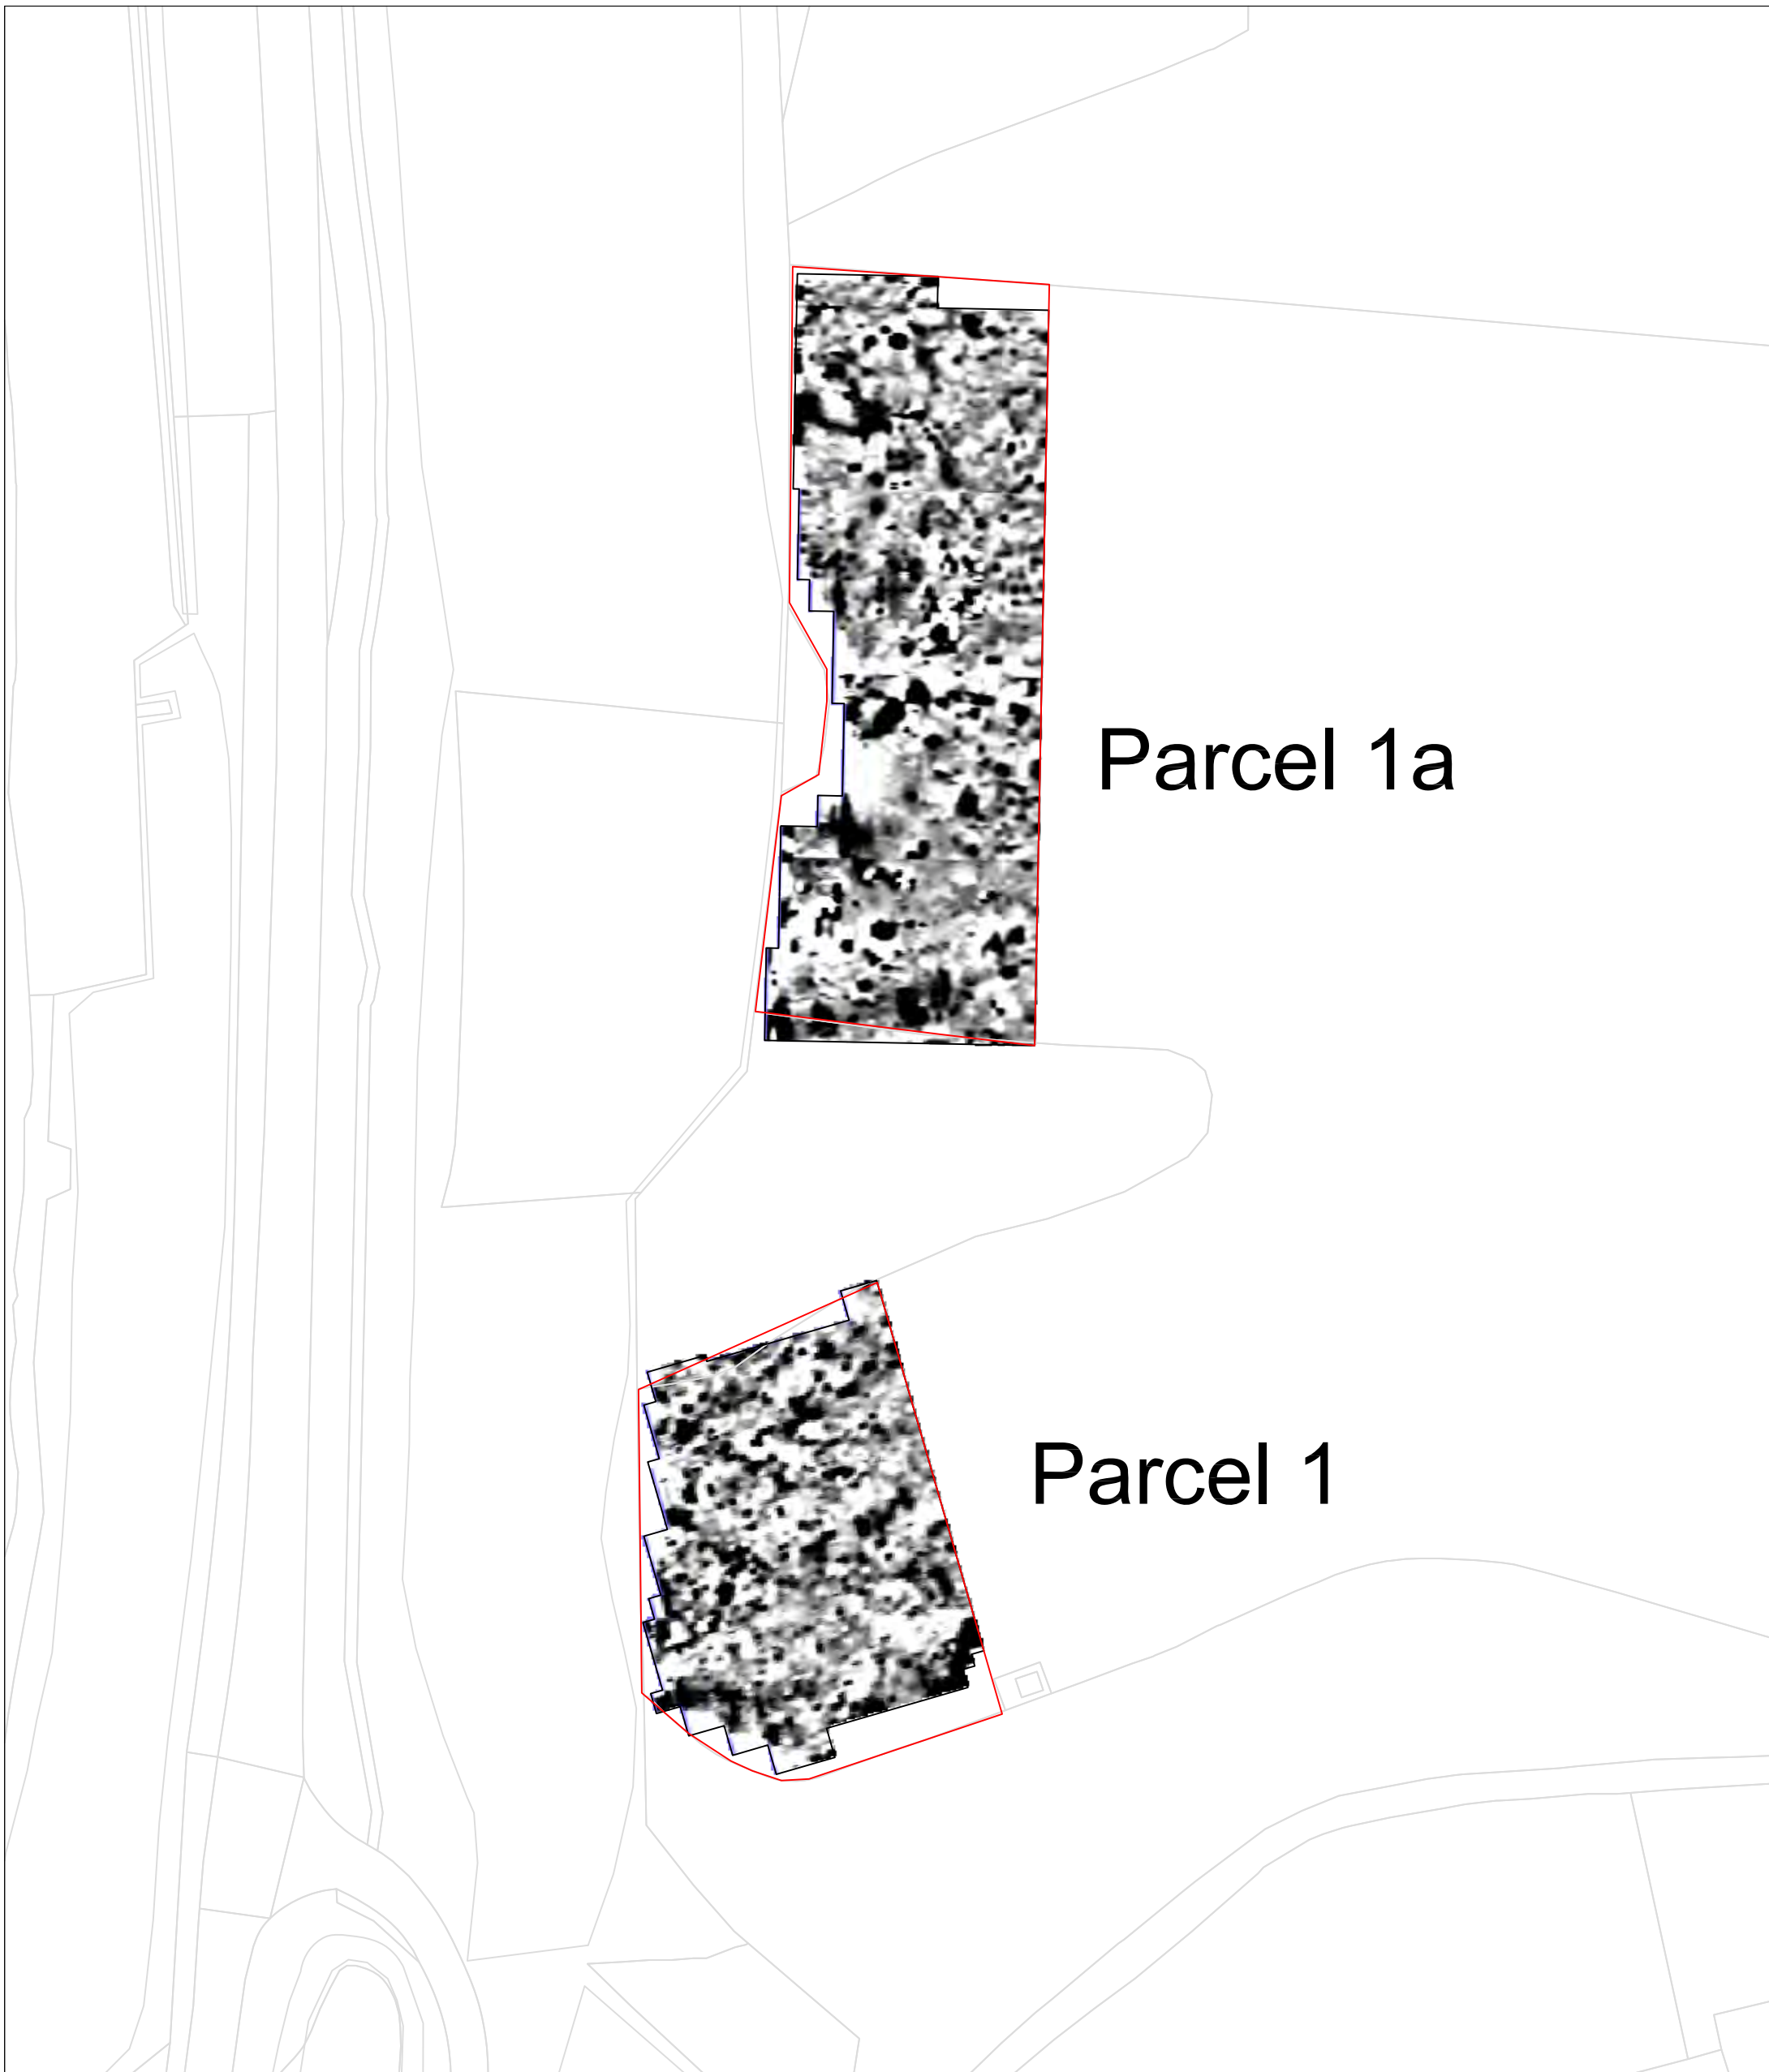
Figure 4

Figure 4: Processed gradiometer survey results - greyscale plot - Parcels 1 and 1a

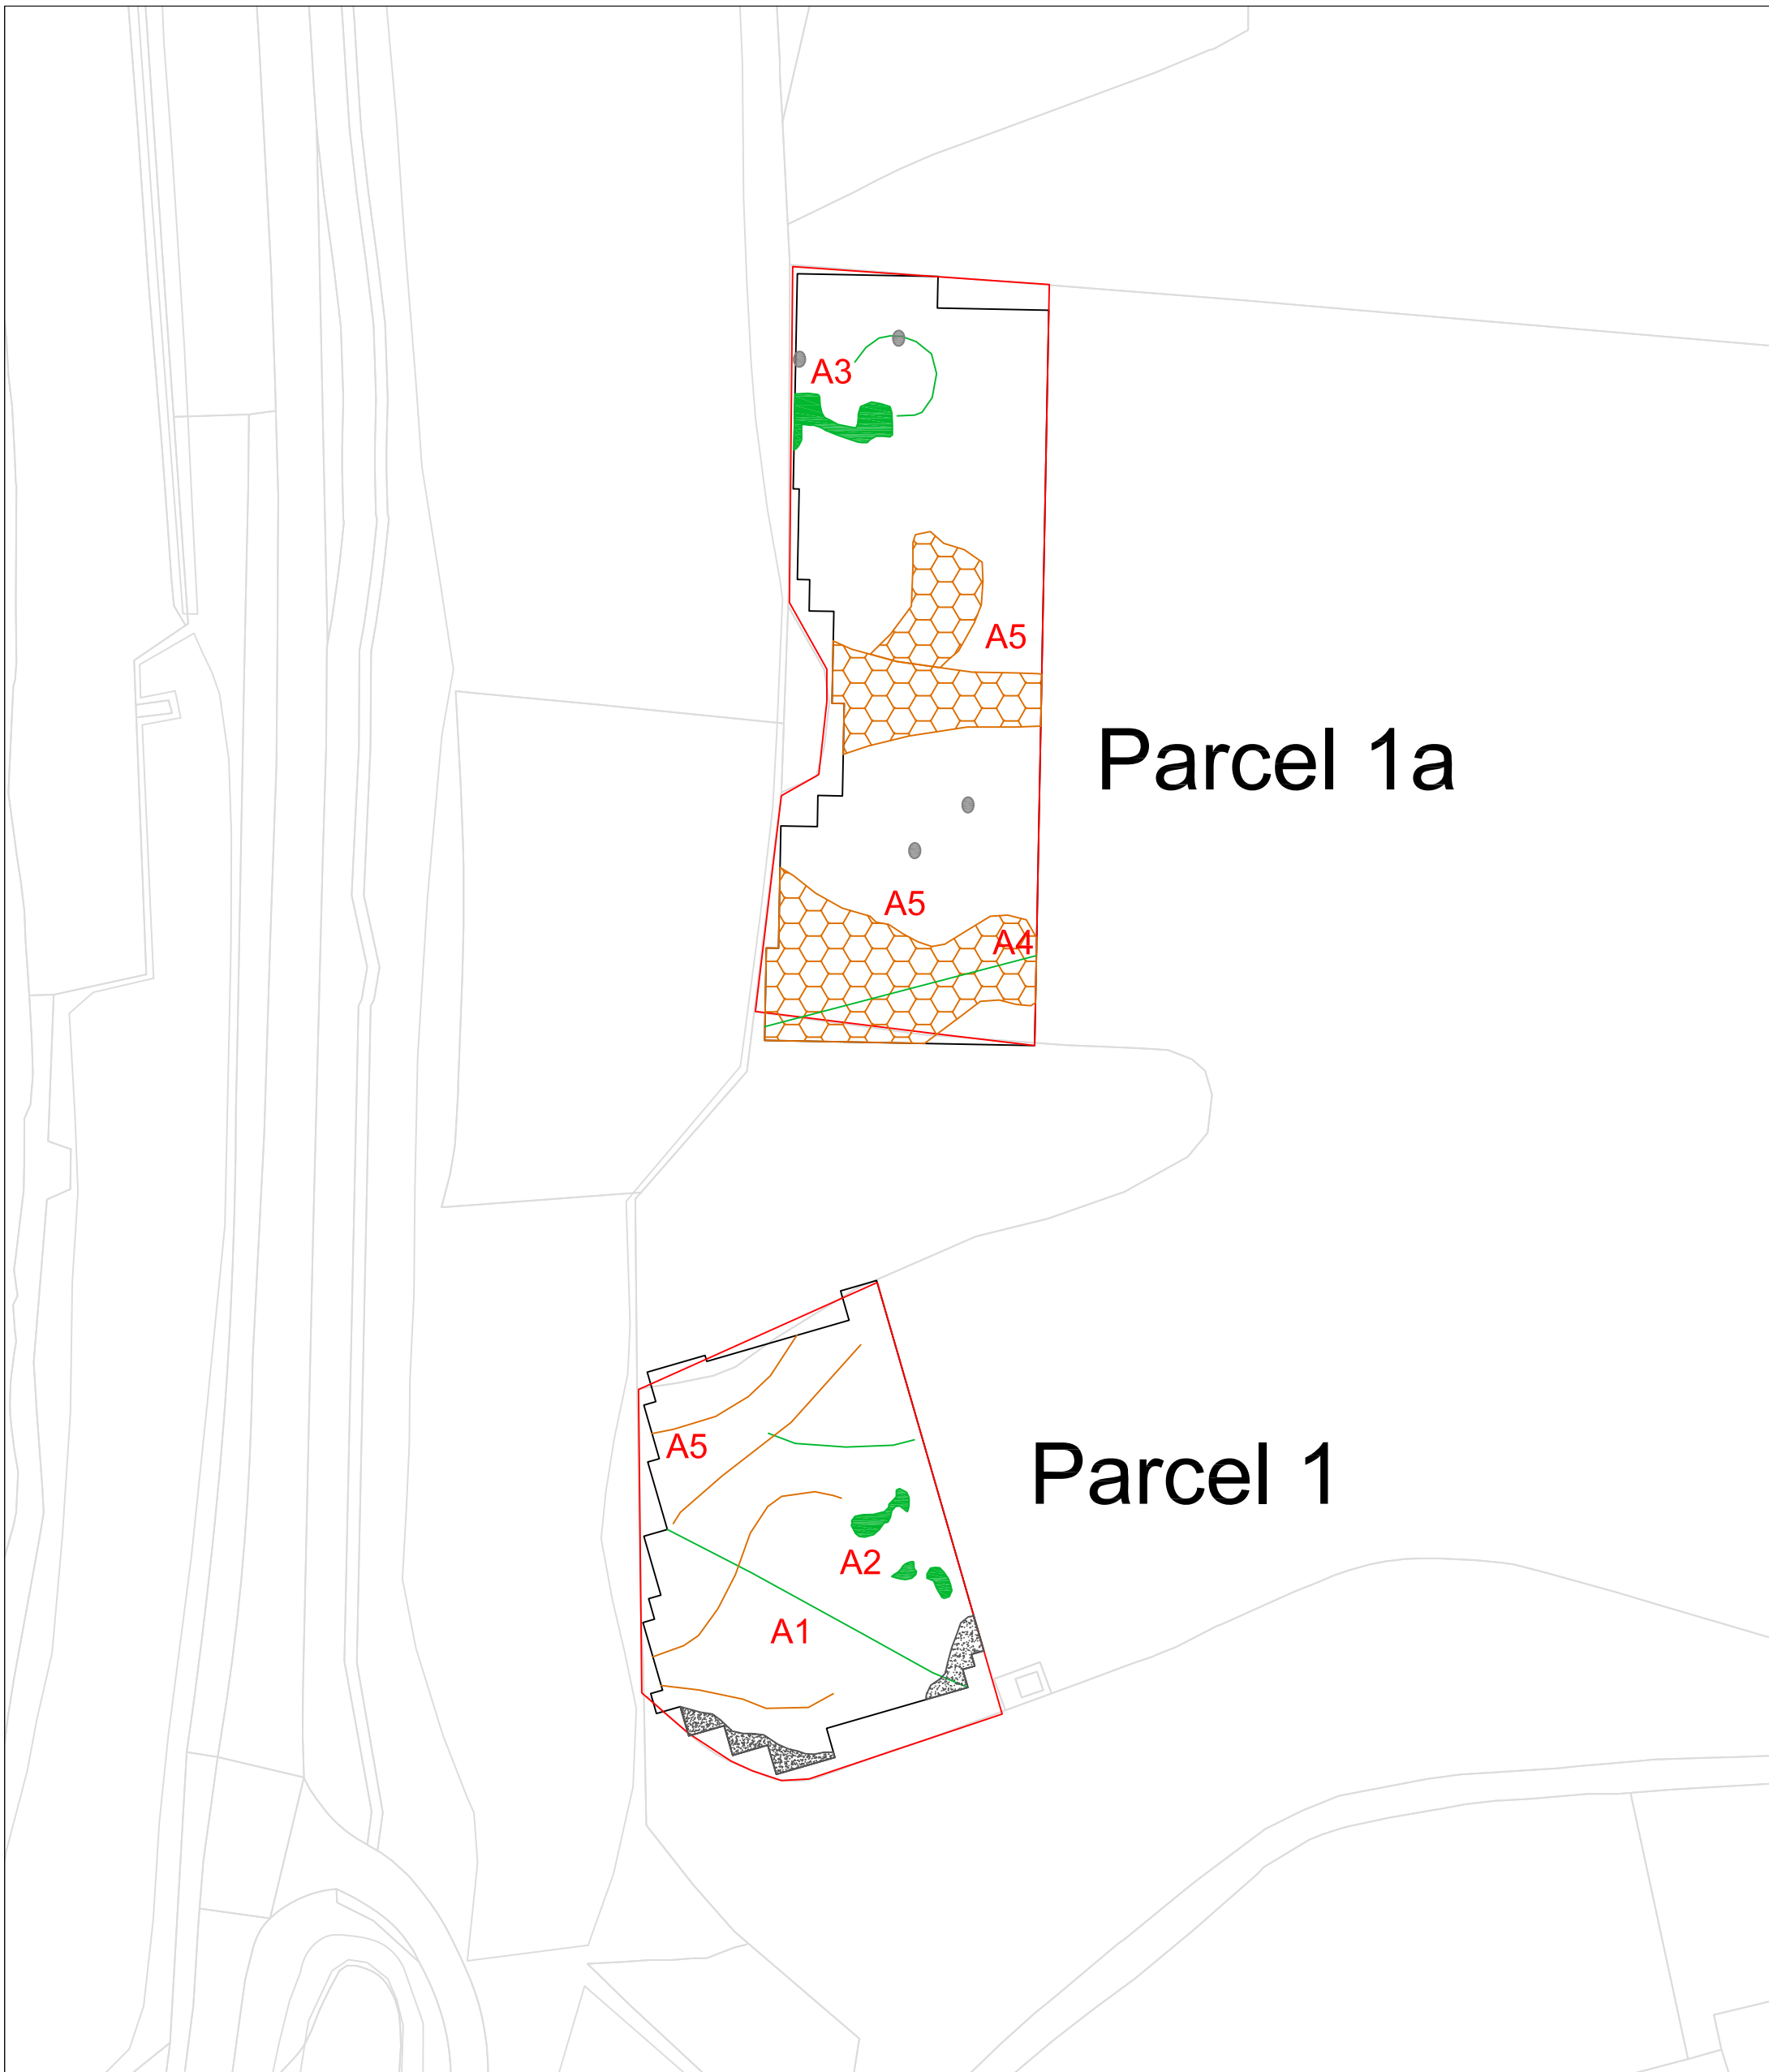
Figure 5: Interpretation of gradiometer survey results - Parcels 1 and 1a

- 6.3 Some tentative curvilinear and linear trends have been identified in the data for both areas. A positive linear trend runs in a north-west to south-east direction across Parcel 1 (**A1**). Three sub circular positive anomalies are observed in the east of Parcel 1 adjacent to a further curvilinear trend running roughly east-west (**A2**). In Parcel 1a a sub-circular trend adjacent to an amorphous strong positive anomaly is observed in the north-west of the dataset (**A3**), as well as a linear trend running north-east to south-west in the south of the dataset (**A4**). Given the steep topography of the land across the two parcels, it is unlikely that these anomalies are archaeological in origin, however it cannot be ruled out given the vista of the survey parcels.

- 6.4 A number of geological trends are observed across both parcels 1 and 1a (**A5**). Geological variations consist of an area of disturbance that is composed of irregular significant increases or decreases in magnetic values compared with background readings and is likely to indicate natural variations in soil composition or geology.

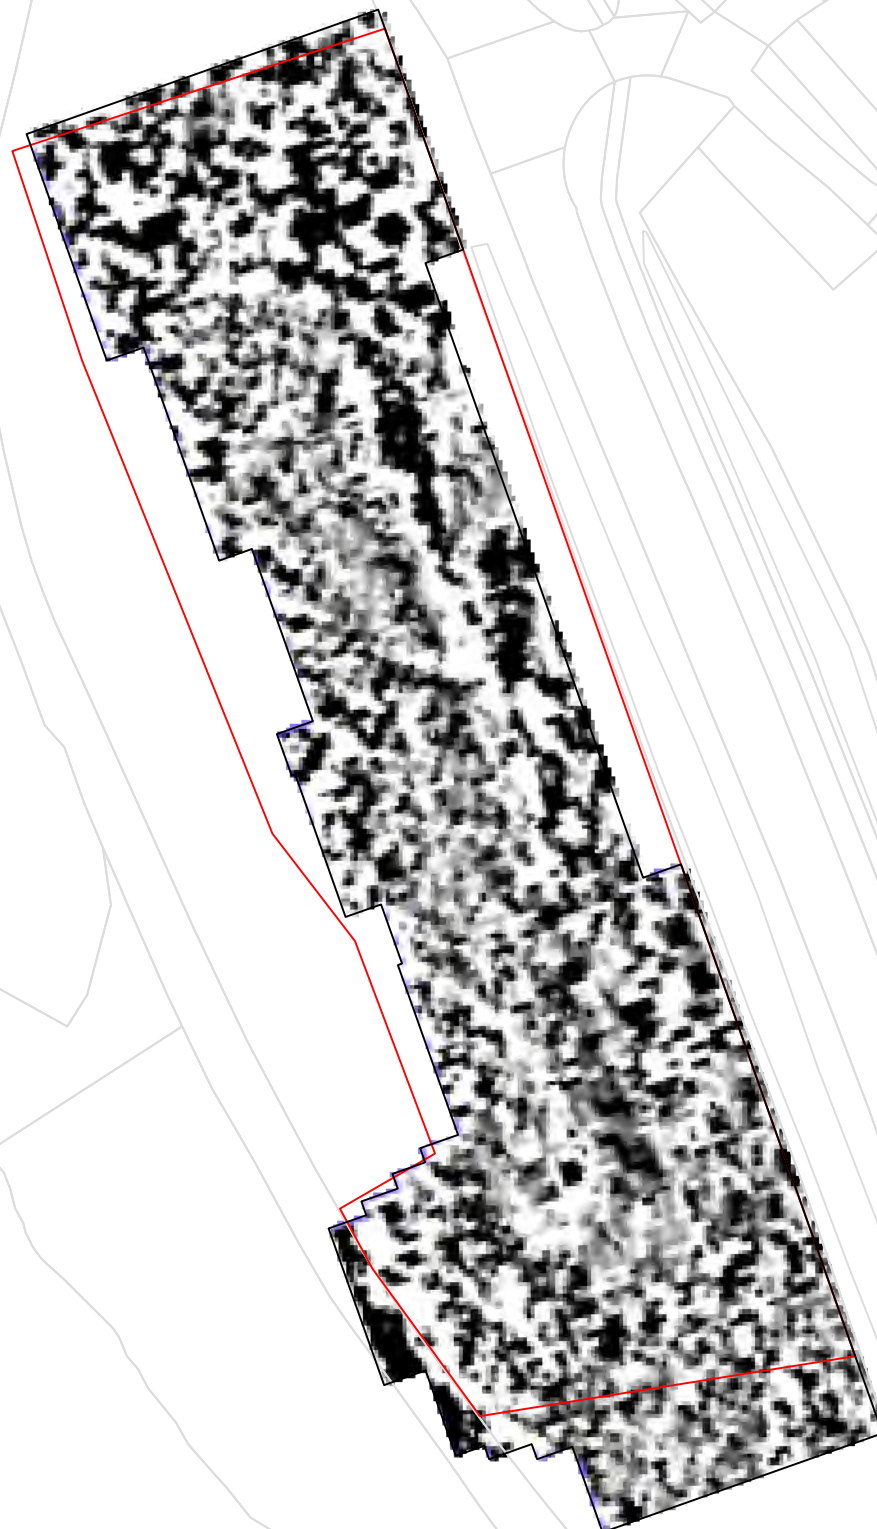
Figure
6

Figure 6: Minimally processed gradiometer survey results - greyscale plot - Parcel 2

Parcel 2 (0.91ha) – Figures 6 - 8**Archaeology**

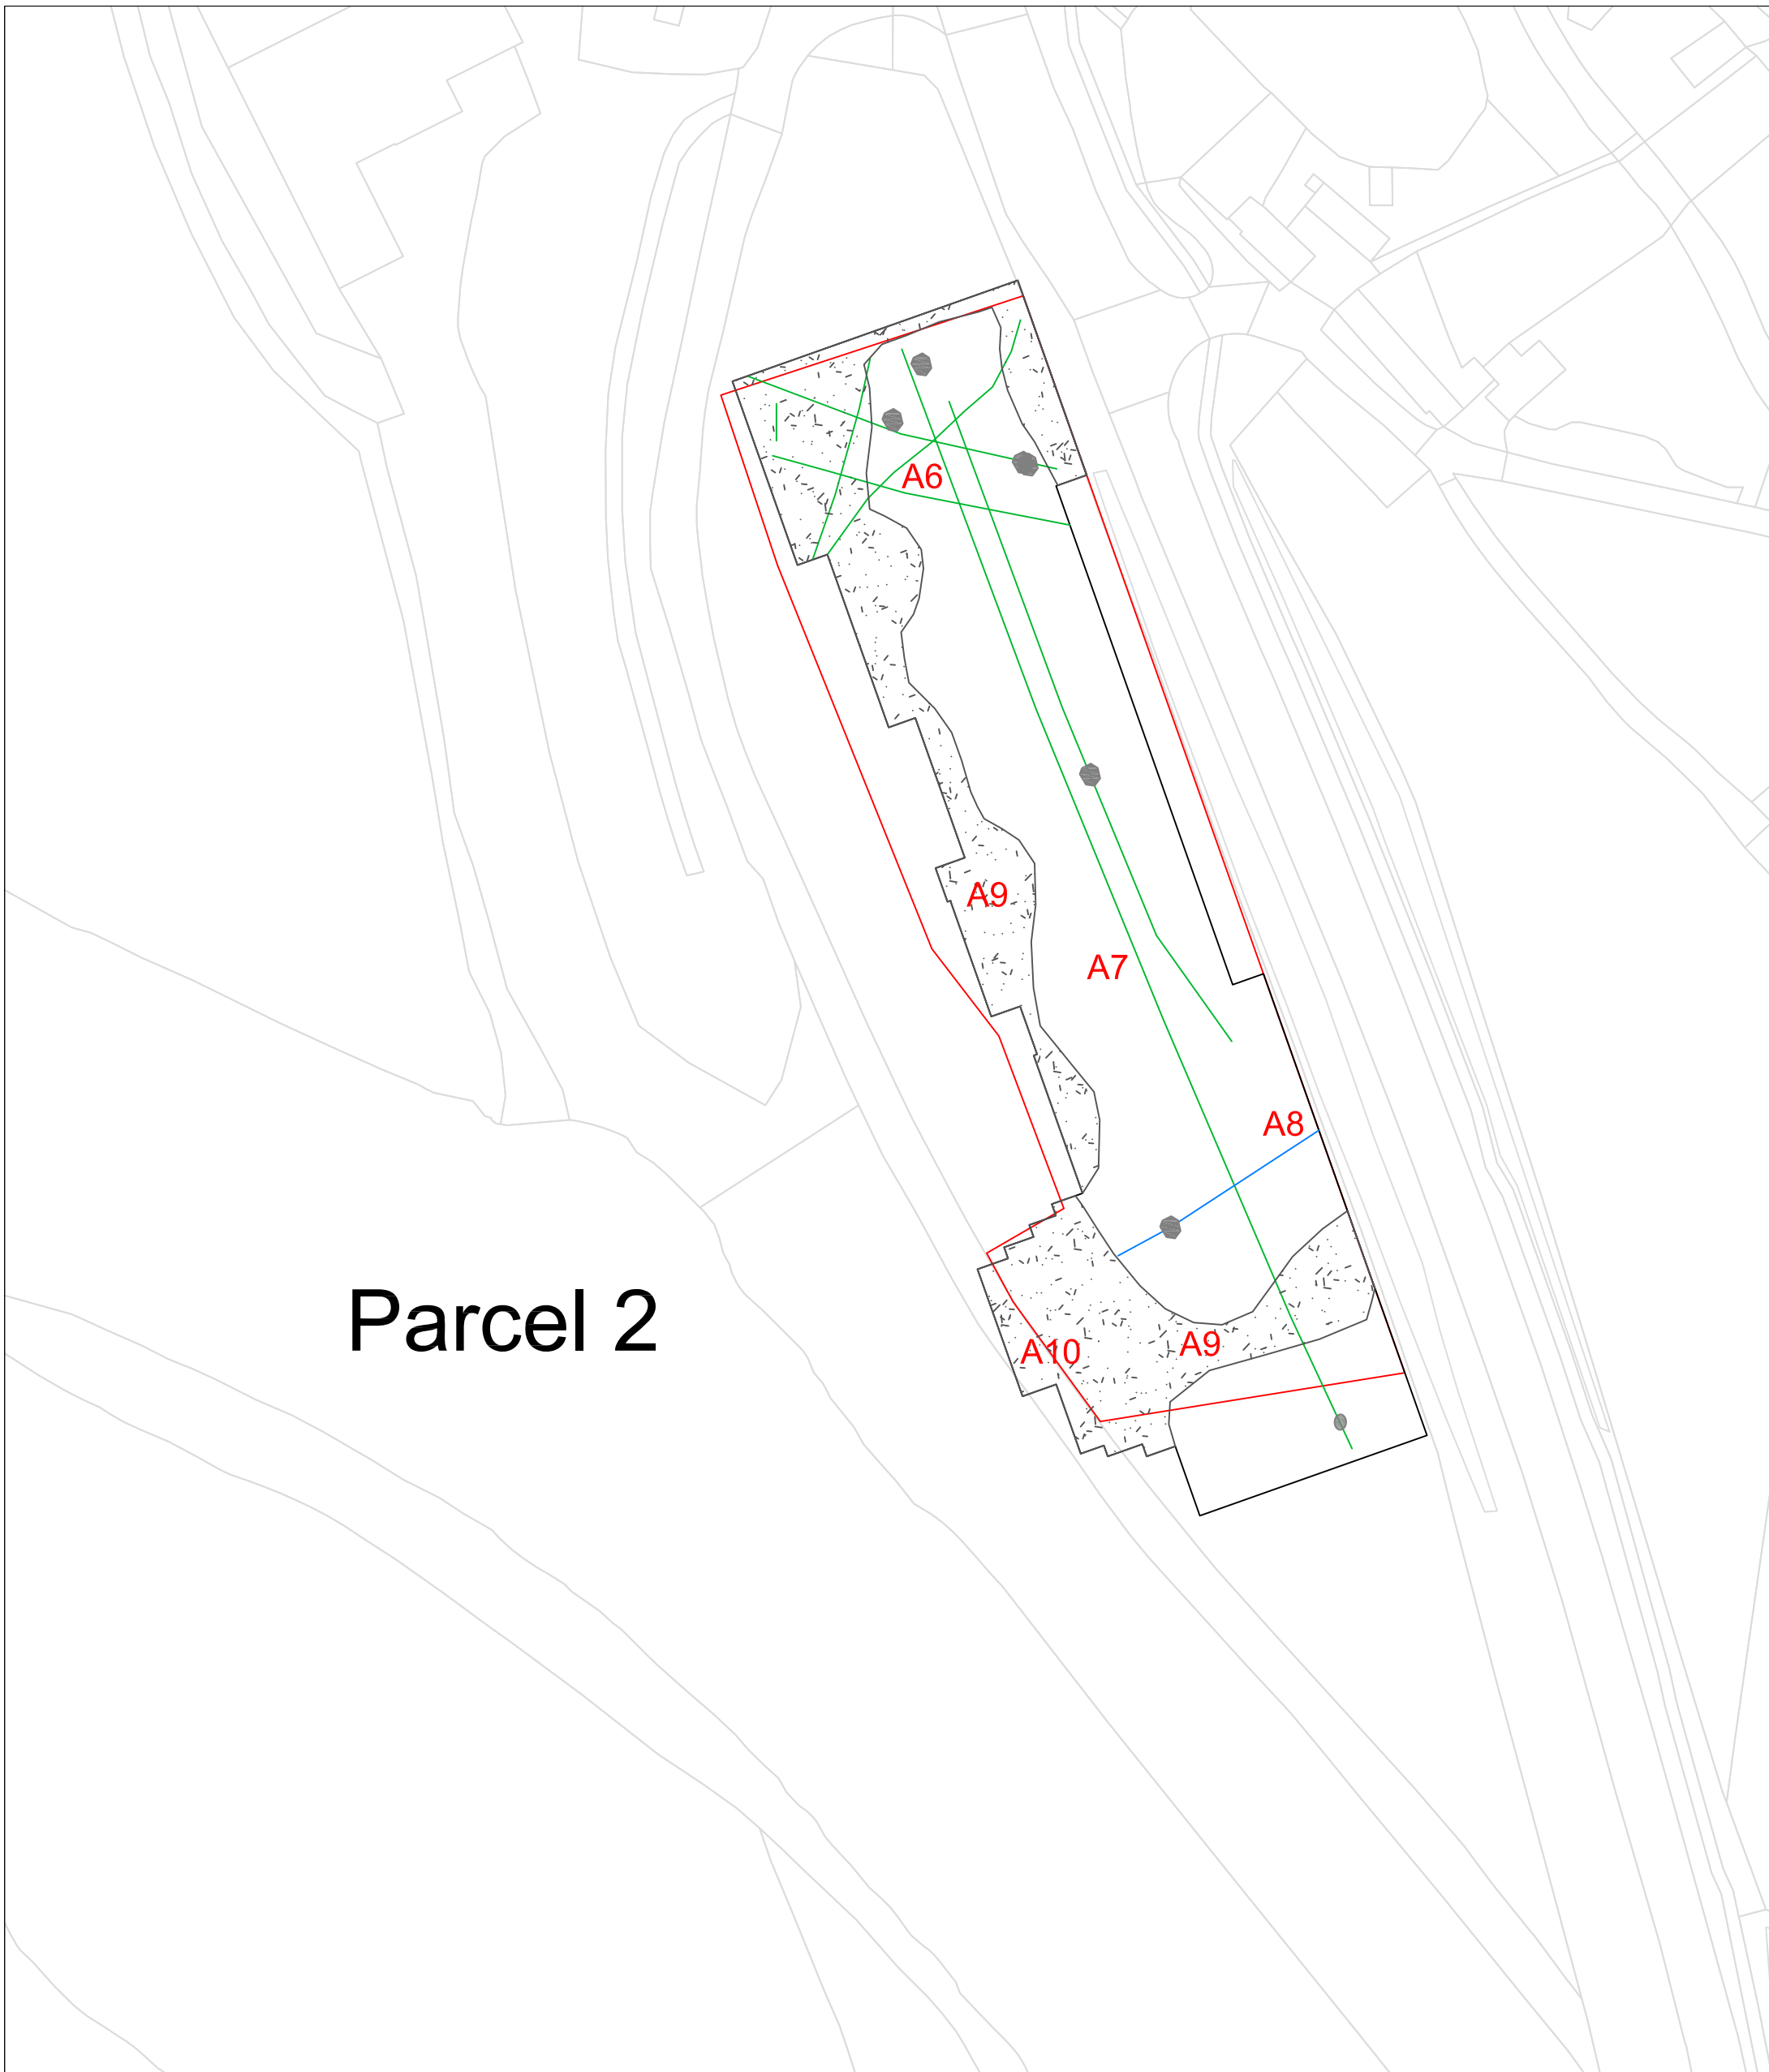
Figure 8: Interpretation of gradiometer survey results - Parcel 2

- 6.19 A number of trends which could have an archaeological origin have been observed in the dataset for this parcel, however given the strong geological response in the data, they could have a natural origin.
- 6.20 Two curvilinear trends are evident in the south of the data, one of which runs towards the graveyard in the south of the parcel and therefore could have an archaeological origin (**A11**). A further sub-circular trend is observed in the north of the dataset which could also have an archaeological origin (**A12**).
