A9 Dualling Programme Pass of Birnam to Glen Garry – Stage 3 Scotland

Archaeological Geophysical Survey

AOC Project No: 51736

Date: May 2017

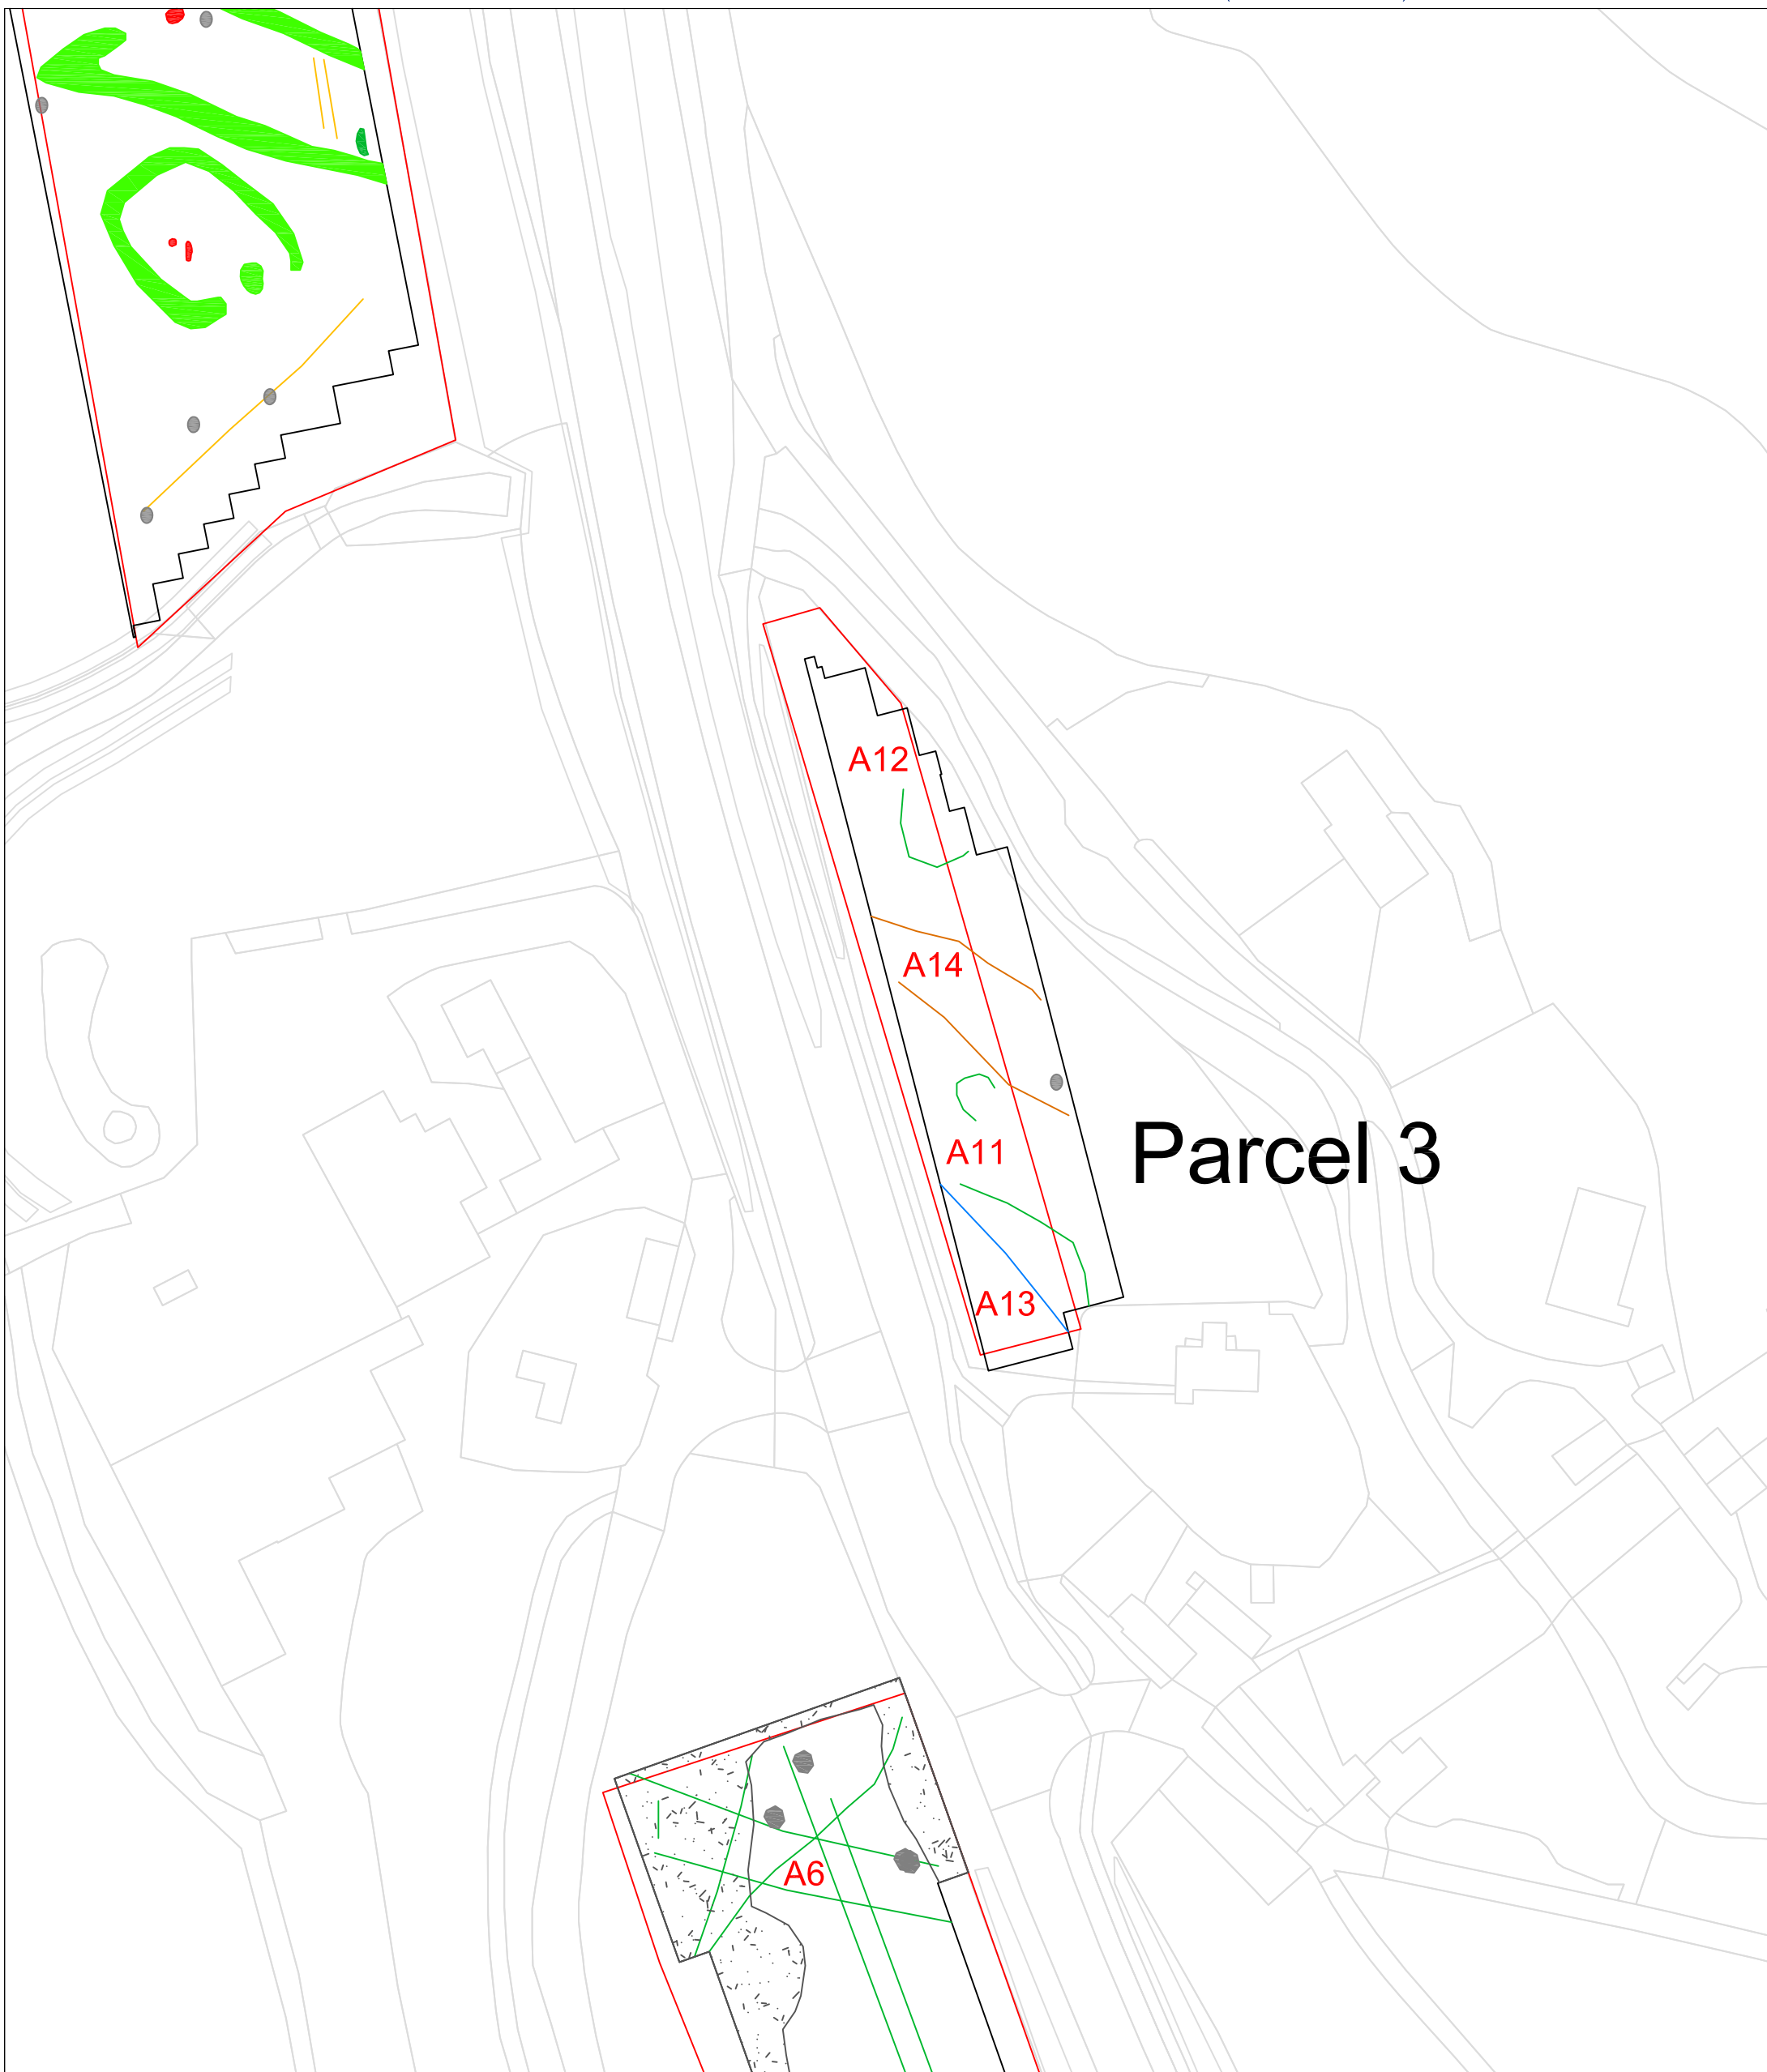
Figure 11: Interpretation of gradiometer survey results - Parcel 3

- 6.22 Two bands of geology are visible in the dataset (**A14**) which correlate with the topography of the parcel, where an incline to the north was observed at the time of survey.
- 6.23 On the eastern boundary there is a small isolated dipolar anomaly (iron spike).

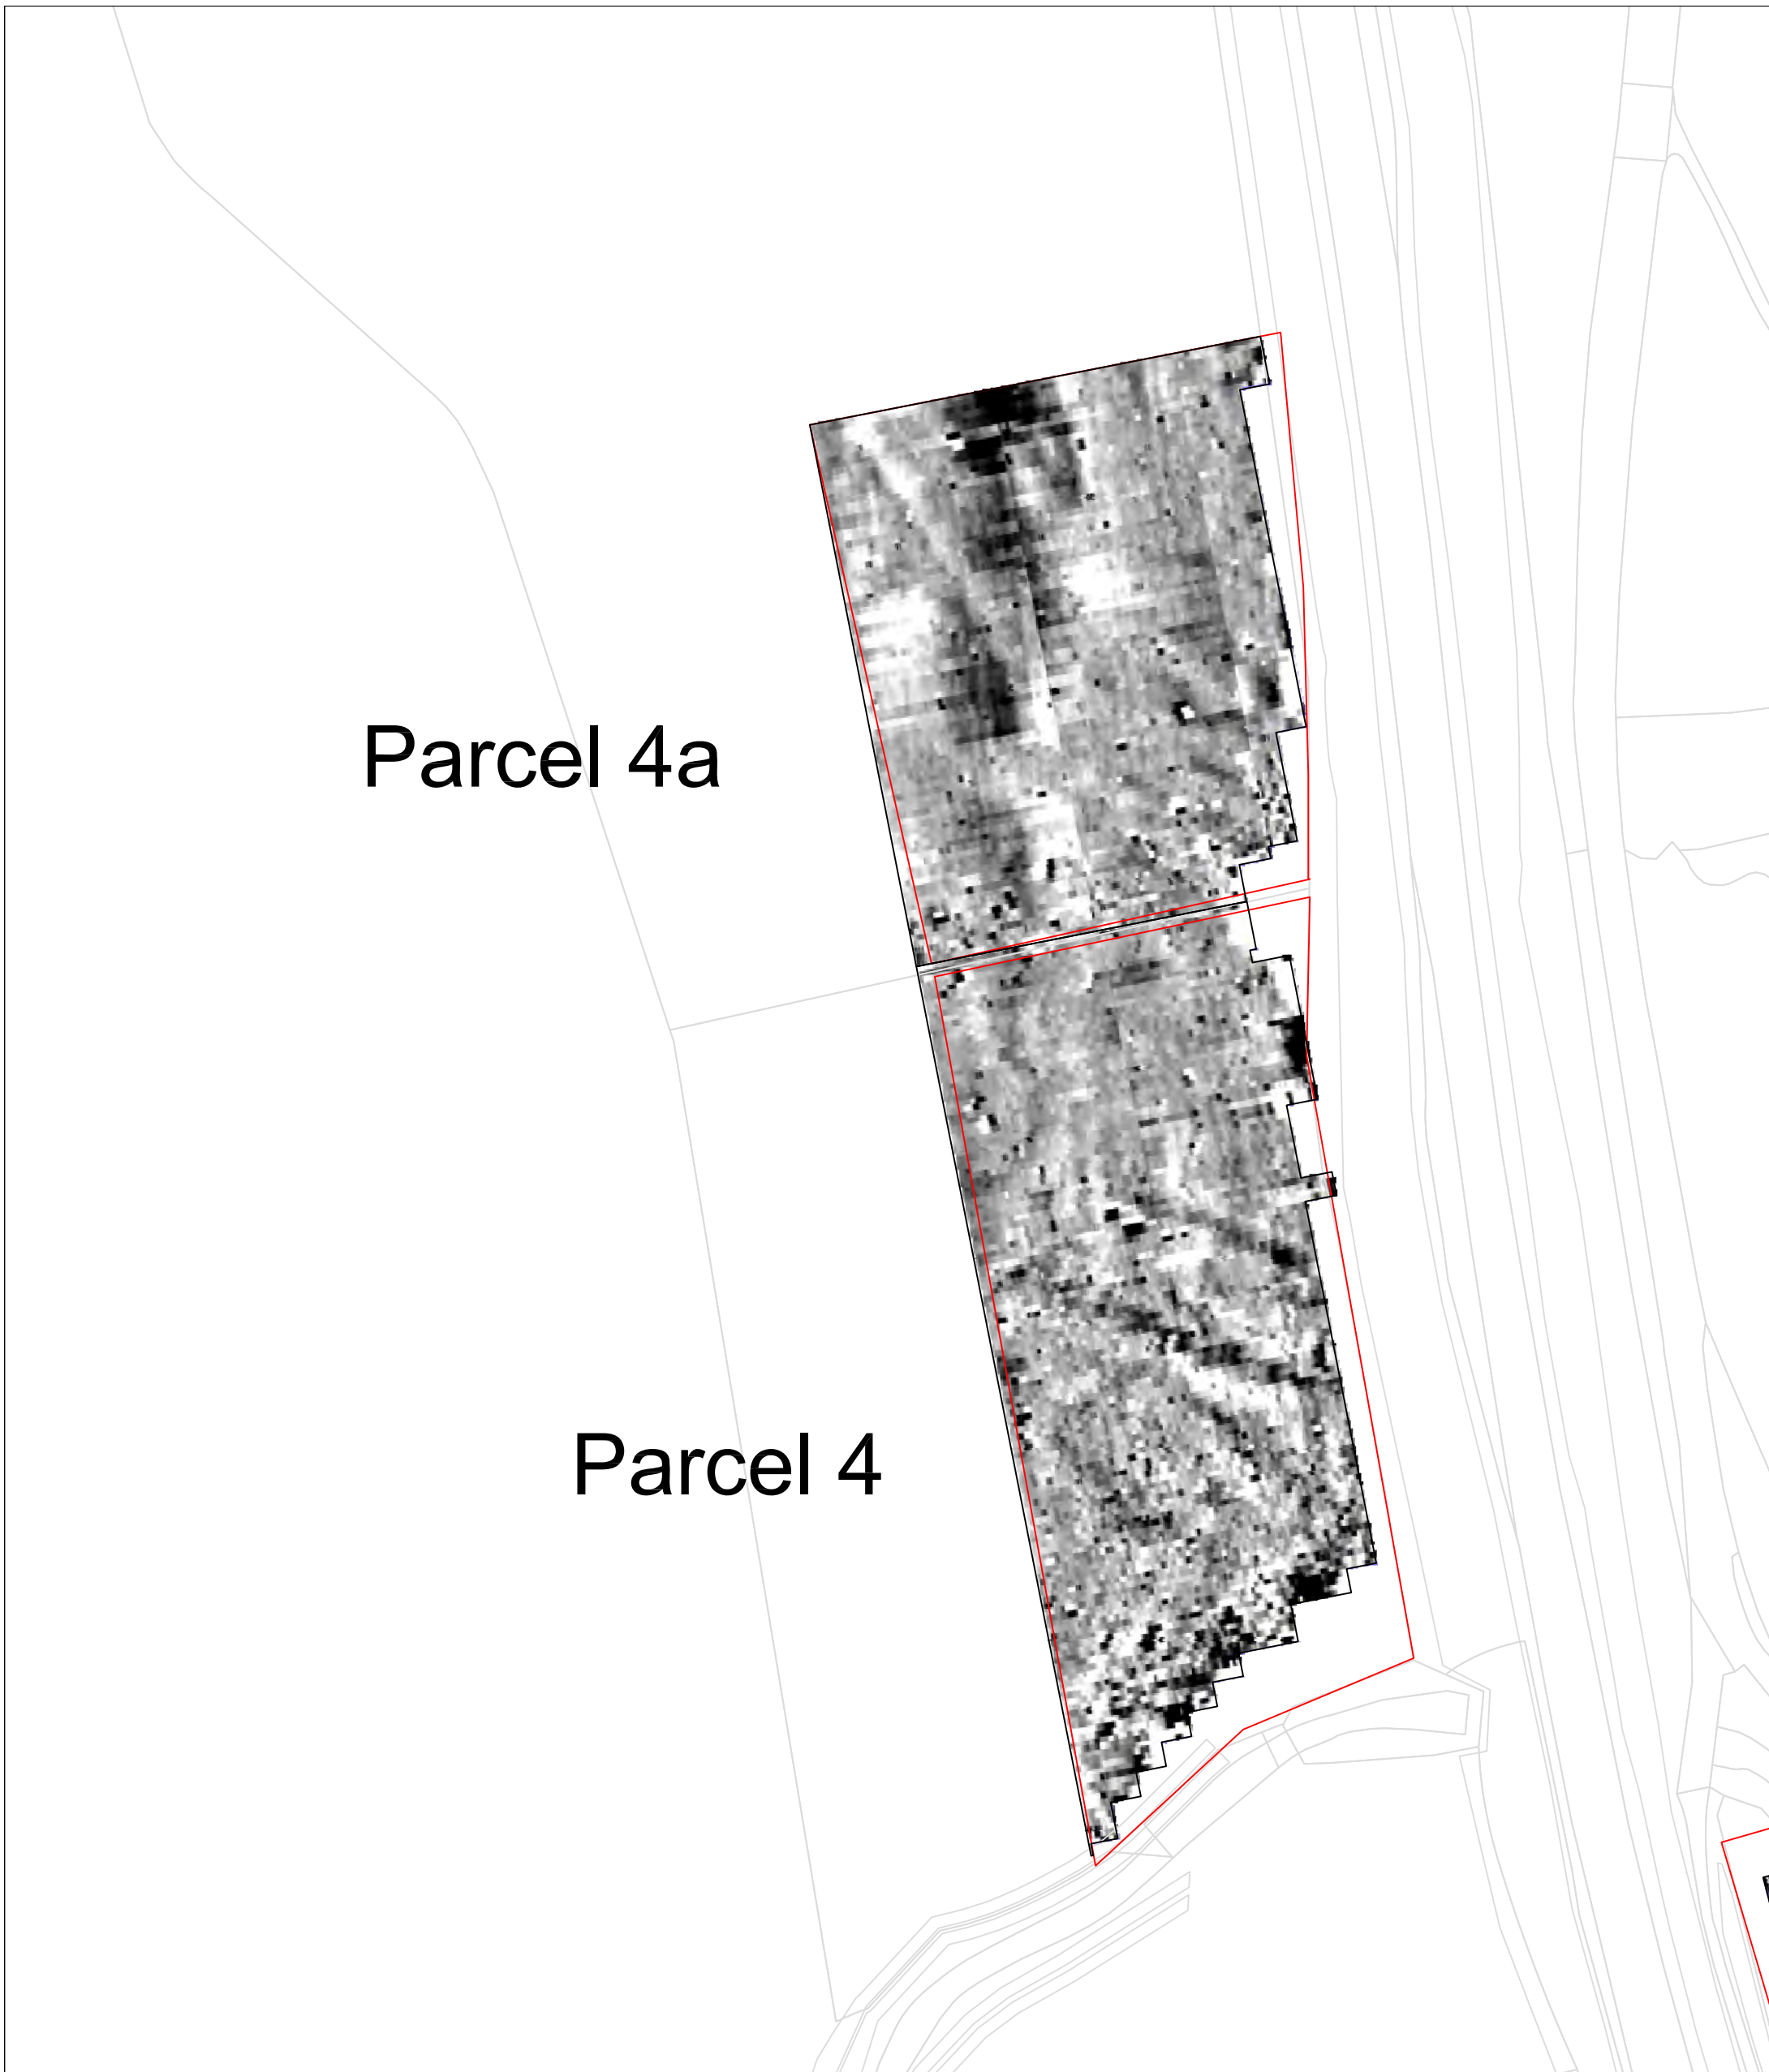
Figure 12

Figure 12: Minimally processed gradiometer survey results - greyscale plot - Parcels 4 and 4a

Parcel 4 and 4a (0.77ha and 0.64ha) – Figures 12 - 14

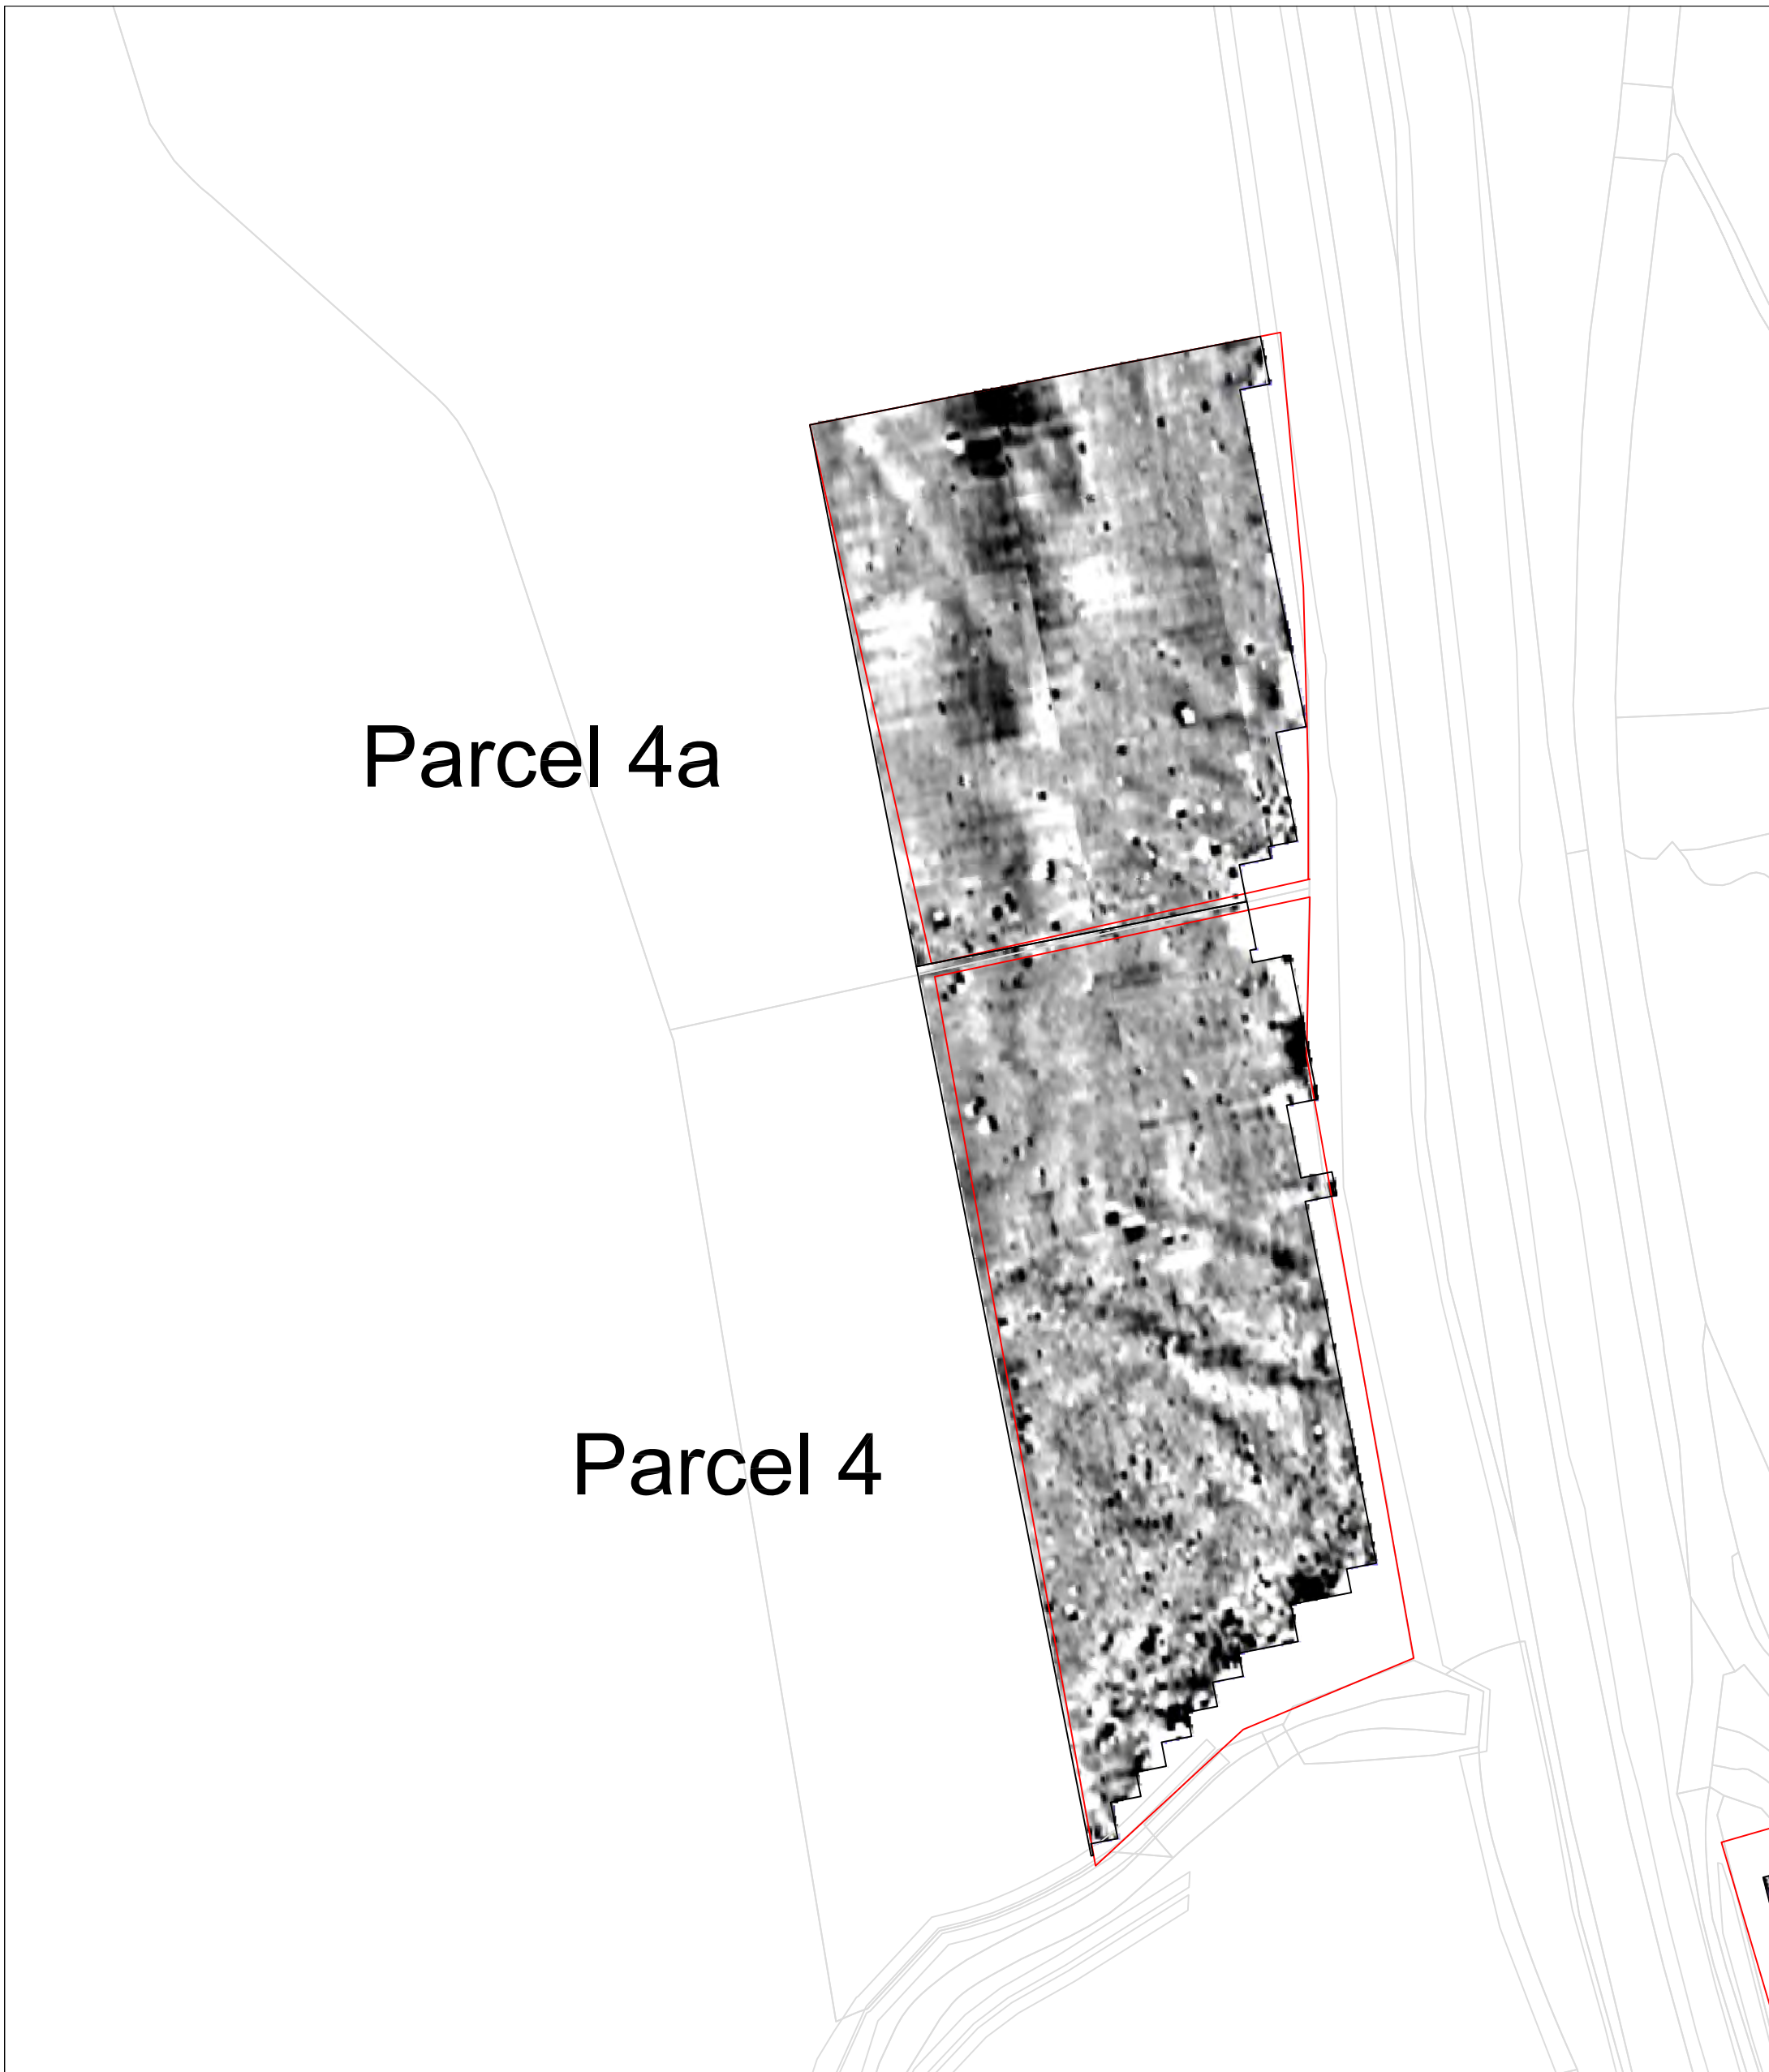
Figure 13

Figure 13: Processed gradiometer survey results - greyscale plot - Parcels 4 and 4a

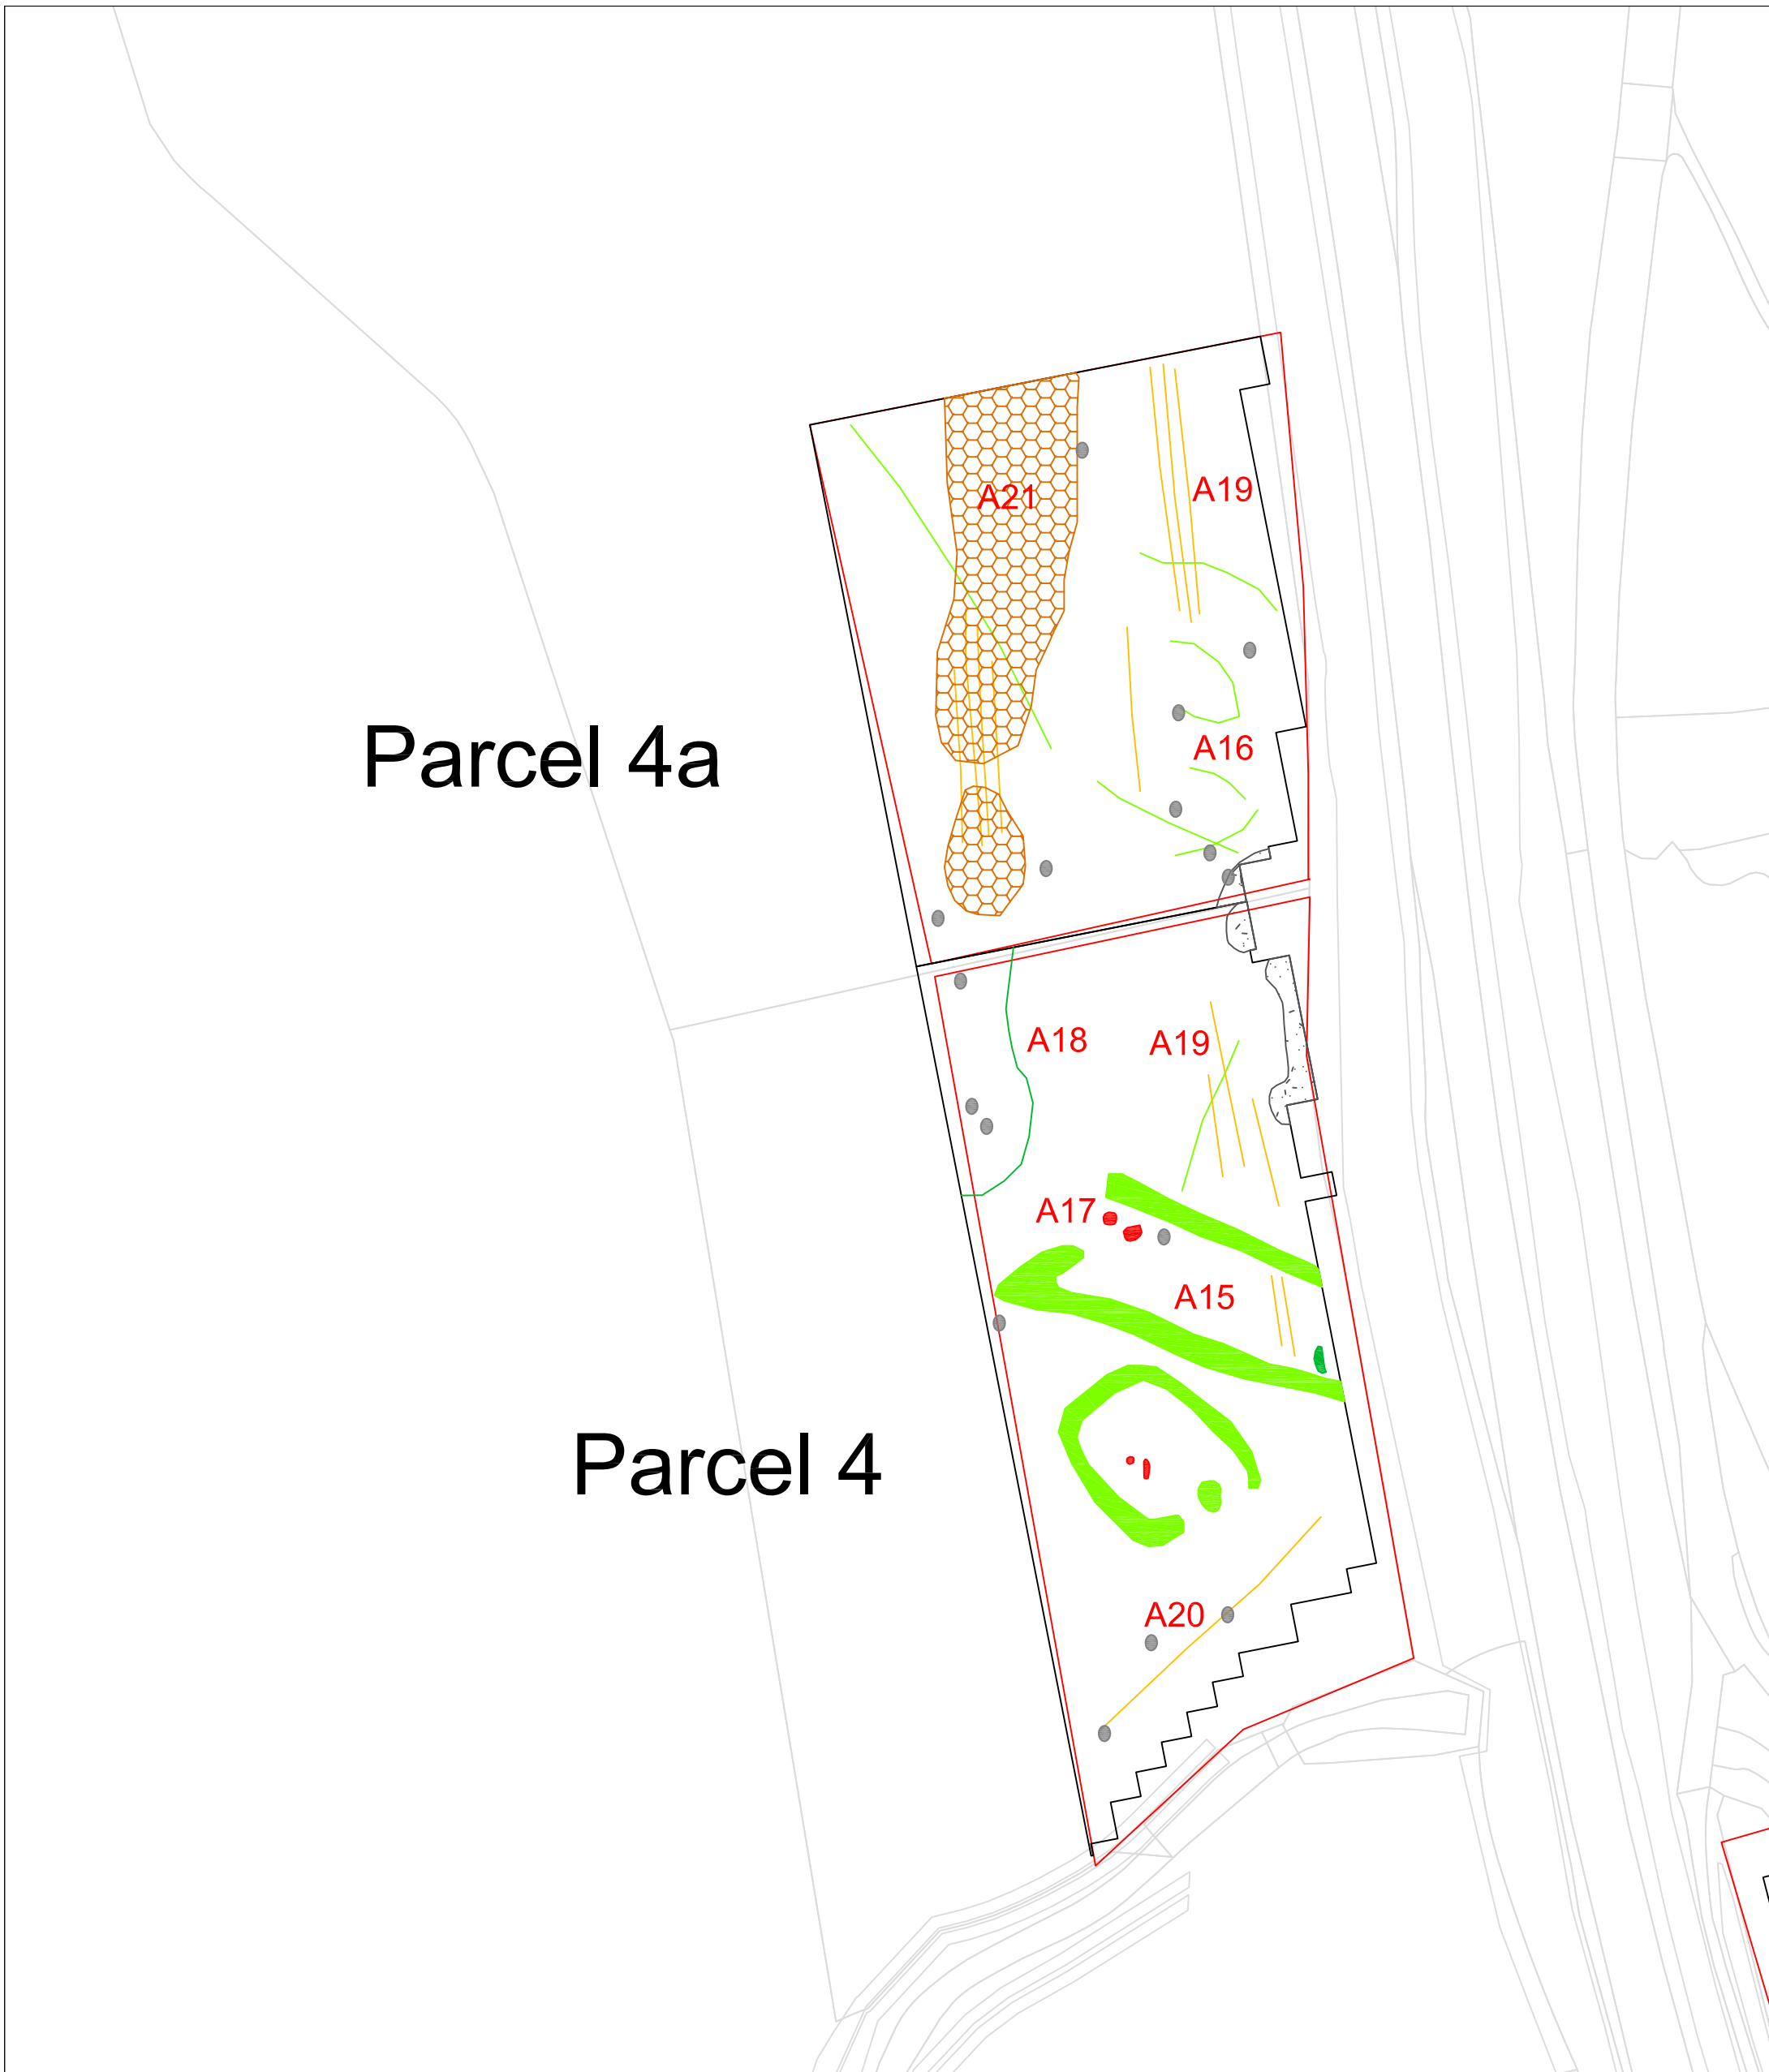
Figure 14: Interpretation of gradiometer survey results - Parcels 4 and 4a

- 6.25 Rectilinear and curvilinear trends which are likely to be of an archaeological nature are visible in the south of the data for Parcel 4 (**A15**). These appear to form an enclosure and further investigation would be required to ascertain their origin.
- 6.26 Curvilinear trends are observed in the east of Parcel 4a, adjacent to a linear trend running north-west to south-east through the parcel which could all be archaeological in origin (**A16**). These may correlate with cropmarks identified through historic oblique aerial photography, which have identified a possible ring-ditch and a possible adjacent enclosure – CANMORE ID 26229 (Canmore 2017).

- 6.29 Ploughing trends running north-south are visible in the dataset for both Parcel 4 and 4a (**A19**). Ploughing trends are represented by a series of regular linear anomalies either composed of an increased or decreased magnetic response compared to background values.
- 6.30 An agricultural headland is also visible running along the southern boundary of Parcel 4 (**A20**).
- 6.31 A strong geological response is visible in the north of Parcel 4a, which has caused some distortion and striping in the dataset (**A21**).
- 6.32 Across the data set there is a small quantity of isolated dipolar anomalies (iron spikes).
- 6.33 Magnetic disturbance is observed along the eastern field boundaries which relates to metal fencing and a drain.

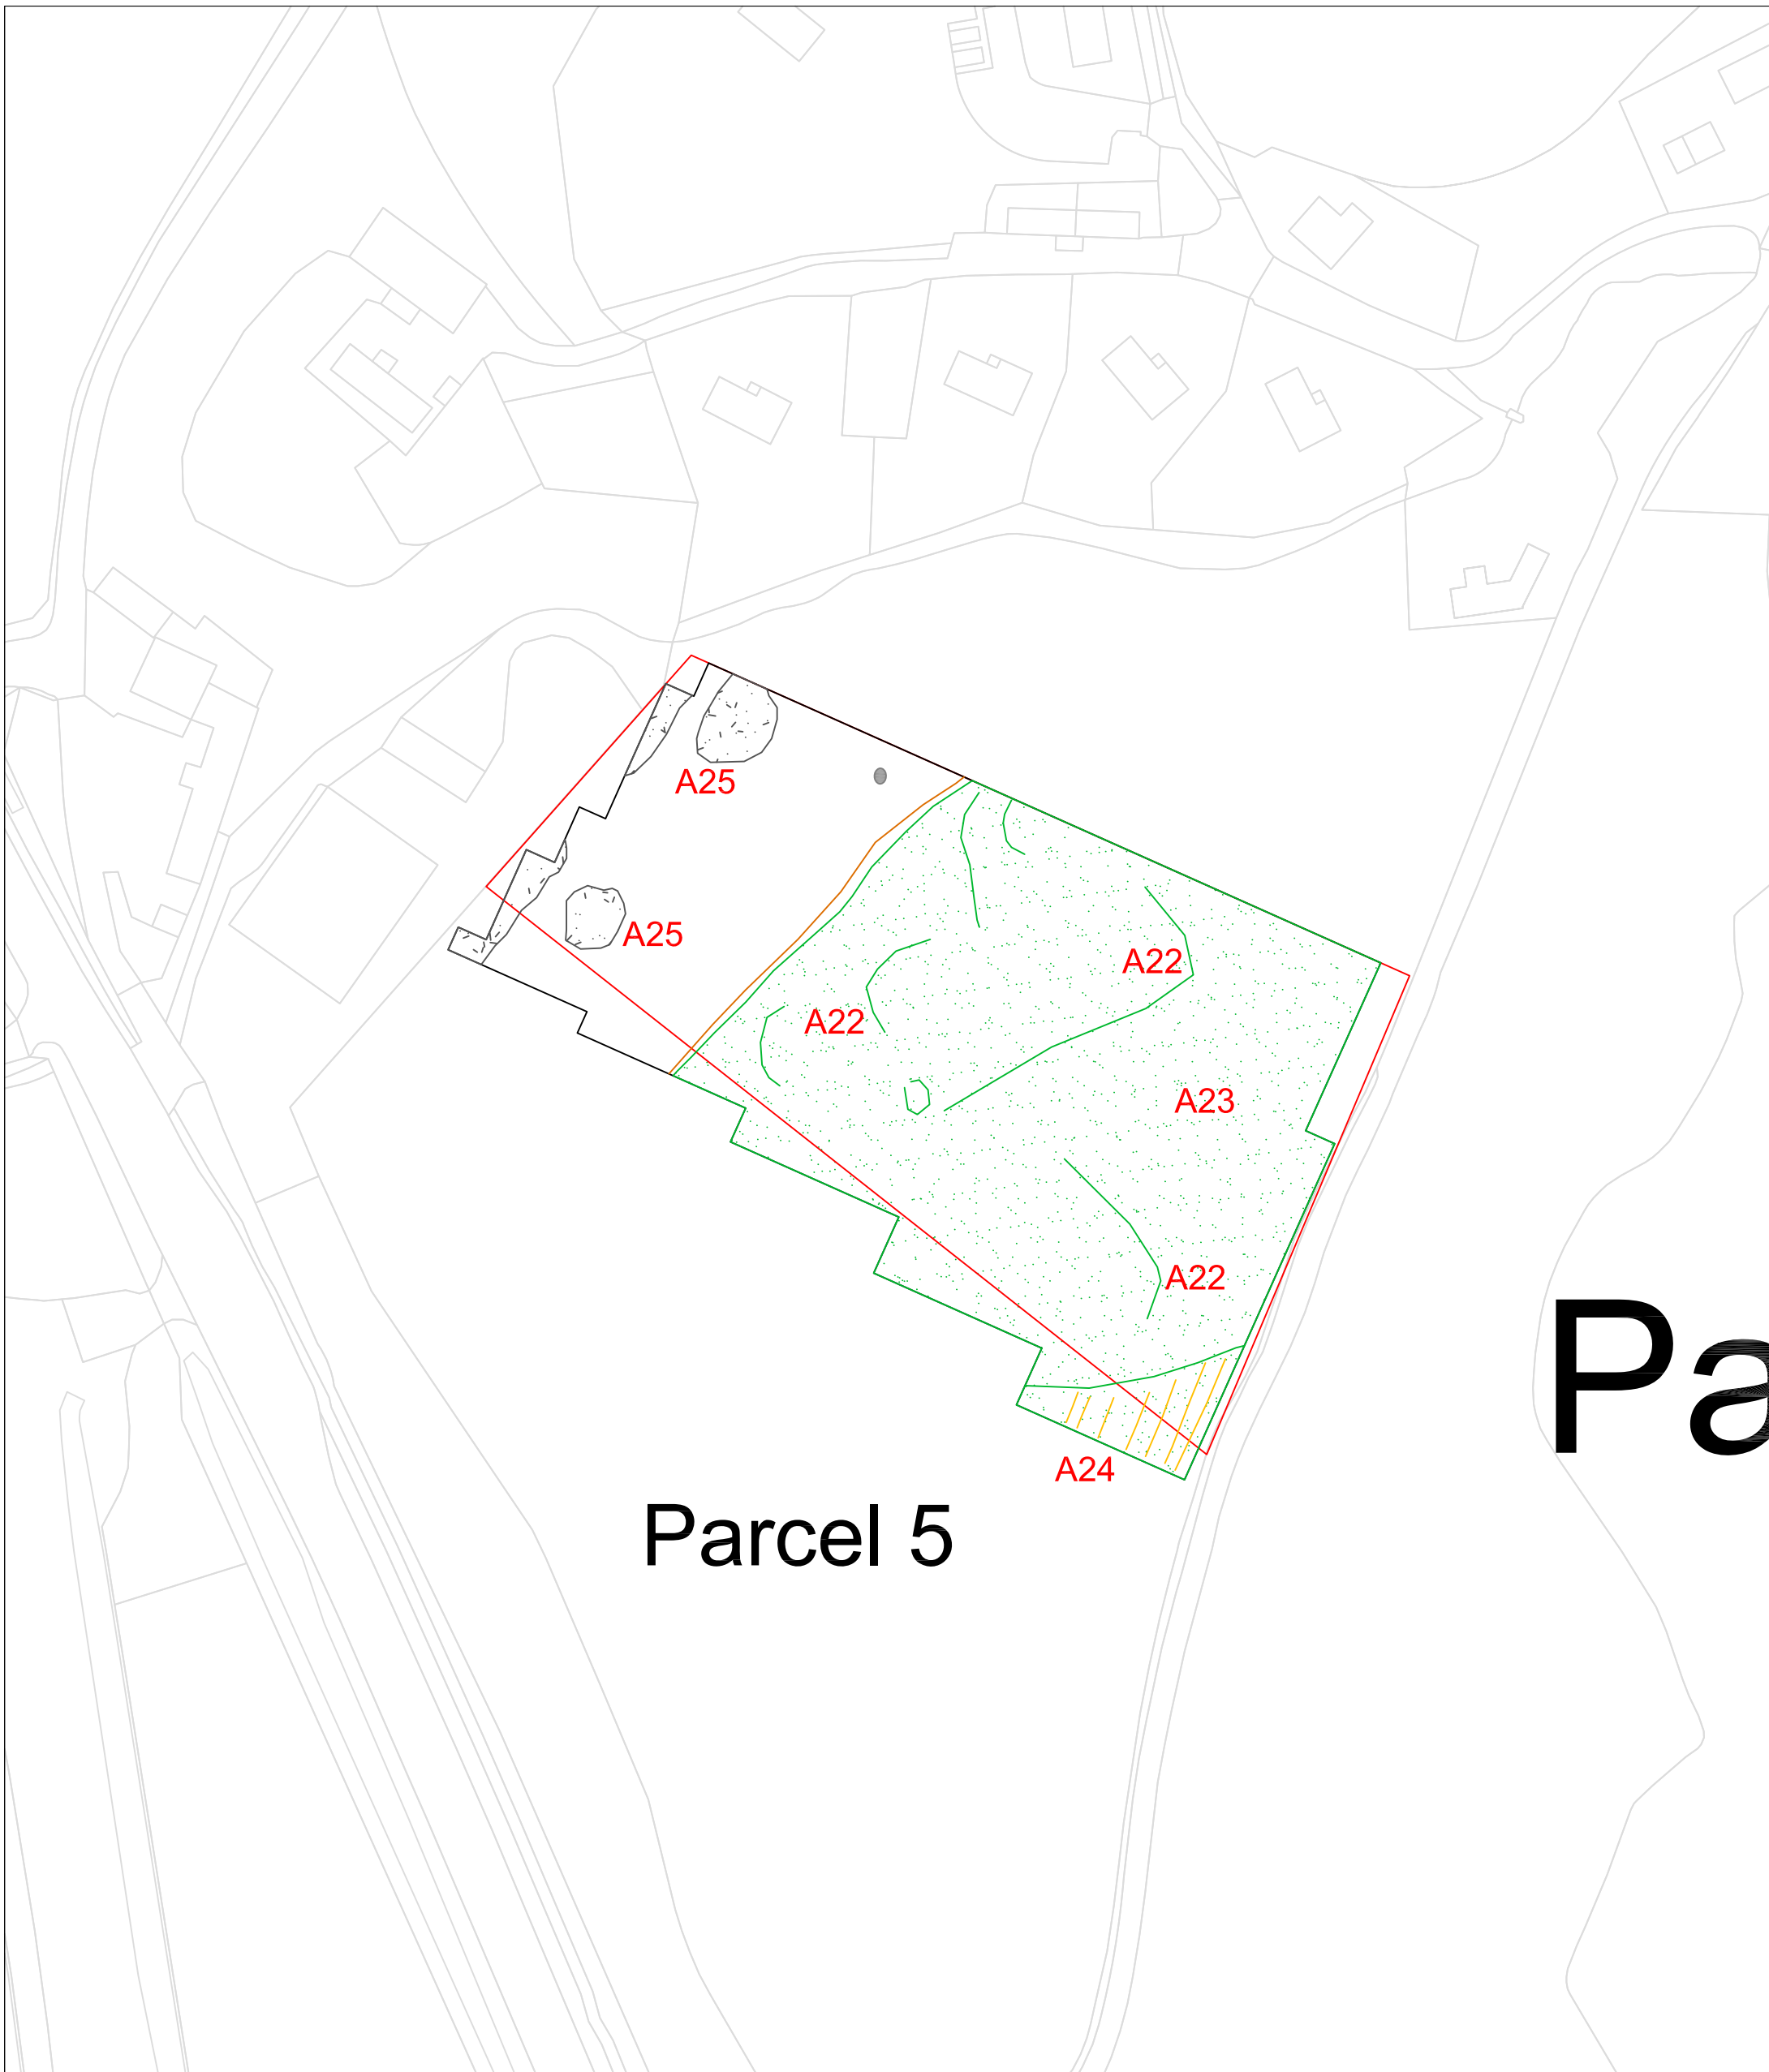
Figure 17: Interpretation of gradiometer survey results - Parcel 5

- 6.37 Ploughing trends are visible in the south-east of the dataset running north-south, running up to to an anomaly that is suggestive of a former field boundary (**A24**). However, this cannot be confirmed through historic mapping and therefore has an unclear origin.
- 6.38 Magnetic disturbance is seen in patches in the west of the dataset and is related to animal feeders and farm debris observed at the time of survey (**A25**). Further disturbance along the western field boundary relates to metal fencing.
- 6.39 There is an isolated dipolar anomaly within the dataset for this parcel (iron spikes).
