A9 Dualling Programme Pass of Birnam to Glen Garry – Stage 3 Scotland

Archaeological Geophysical Survey

AOC Project No: 51736

Date: May 2017

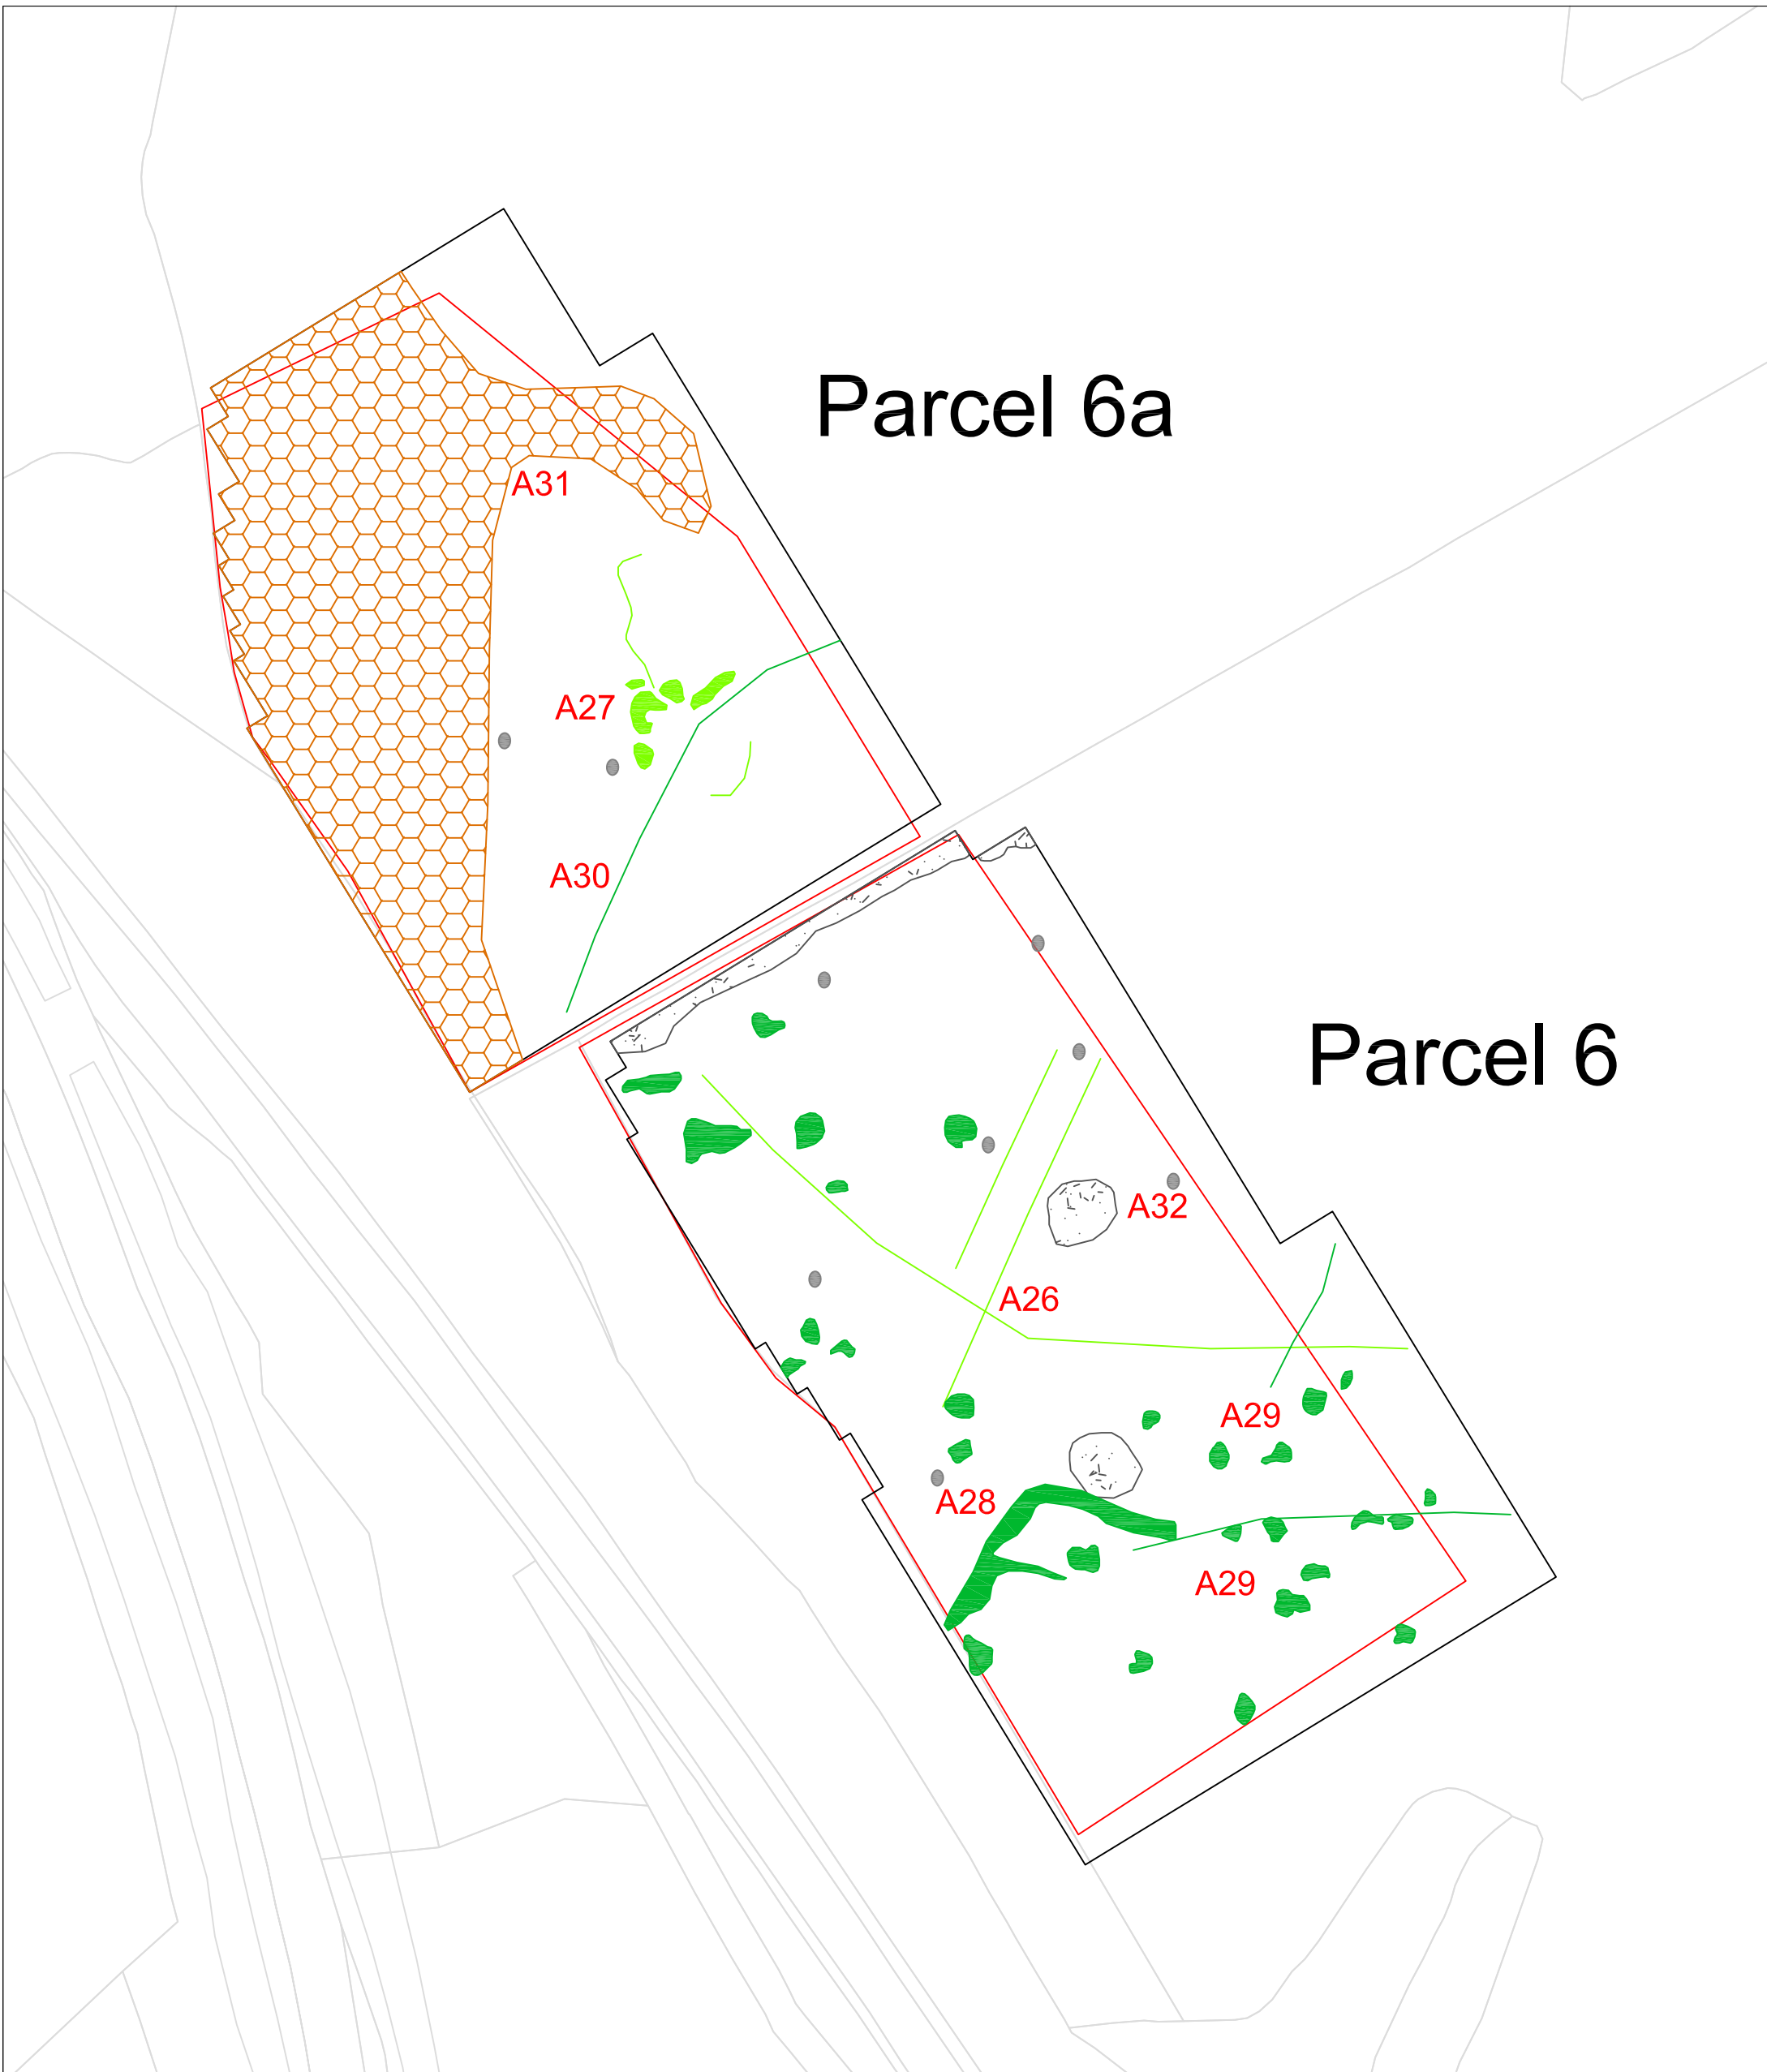
Figure 20: Interpretation of gradiometer survey results - Parcels 6 and 6a

- 6.47 A large area of geology is visible in the dataset for Parcel 6a (**A31**) which correlates with the very steep and undulating topography of the area.
- 6.48 Magnetic disturbance is seen in two areas in the centre of Parcel 6 which relate to boreholes in the parcel, observed at the time of survey (**A32**).
- 6.49 Across the data set there is a small quantity of isolated dipolar anomalies (iron spikes).

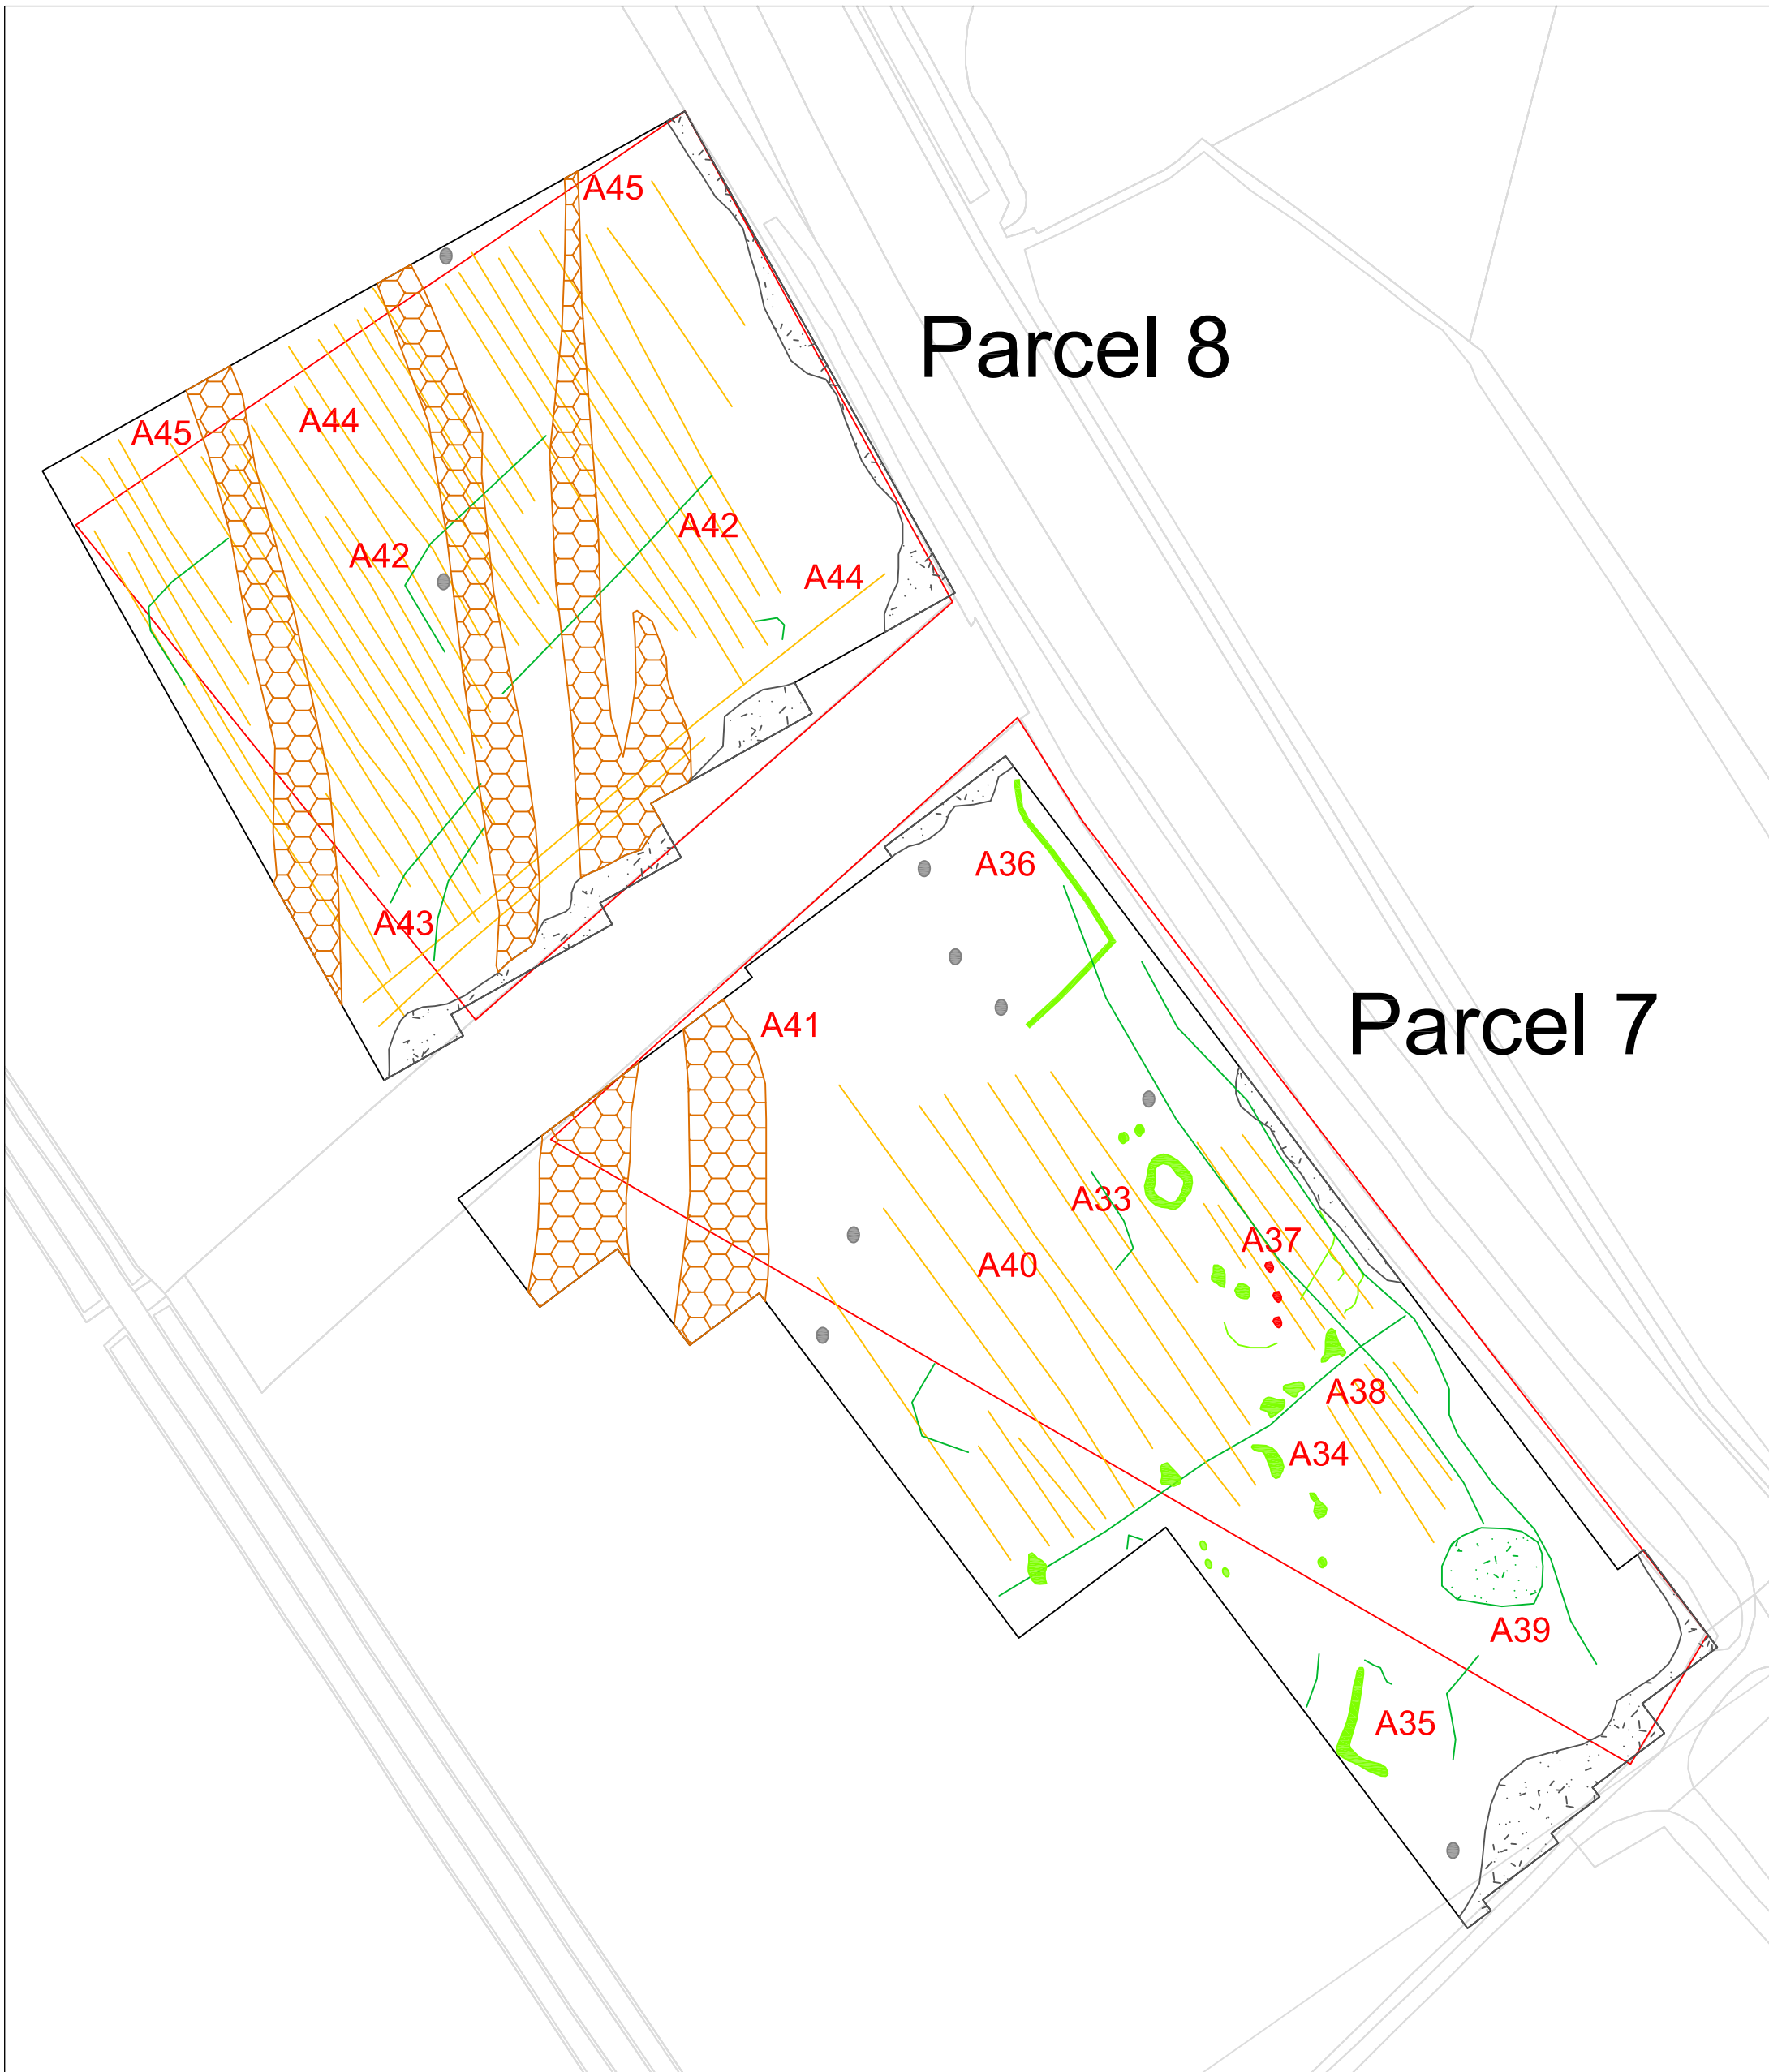
Figure 23: Interpretation of gradiometer survey results - Parcels 7 and 8

- 6.53 A further rectilinear feature is observed in the north-east of the dataset (**A36**) which could be archaeological in nature and related to the adjacent anomalies discussed above.

- 6.57 Ploughing trends are visible across the dataset running in a north-west to south-east direction (**A40**).
- 6.58 An area of geology is visible in the north-west of the dataset (**A41**) which continues on into Parcel 8 to the north.
- 6.59 Magnetic disturbance is observed in the south of the dataset and along the eastern boundary and relates to an access trackway running along the southern boundary and metal boundary fencing.
- 6.60 Across the data set there is a small quantity of isolated dipolar anomalies (iron spikes).

- 6.62 Some tentative linear and rectilinear trends are visible in the dataset running in a north-east to south-west direction (**A42**), which although could be archaeological in nature, could also relate to former ploughing trends running in a different direction to those discussed below.
- 6.63 Two parallel curvilinear trends are observed in the south west of the dataset which also have a very weak tentative response, however an archaeological origin cannot be ruled out (**A43**).

- 6.64 Ploughing trends are visible across the entire dataset running in a north-west to south-east direction (**A44**) as well as a ploughing headland following the southern boundary. These are likely to be modern conventional ploughing trends.
- 6.65 Bands of geology are visible across the dataset as negative trends running from the north to the south (**A45**). These may be related to the river to the west and could be palaeochannels on the floodplain.
- 6.66 Magnetic disturbance is observed along the eastern and southern boundary and relates to metal fencing and debris.
- 6.67 Across the data set there is a small quantity of isolated dipolar anomalies (iron spikes).

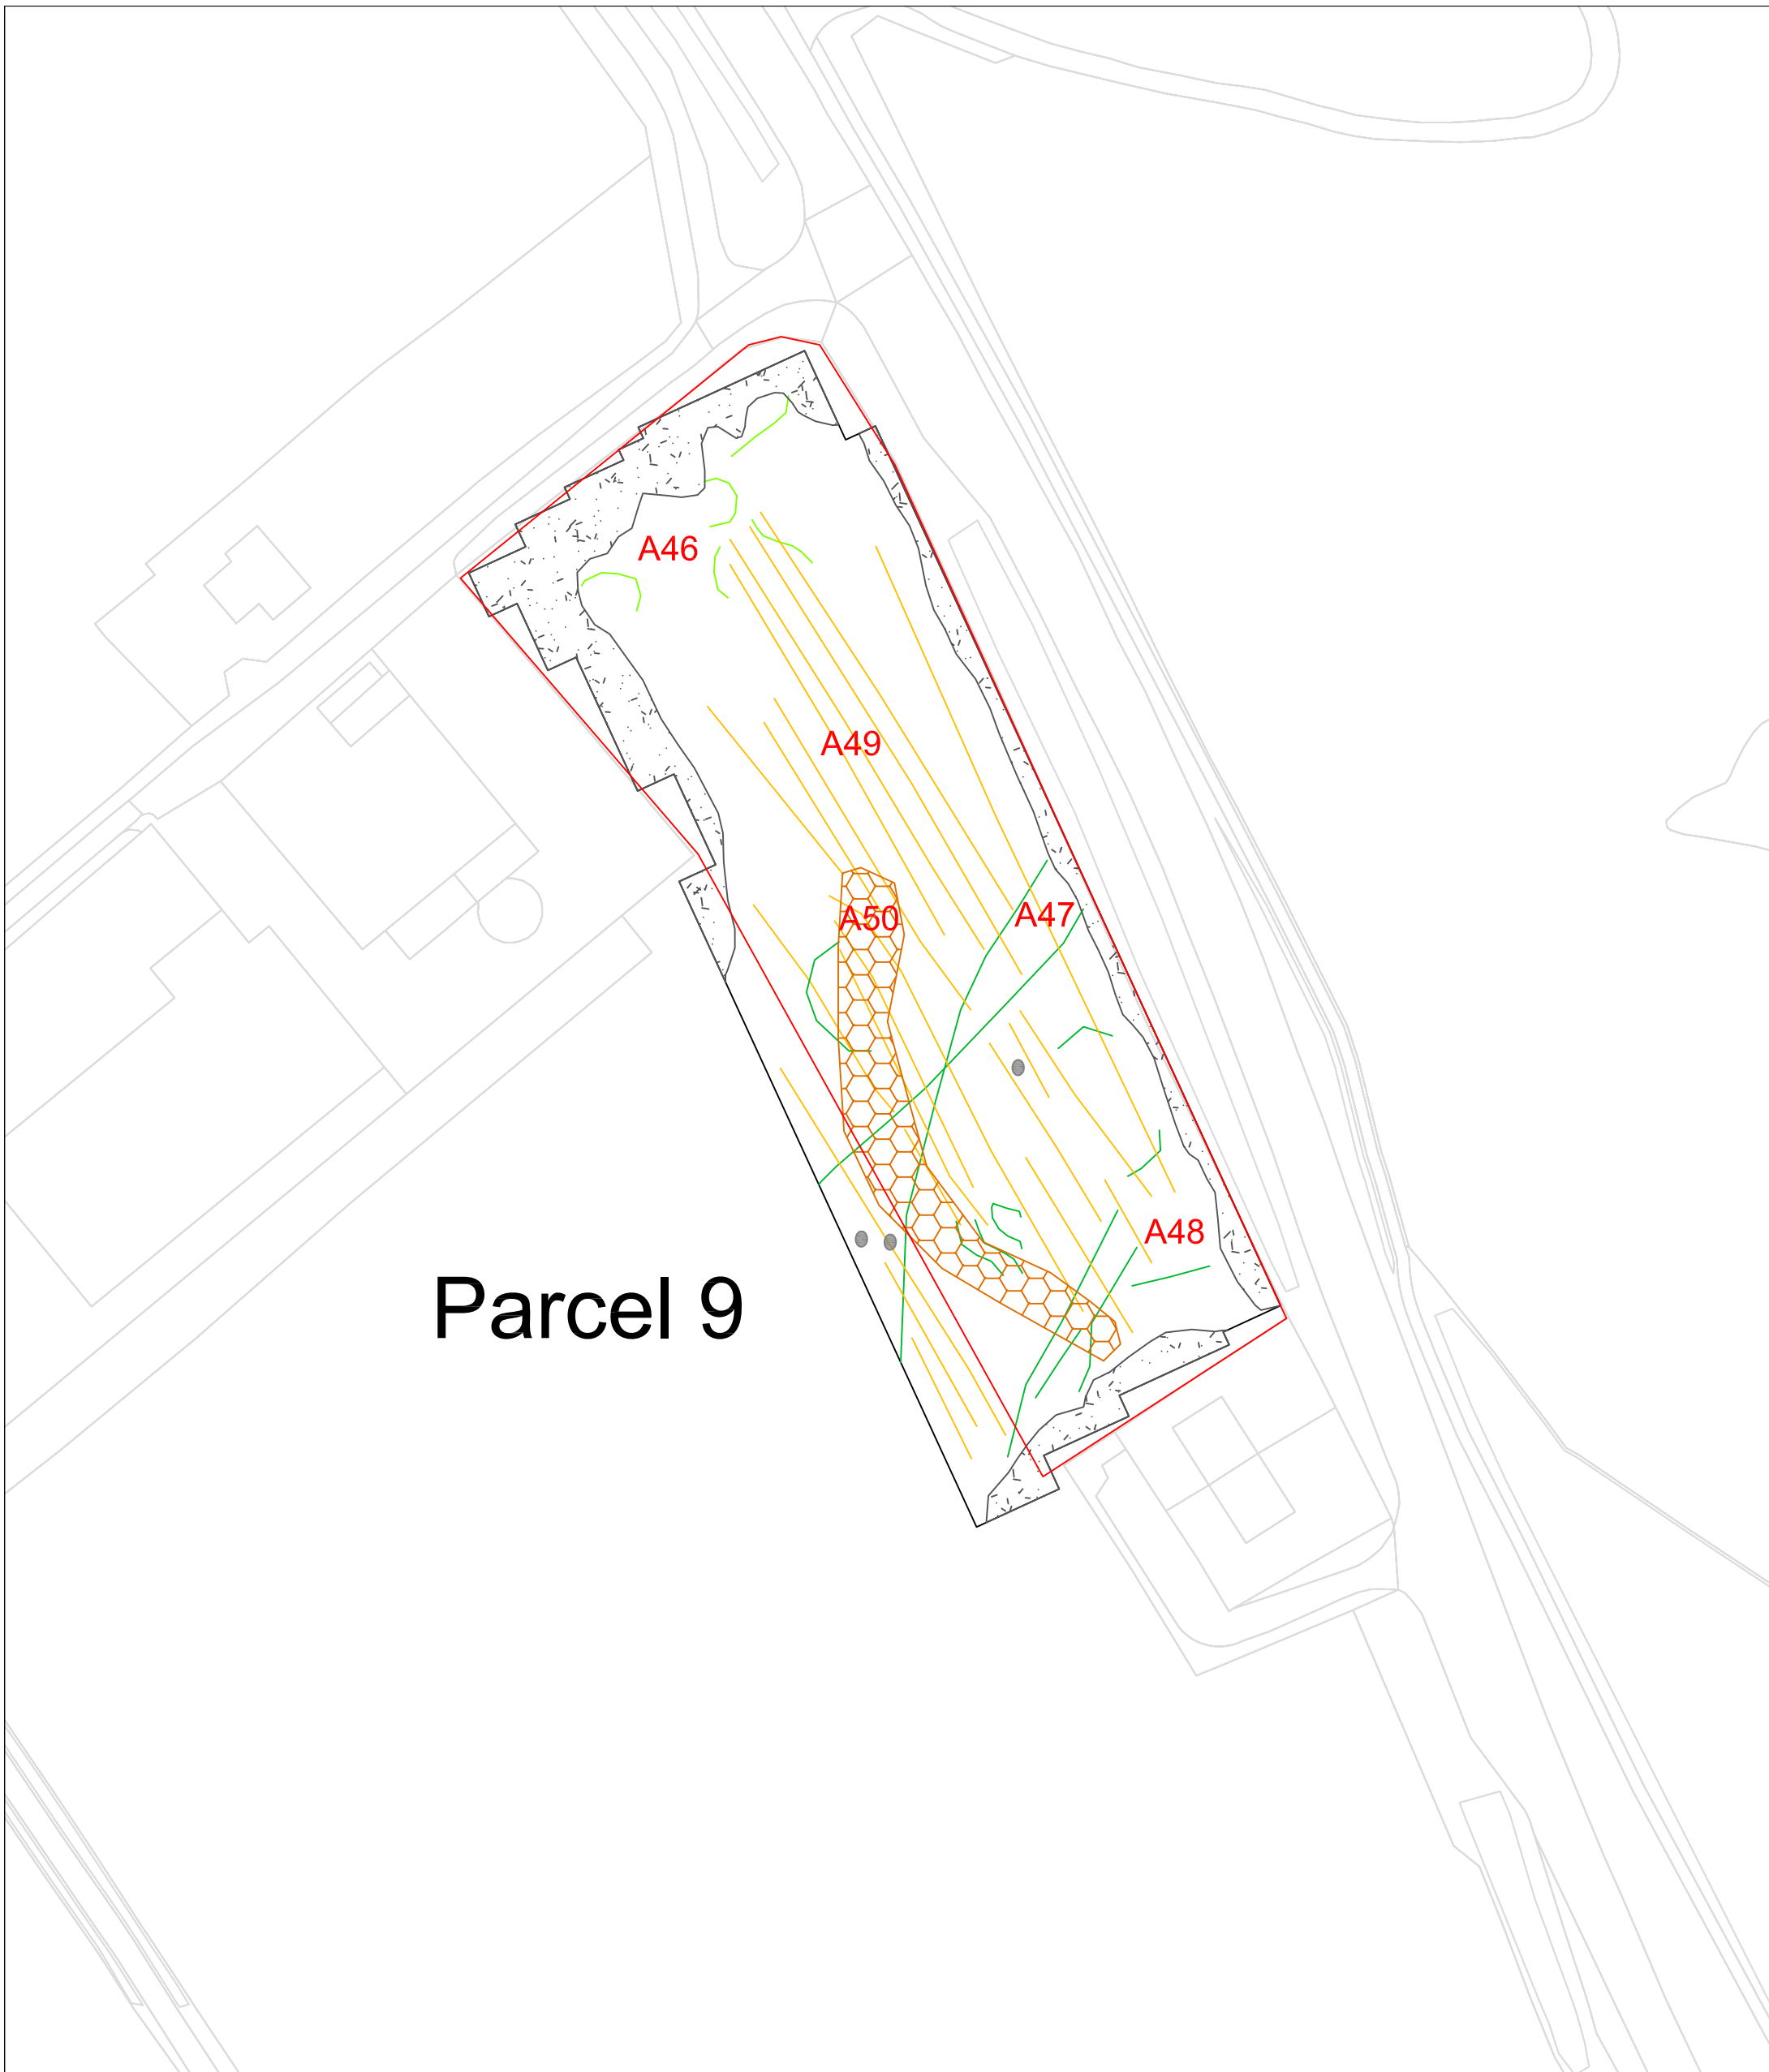
Figure 26: Interpretation of gradiometer survey results - greyscale plot - Parcel 9

- 6.72 Ploughing trends are visible as negative anomalies running north-west to south-east through the dataset (**A49**).
- 6.73 A band of geology, similar to those observed in Parcel 8, curves round from the south to the north through the dataset as a wide positive trend (**A50**).
- 6.74 Magnetic disturbance is observed along the eastern boundary adjacent to the A9, the southern boundary adjacent to housing, and the northern and western boundary relating to farm buildings, fencing and a trackway.
- 6.75 Across the data set there is a small quantity of isolated dipolar anomalies (iron spikes).

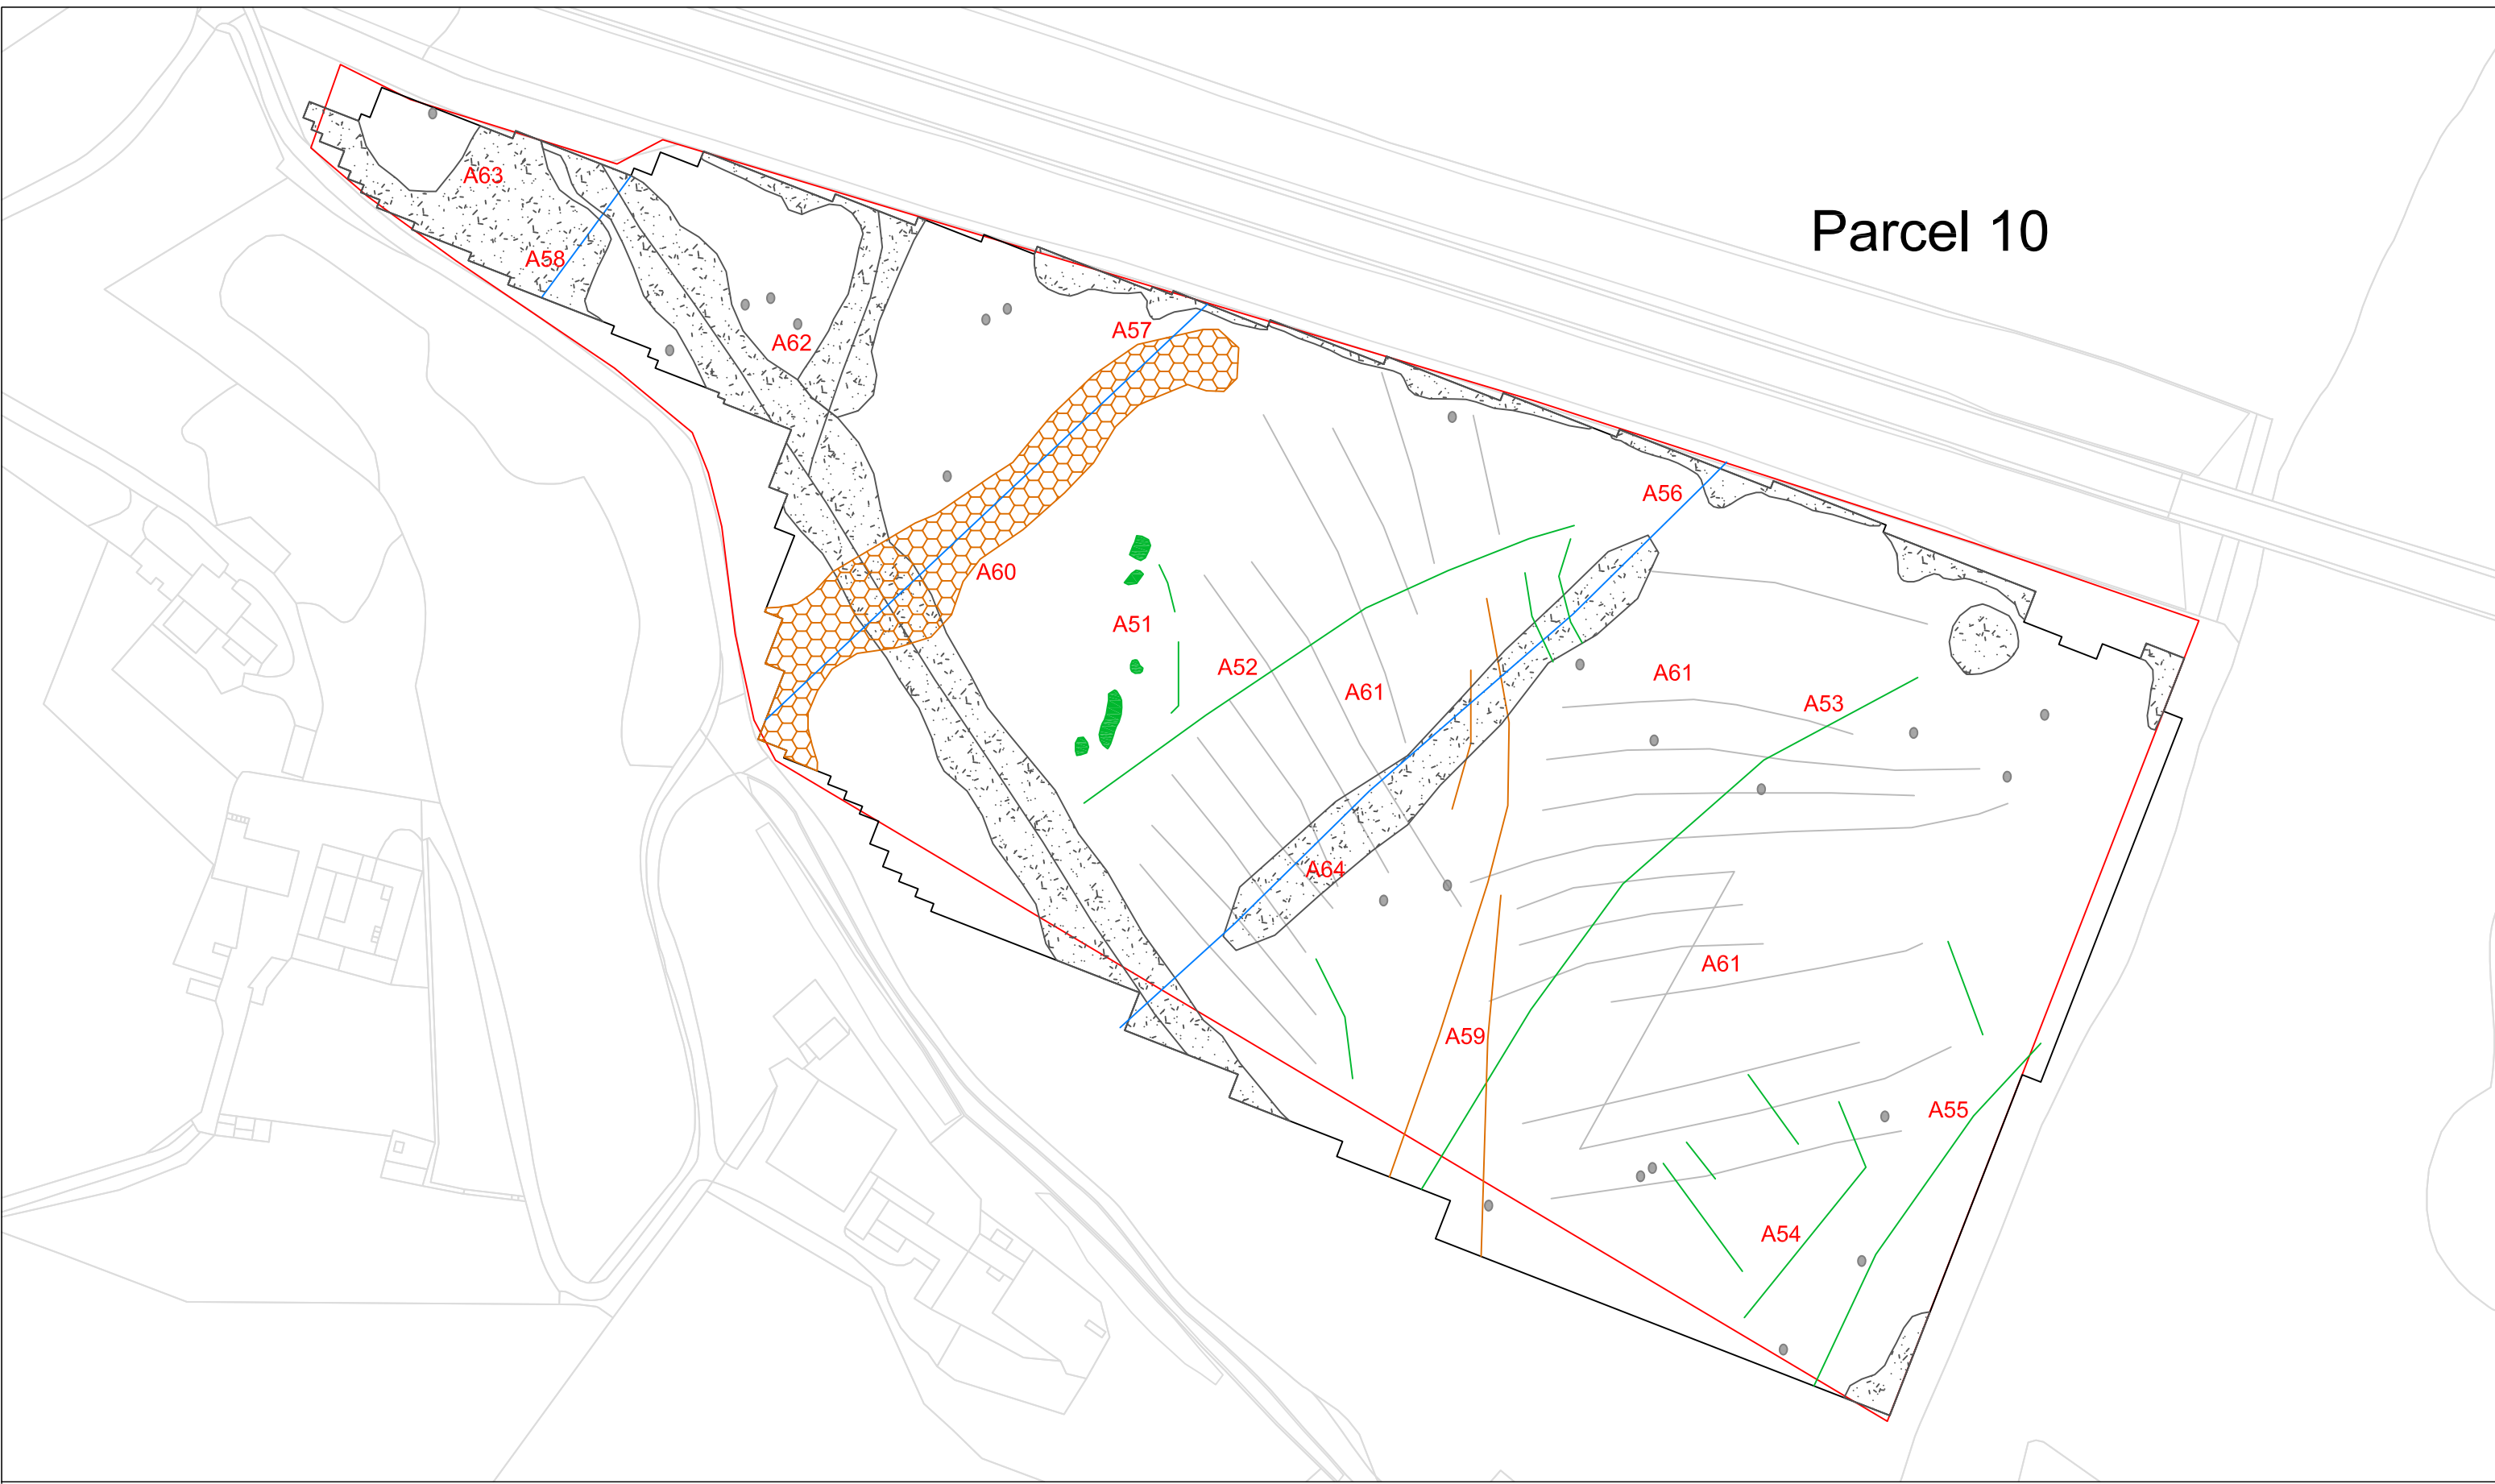
Figure 29: Interpretation of gradiometer survey results - Parcel 10

- 6.77 A number of trends have been identified across the dataset for this parcel, which although weak and tentative, cannot be ruled out due to their proximity to the Mains of Dunfallady, cross slab, burial ground and cairn (CANMORE IDs 131760, 26295, 26309 and 26297, Canmore 2017).

- 6.78 Sub-circular and sub-rectangular positive anomalies have been observed in the centre-west of the dataset which could be archaeological in origin (**A51**).

- 6.90 The north-western extents of the dataset consist of magnetic disturbance, which is likely to be modern in origin (**A63**). The ground in this section was heavily rutted and uneven underfoot suggesting it had been heavily waterlogged at some point, however it is unclear if the magnetic disturbance relates to this.
- 6.91 Magnetic disturbance is observed along the northern boundary adjacent to the A9 and the south-western boundary relating to metal boundary fencing.
- 6.92 Across the data set there is a small quantity of isolated dipolar anomalies (iron spikes).
