# A83 Rest and be Thankful

## Stakeholder Update

**18 November 2020**

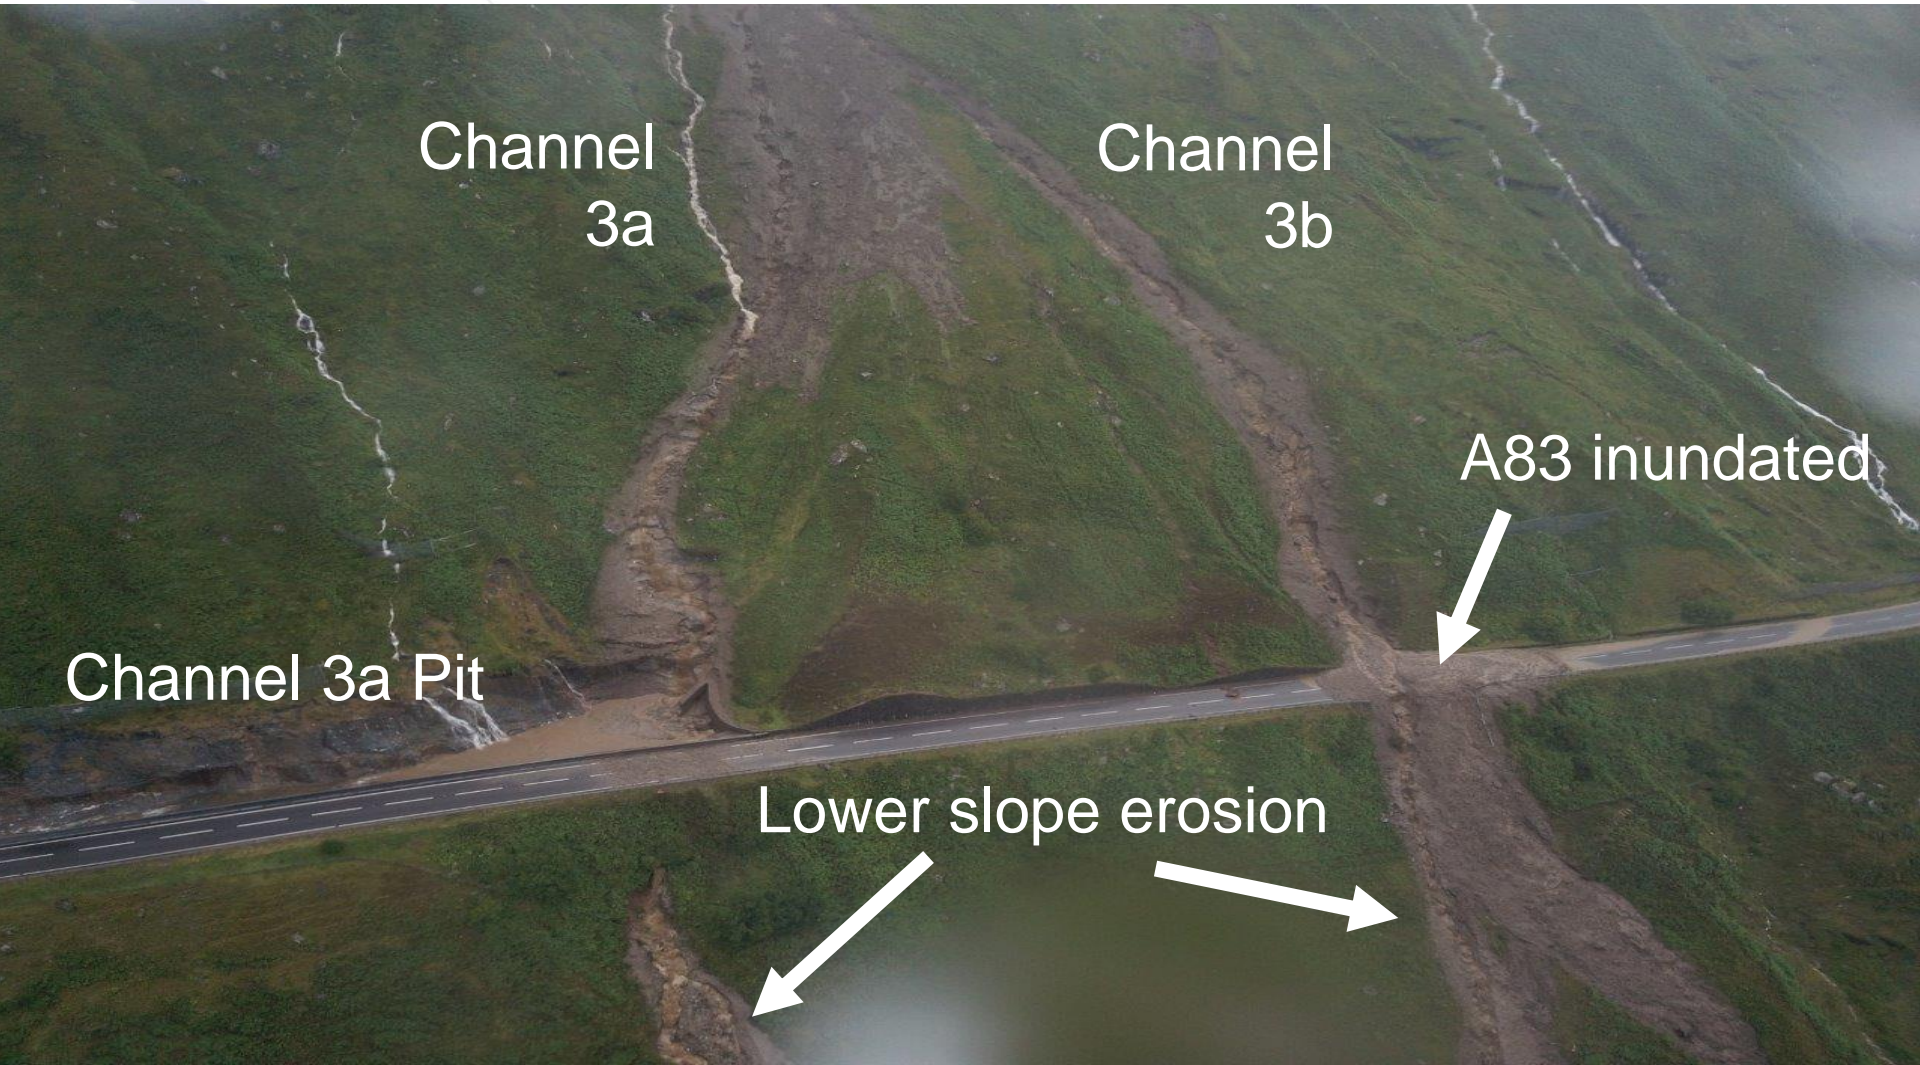
Incident on 4 August 2020 (10,000 tonne event)

Channel  
3a

Channel  
3b

A83 inundated

Channel 3a Pit

Lower slope erosion

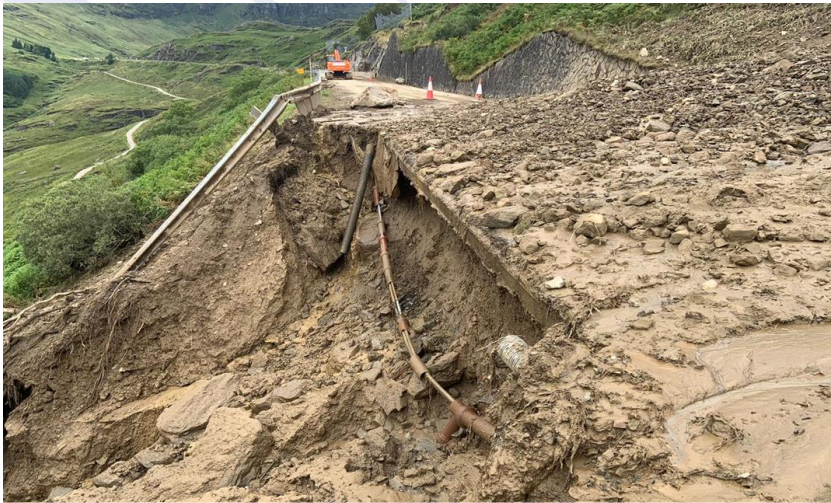
**A83 carriageway inundated and undermined**

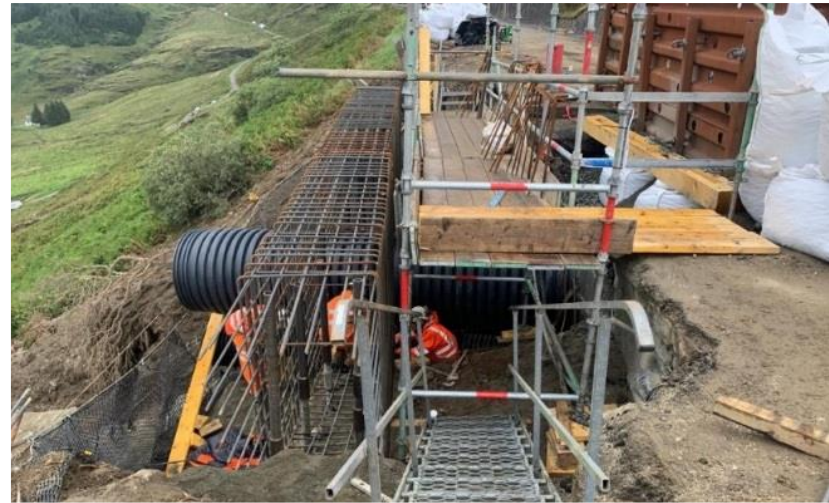
**Construction of new retaining wall/culvert**

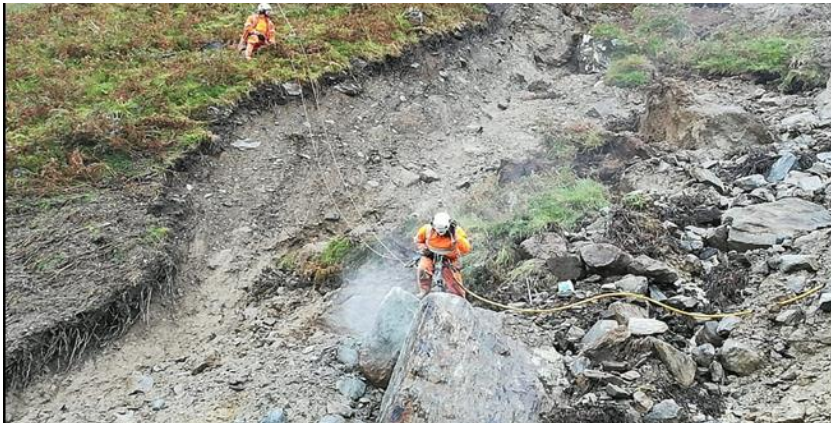
**Significant channel debris**

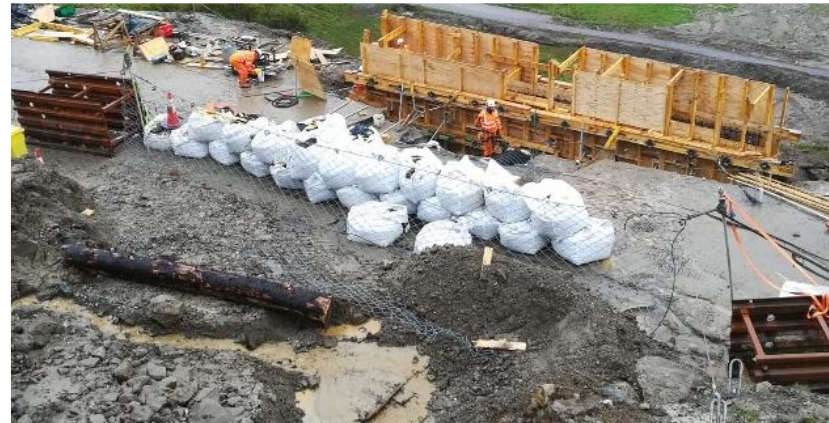
**Temporary pit and roadside mitigation**

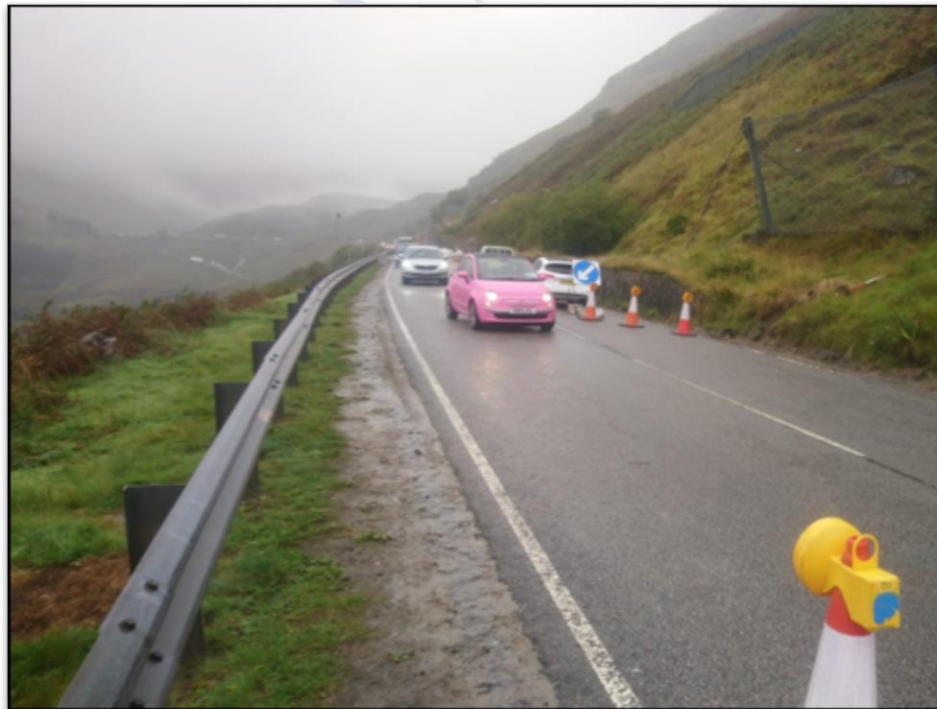
A83 re-opened under single lane operation on 7 September.

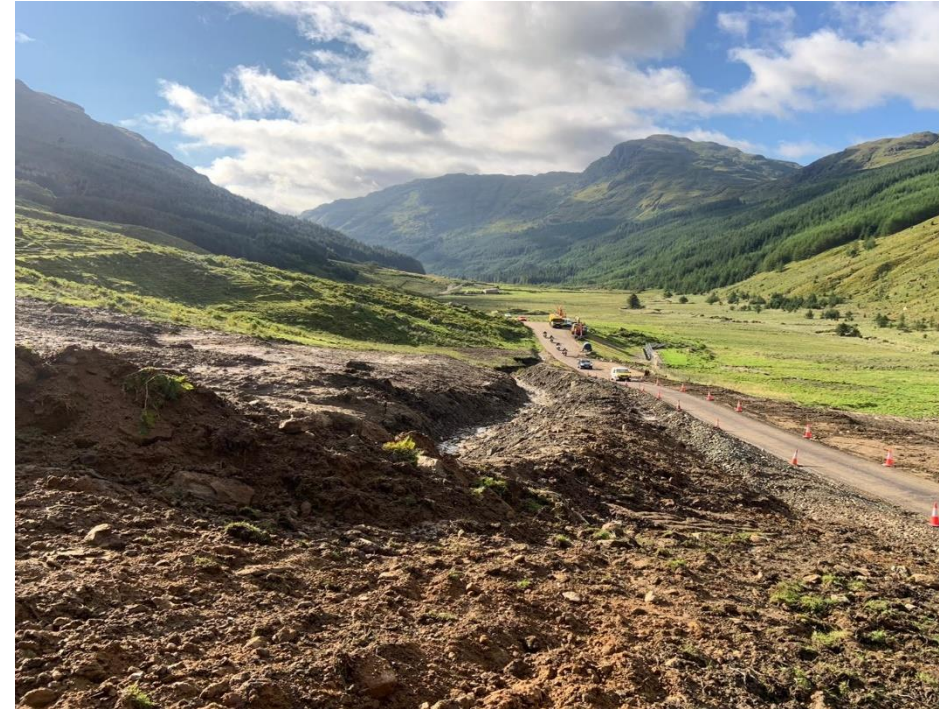
Enhanced earthwork bund enhanced above Old Military Road.

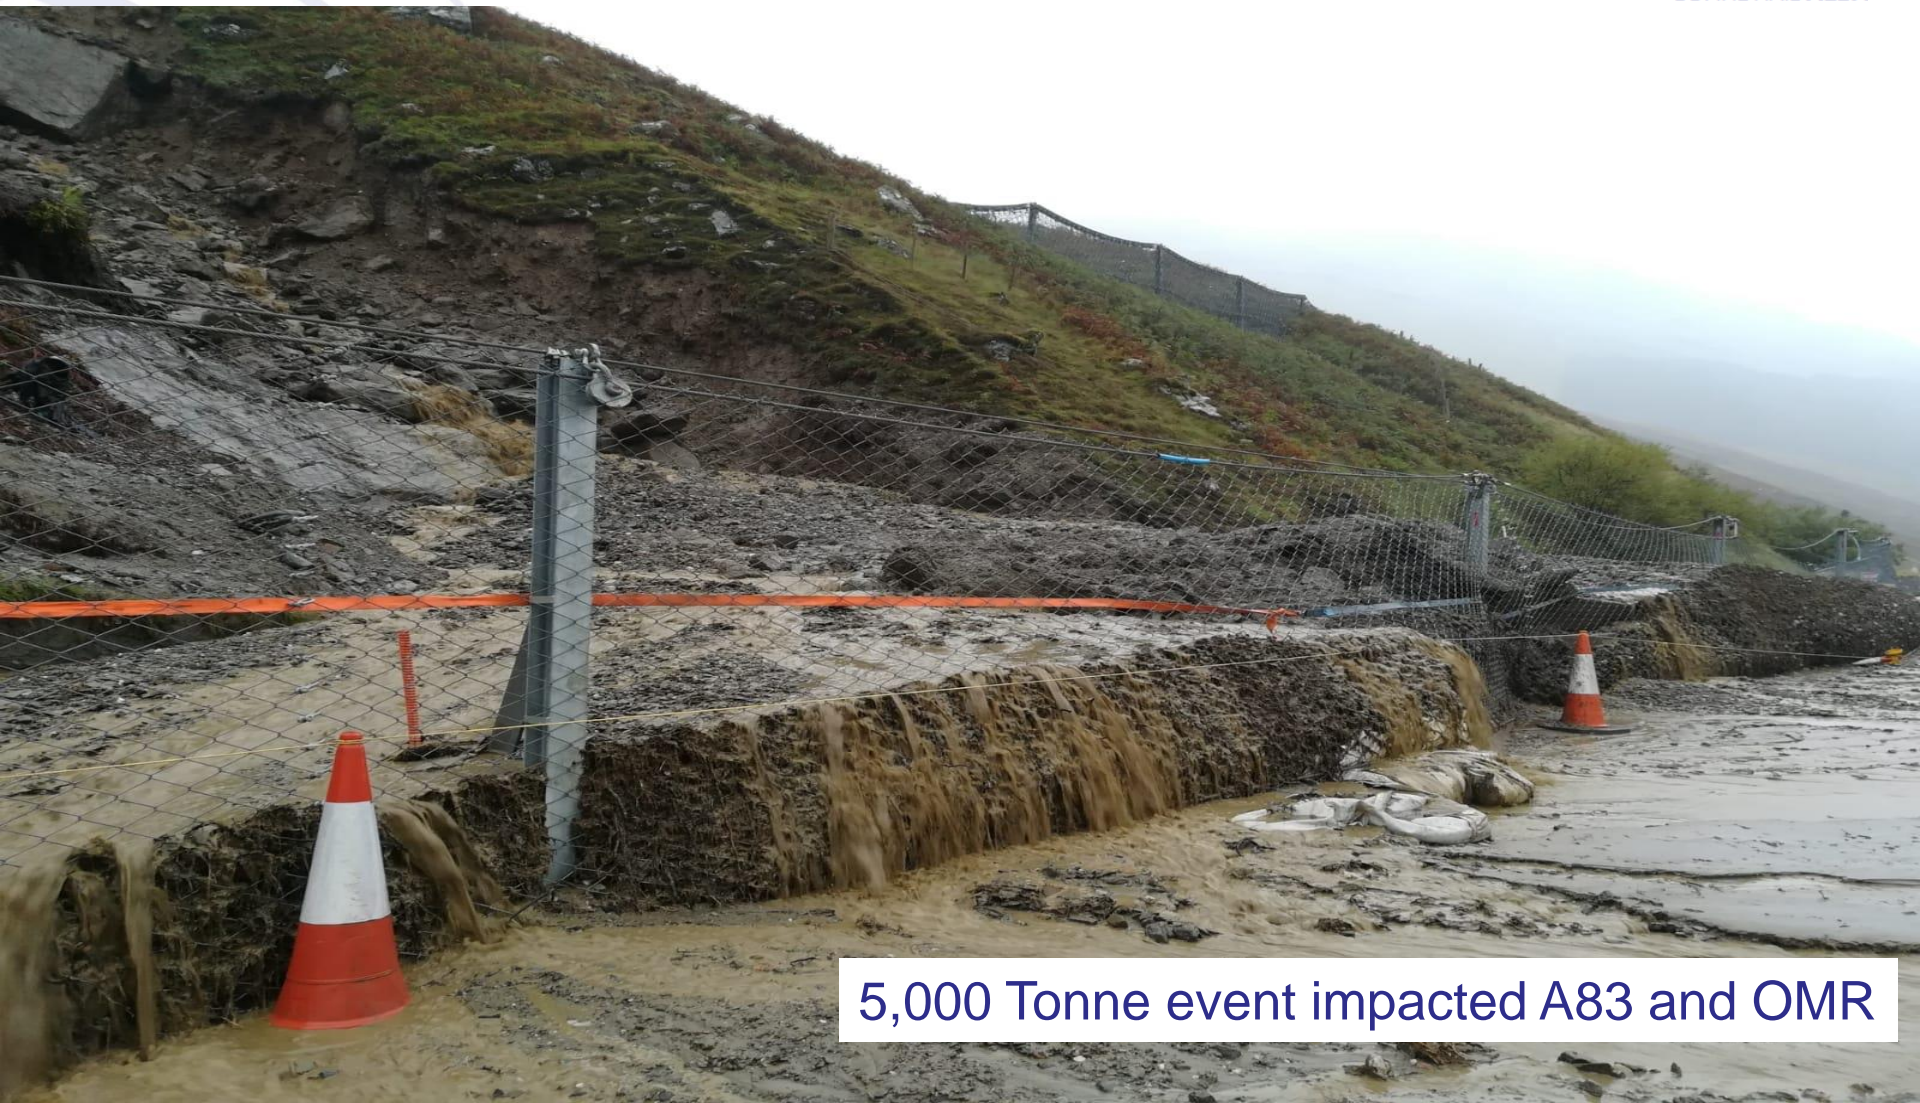
Incident on 13 September 2020

5,000 Tonne event impacted A83 and OMR

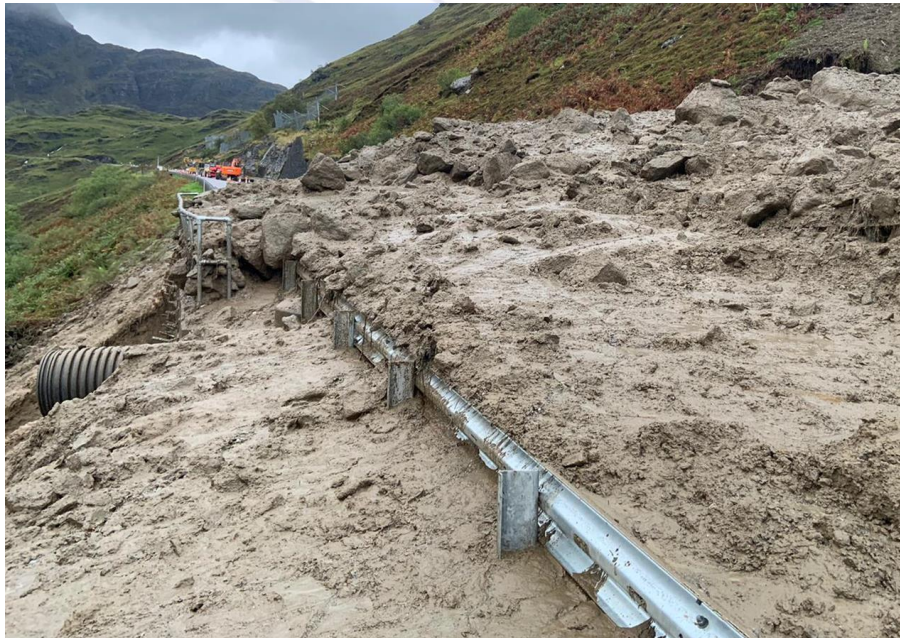
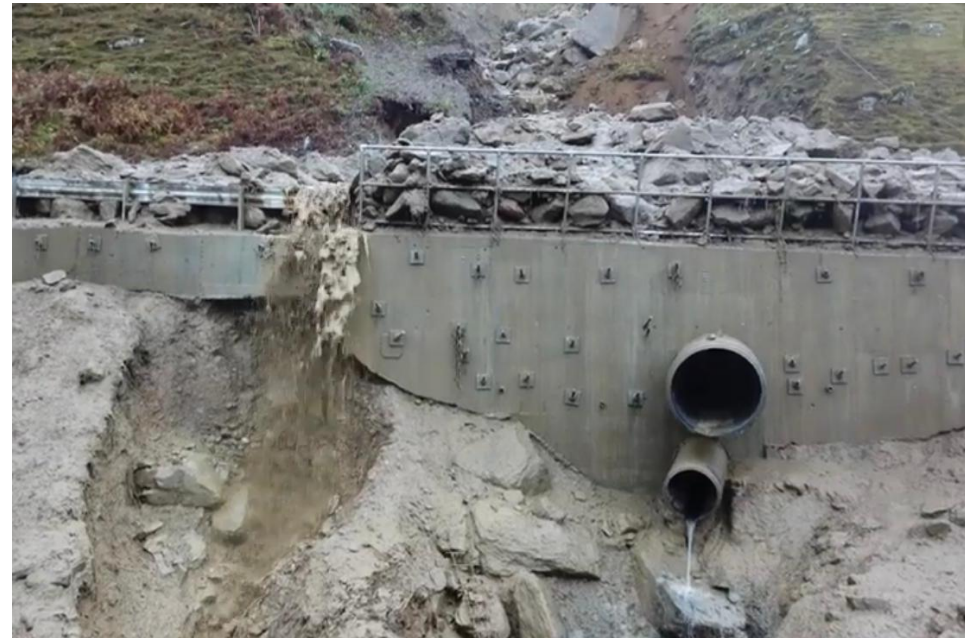
Incident on 13 September 2020

- A83 inundated with material from newly formed Channel 3b.
- Safety barrier and pedestrian guardrail provided some retention.
- New retaining wall supporting A83 withstood landslide event.

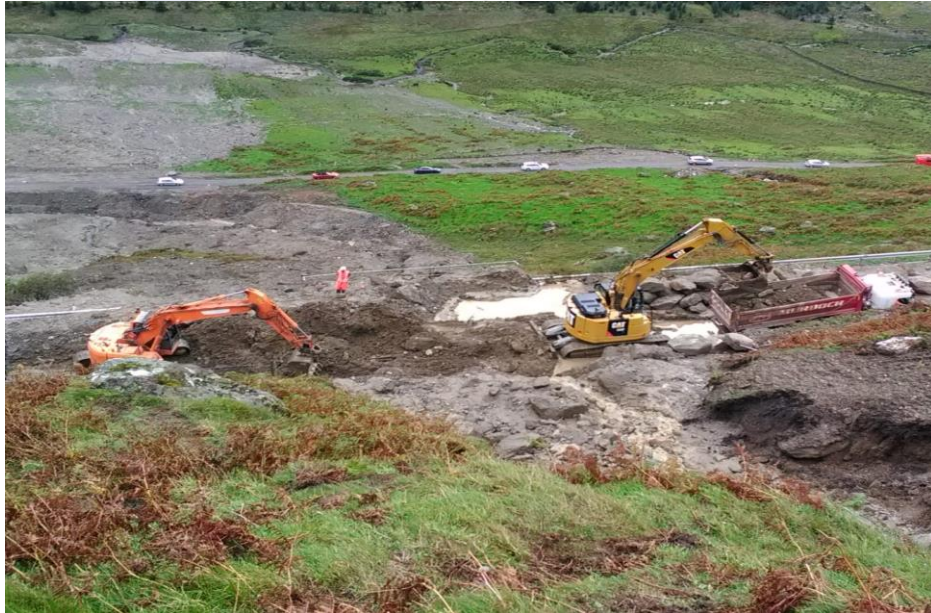
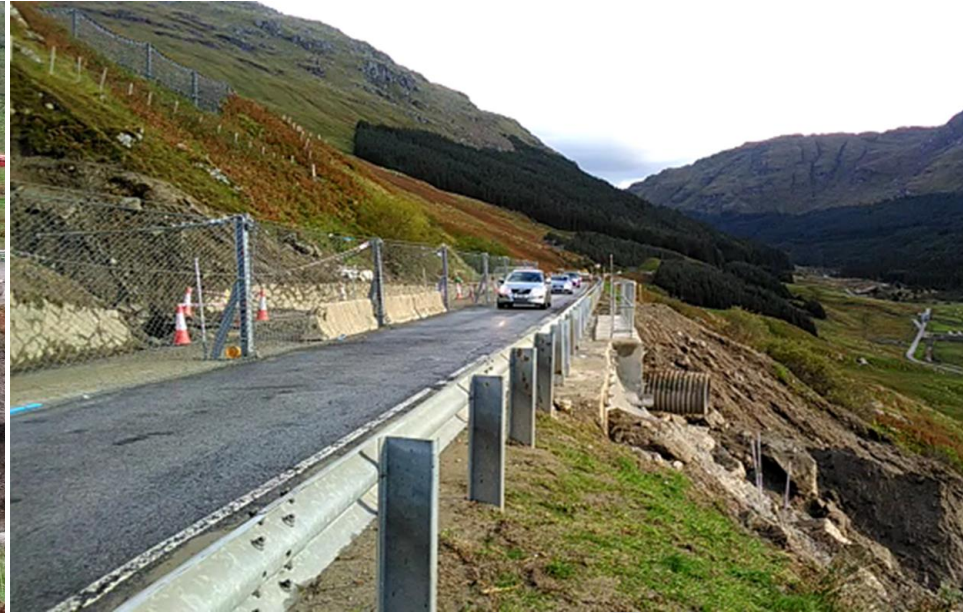
Landslide Recovery Effort - September 2020

- Significant debris clearance undertaken.
- Limited remedial works required to road infrastructure assets.
- A83 re-opened under traffic signal control 24 September.

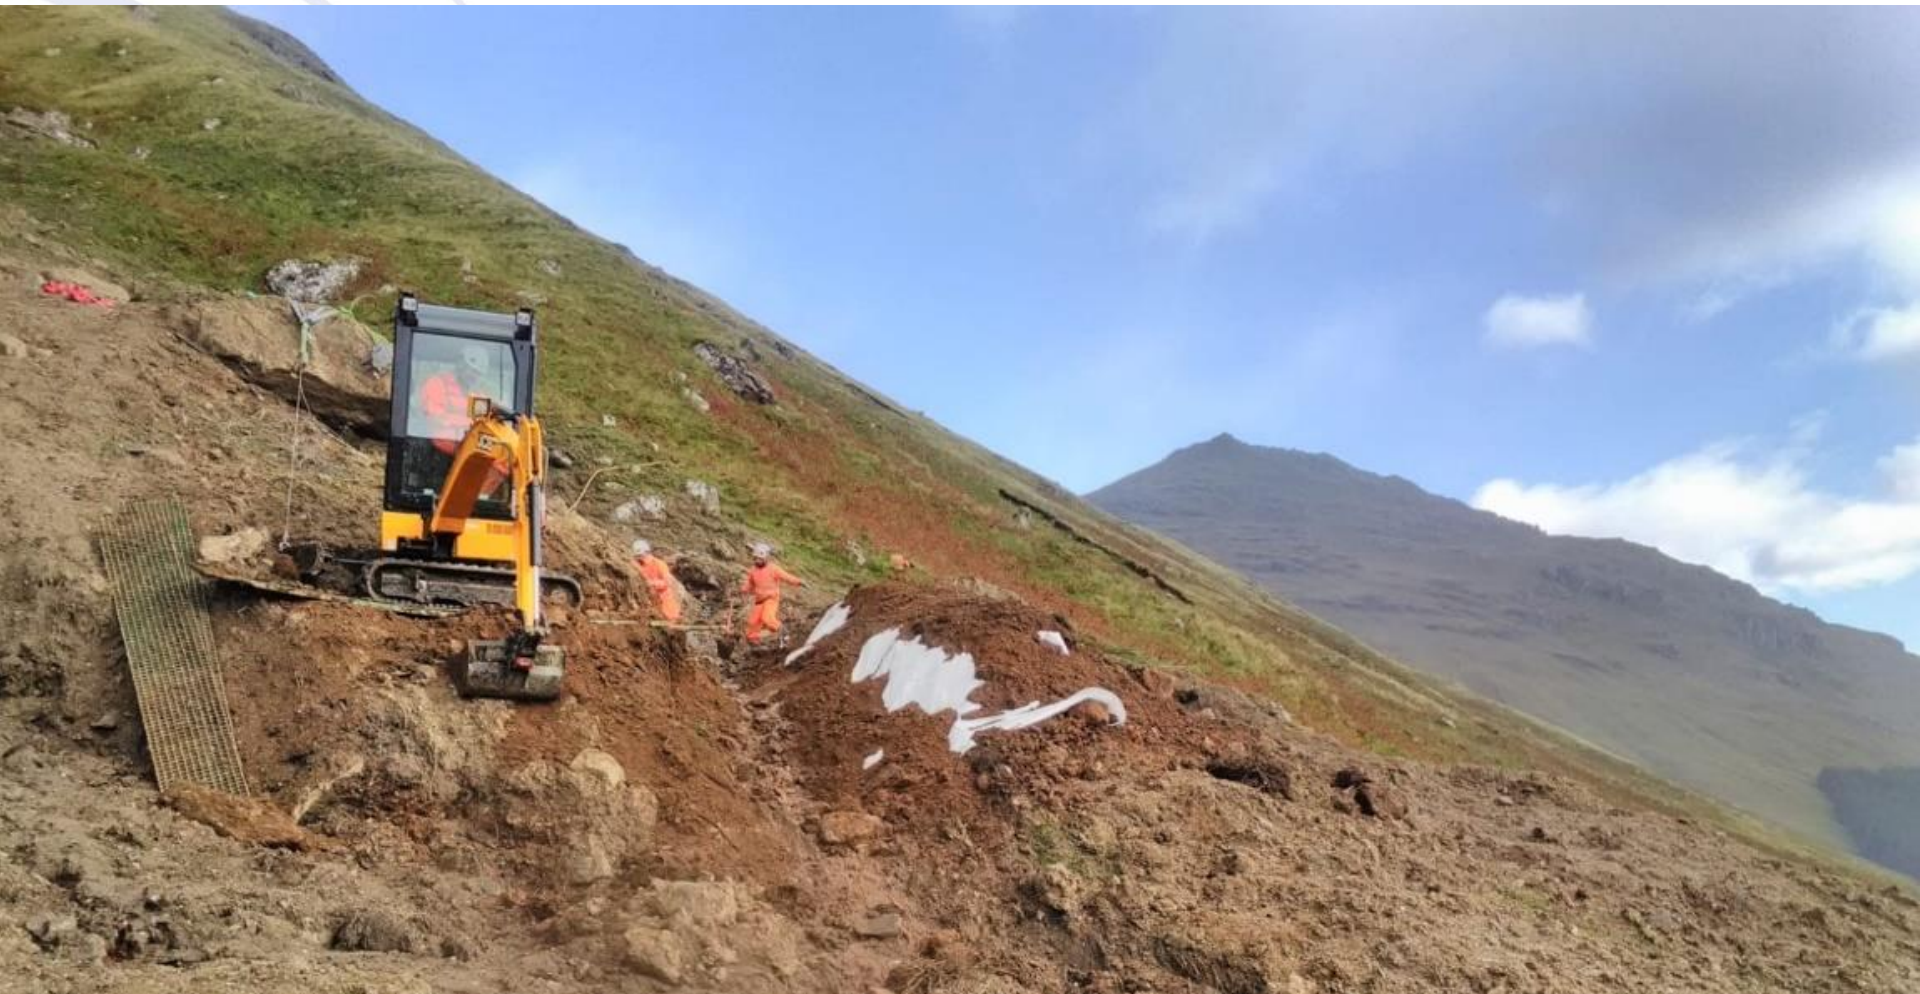
Channel 3b Mitigation – Watercourse Diversion

- Machine helicoptered onto hill to return watercourse to original line.

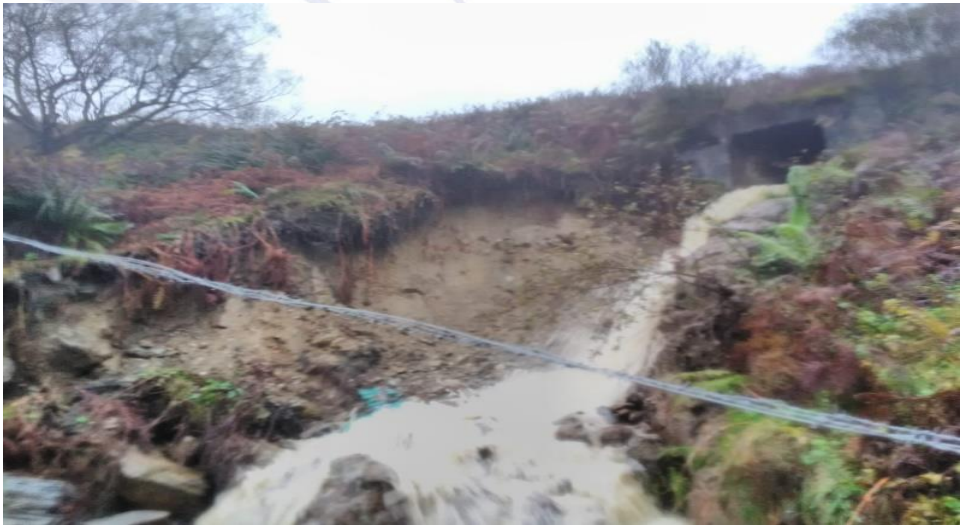
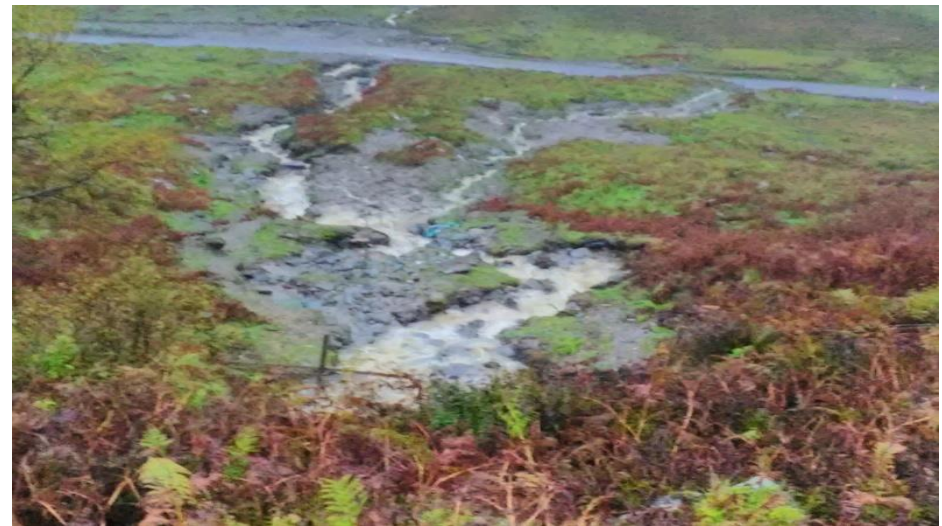
20 & 21 October 2020 Rainfall Event

- Yellow weather warning issued for 20 and 21 October.
- OMR local diversion implemented 19 October as proactive measure.
- 86mm of rainfall experienced in 48 hour period.
- OMR closed midnight 21 October due to overtopping and erosion of slope below A83.
- OMR re-opened on 22 October following inspection and remedial action.

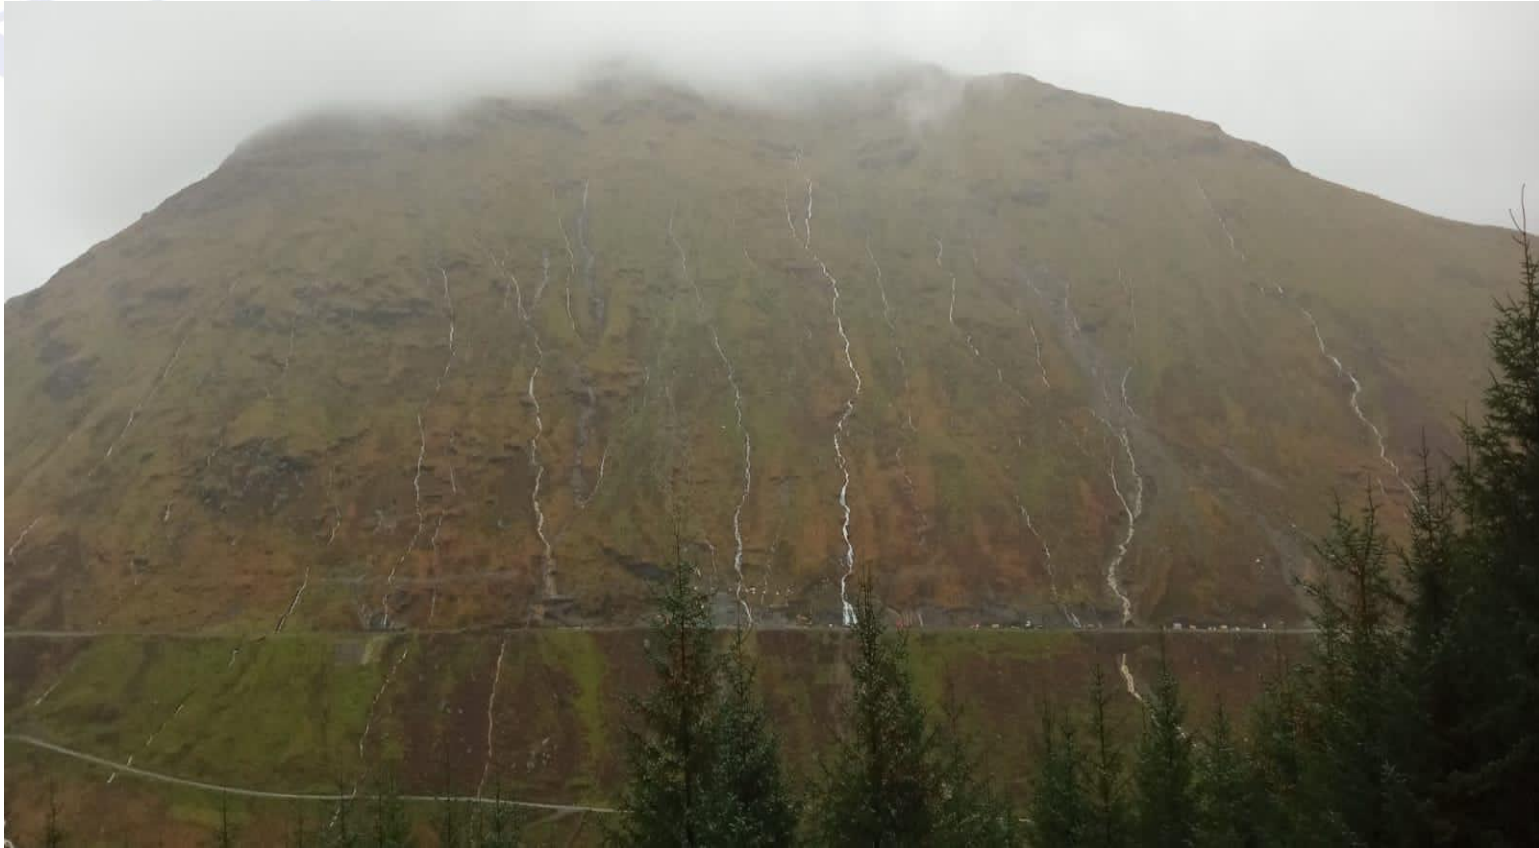
Incidents - 31 October 2020

- OMR diversion implemented 30 October in response to Yellow weather warning.
- OMR closed 31 October (AM) due to landslip events and surface water flow.
- 106mm of rainfall experienced in 48 hour period.

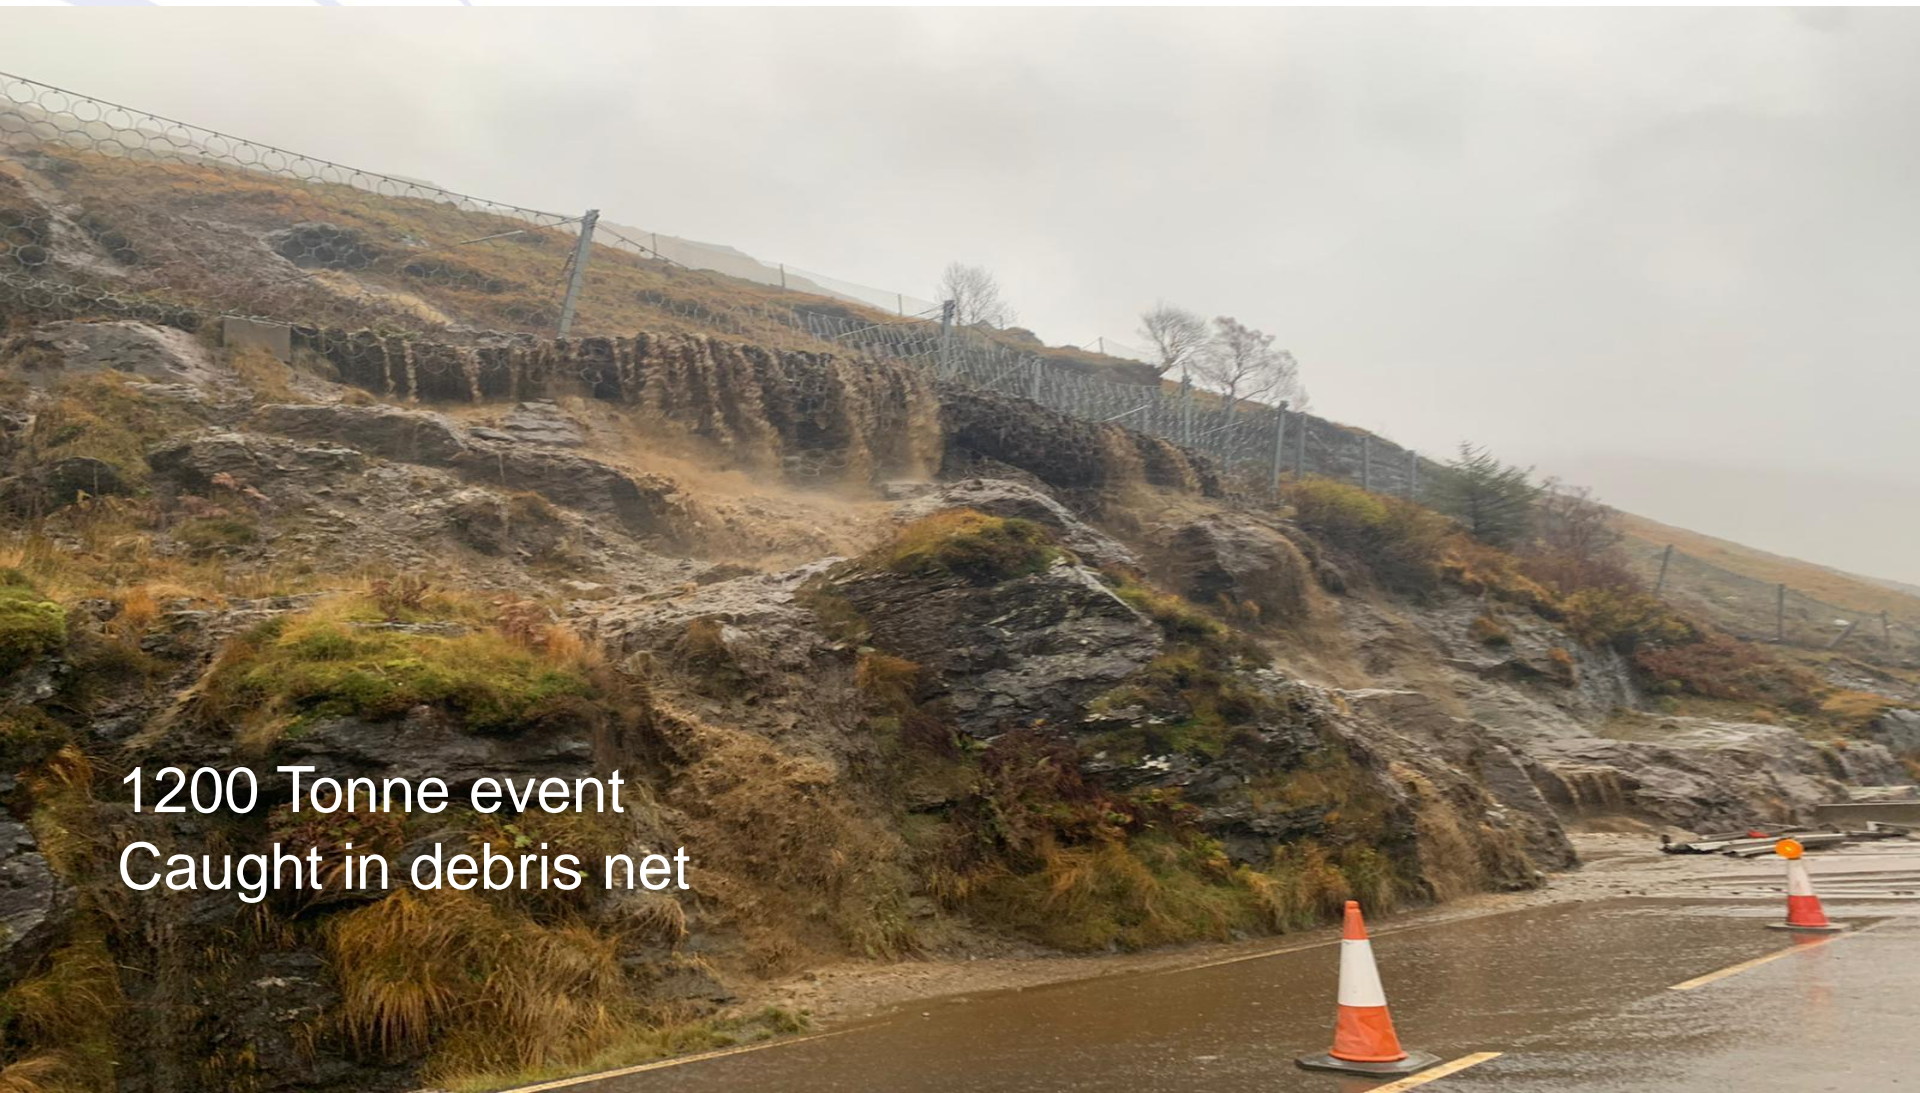
1200 Tonne event  
Caught in debris net

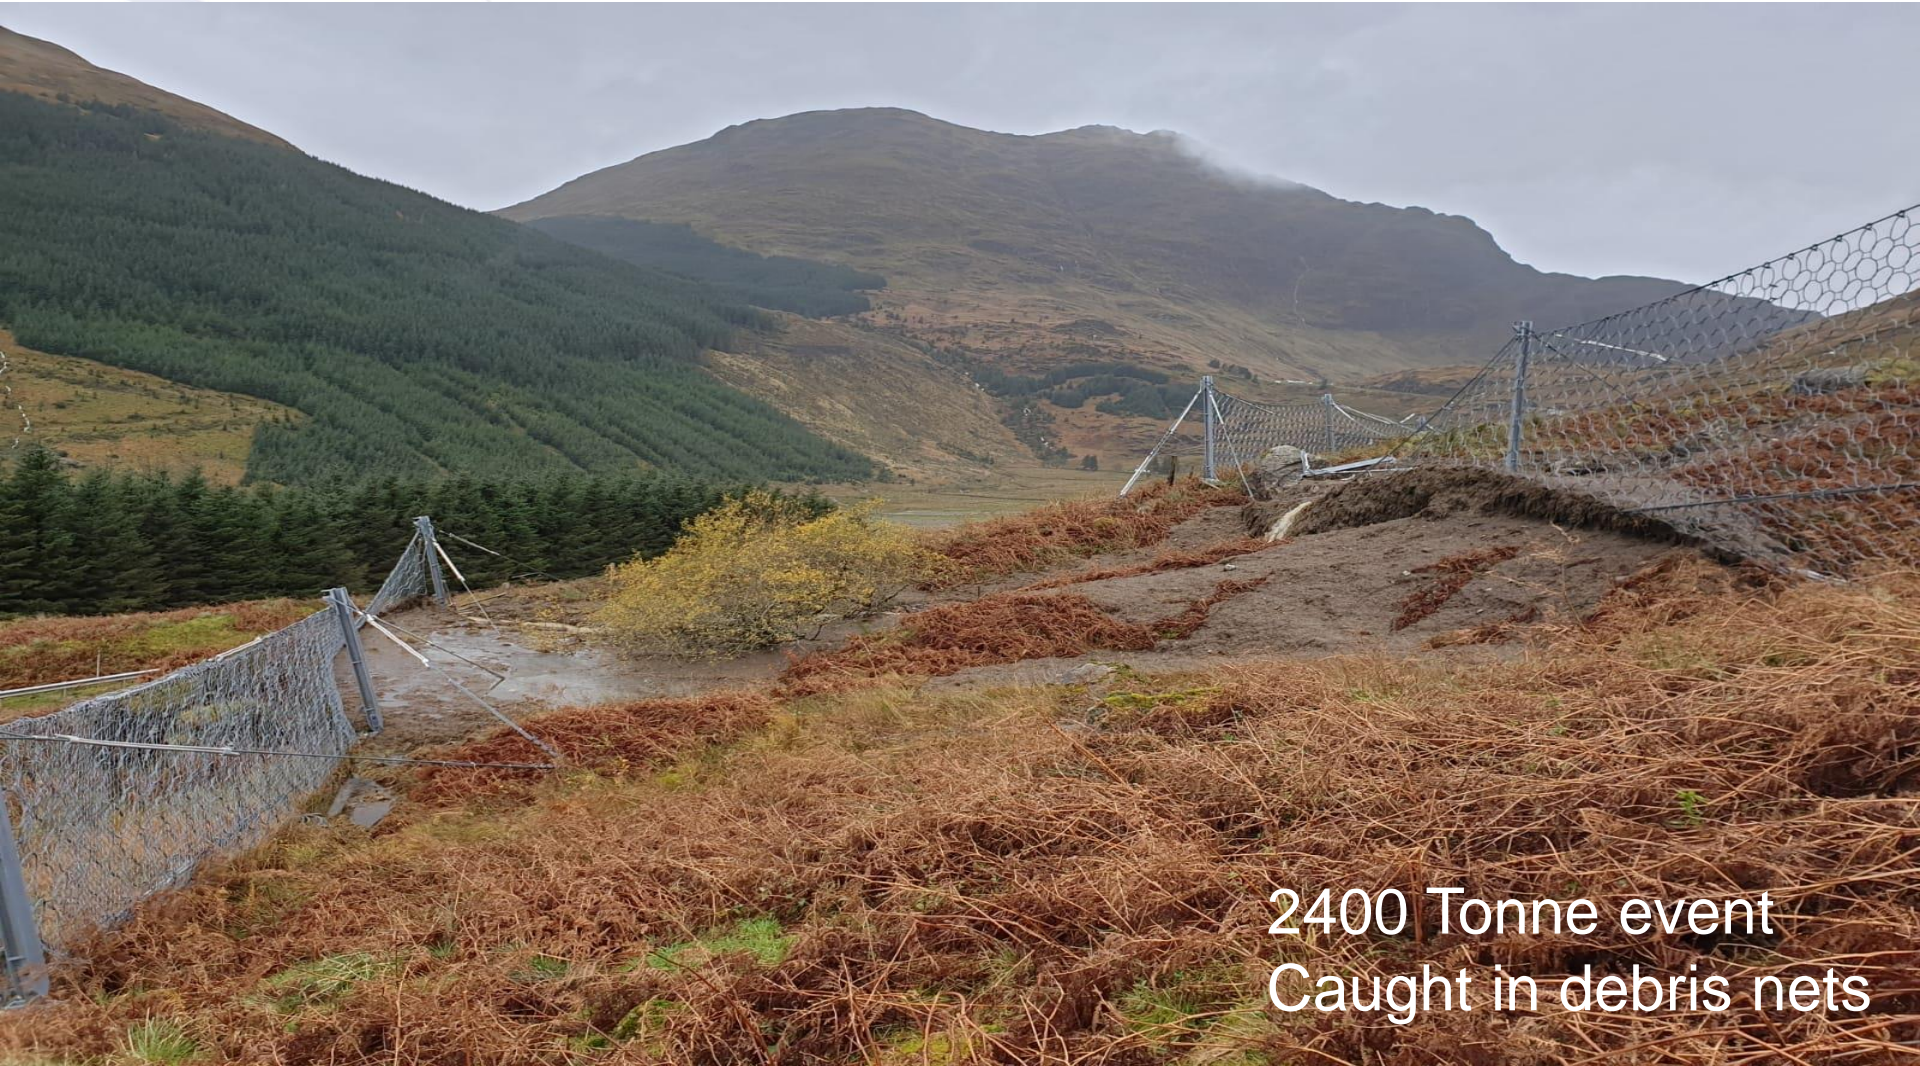
2400 Tonne event  
Caught in debris nets

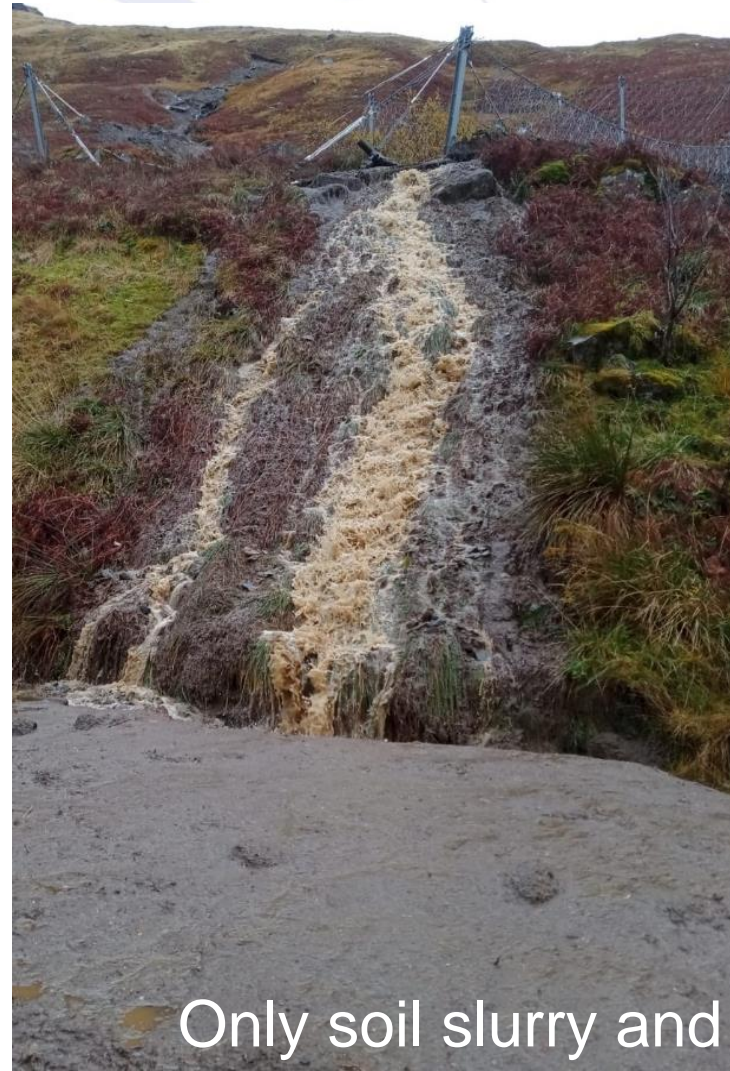
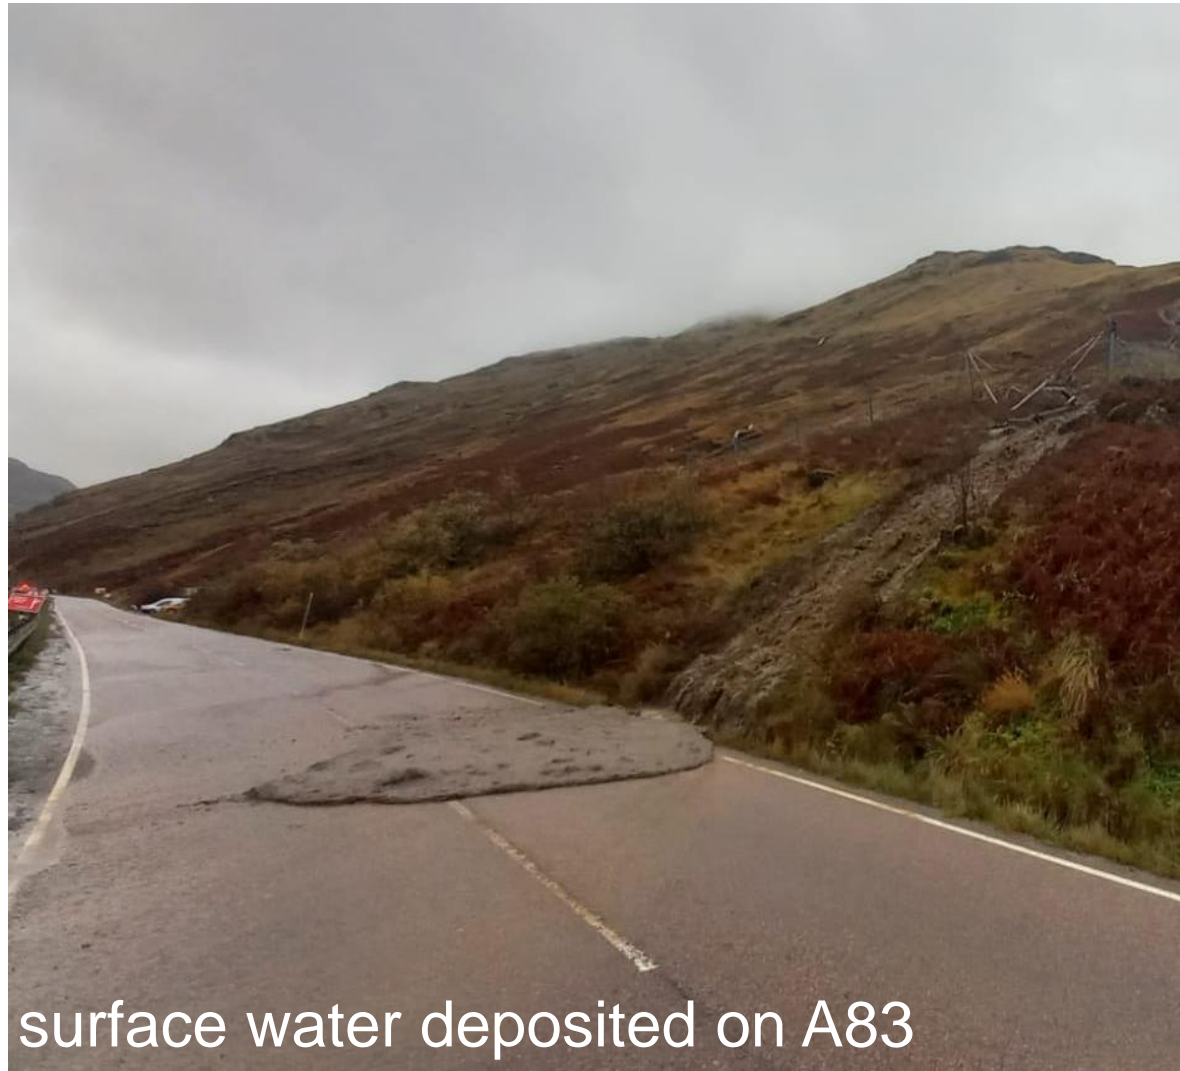
Only soil slurry and surface water deposited on A83

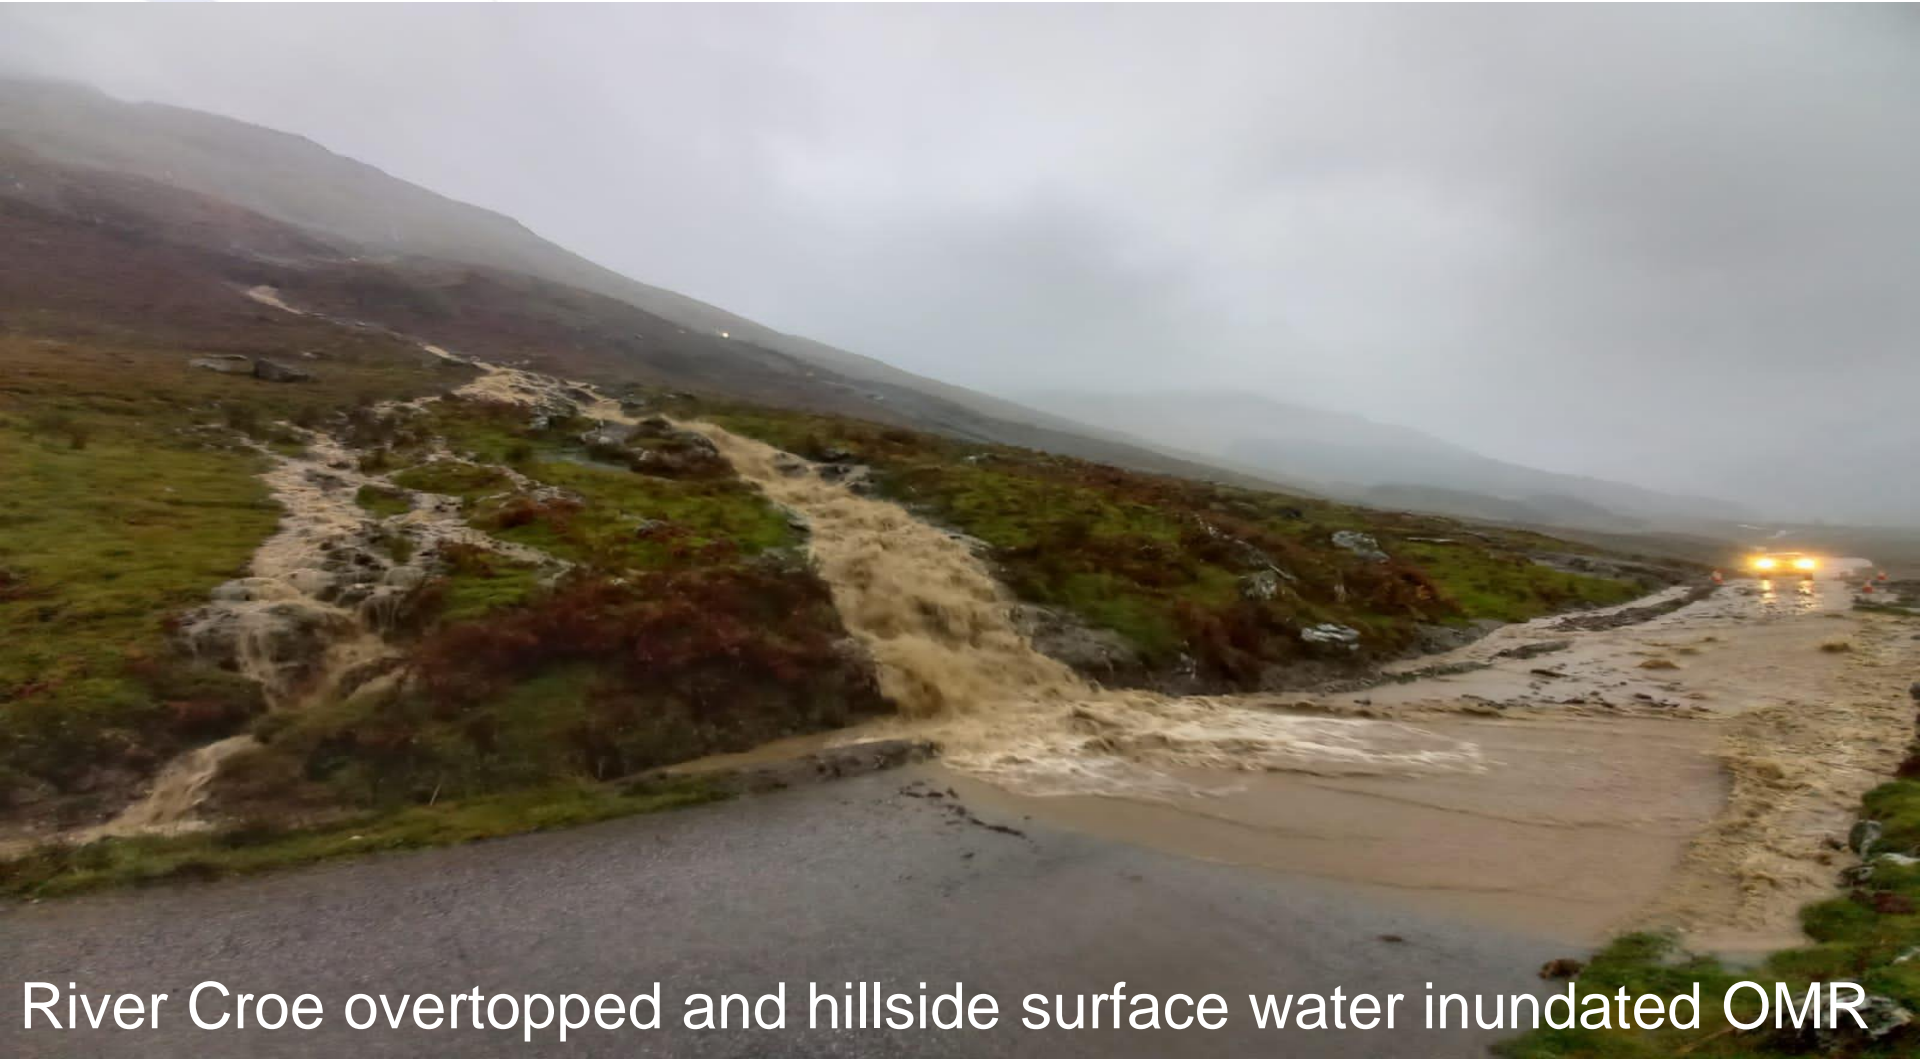
River Croe overtopped and hillside surface water inundated OMR

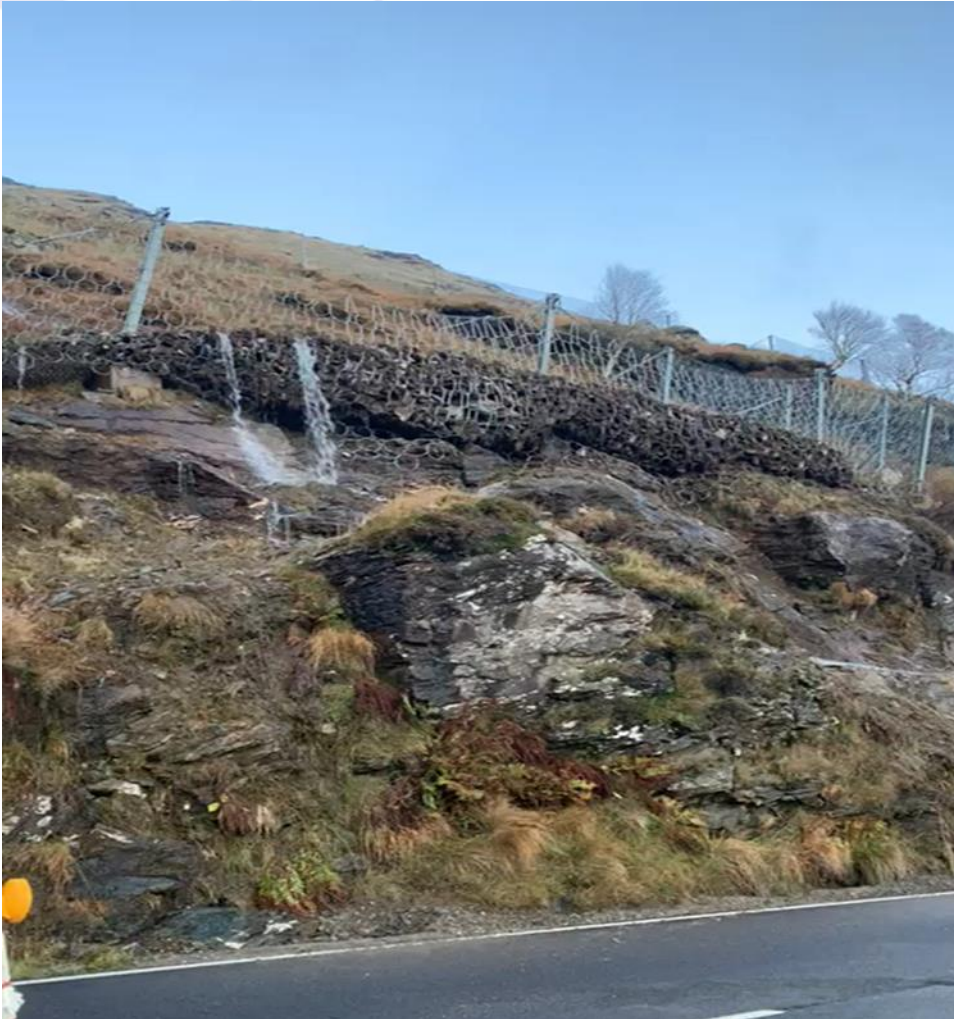
Landslide Recovery Effort - November 2020

- OMR re-opened to traffic 2 November.
- Rock fall barriers emptied and debris clearance undertaken.
- Rockfall barrier repairs required for A83 to become operation.
- A83 readied for re-opening 16 November.
