# A83 Rest and be Thankful

## Stakeholder Update

**18 November 2020**

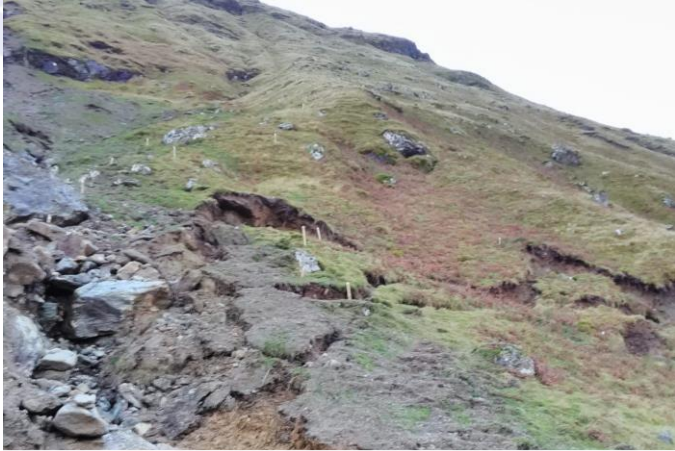
Upper Slope above Channel 3b

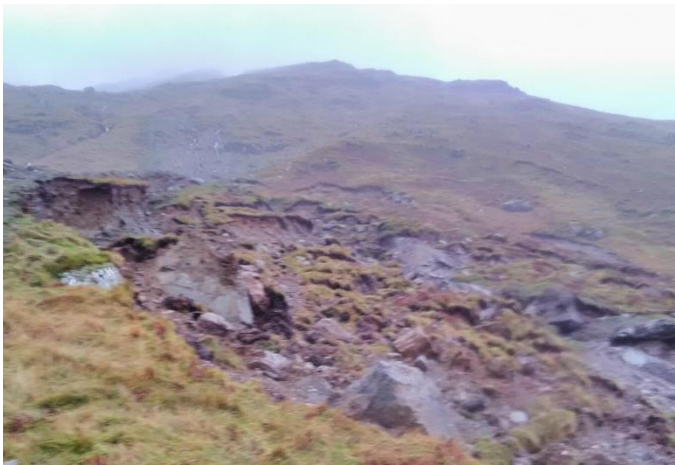
View from Channel 3b to upper slope

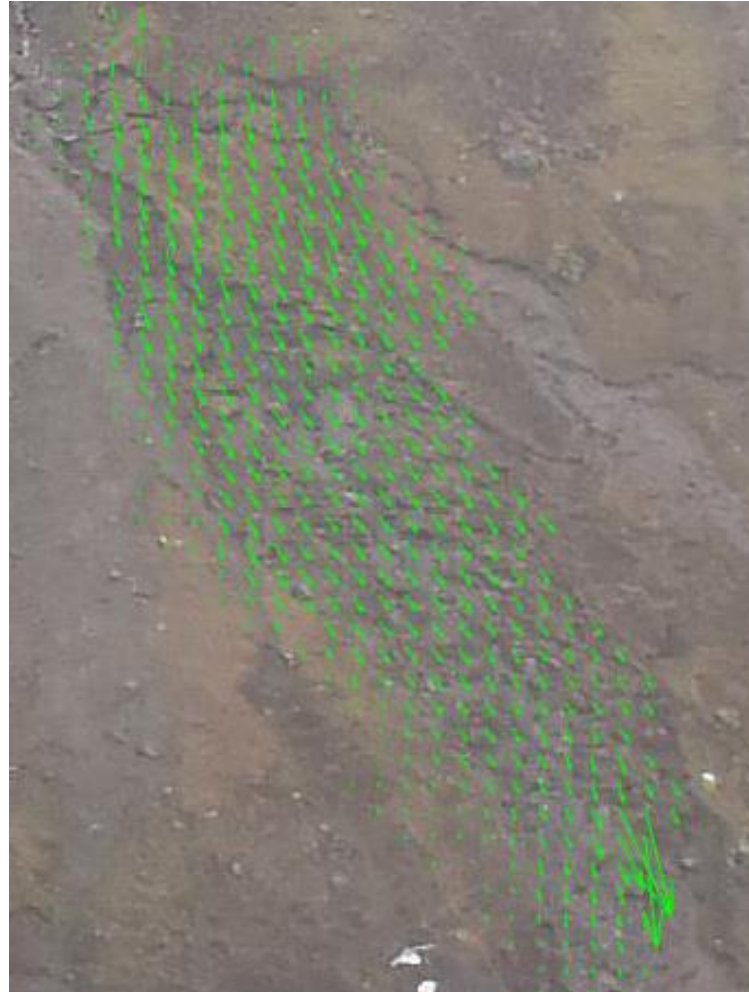
Time-lapse Imagery - Movement Vectors
