21st A83 Taskforce Meeting – 03 March 2022

Current Works Project Update – Presented by BEAR Scotland

Hillside Update and Monitoring – Observations, Measurement and Management

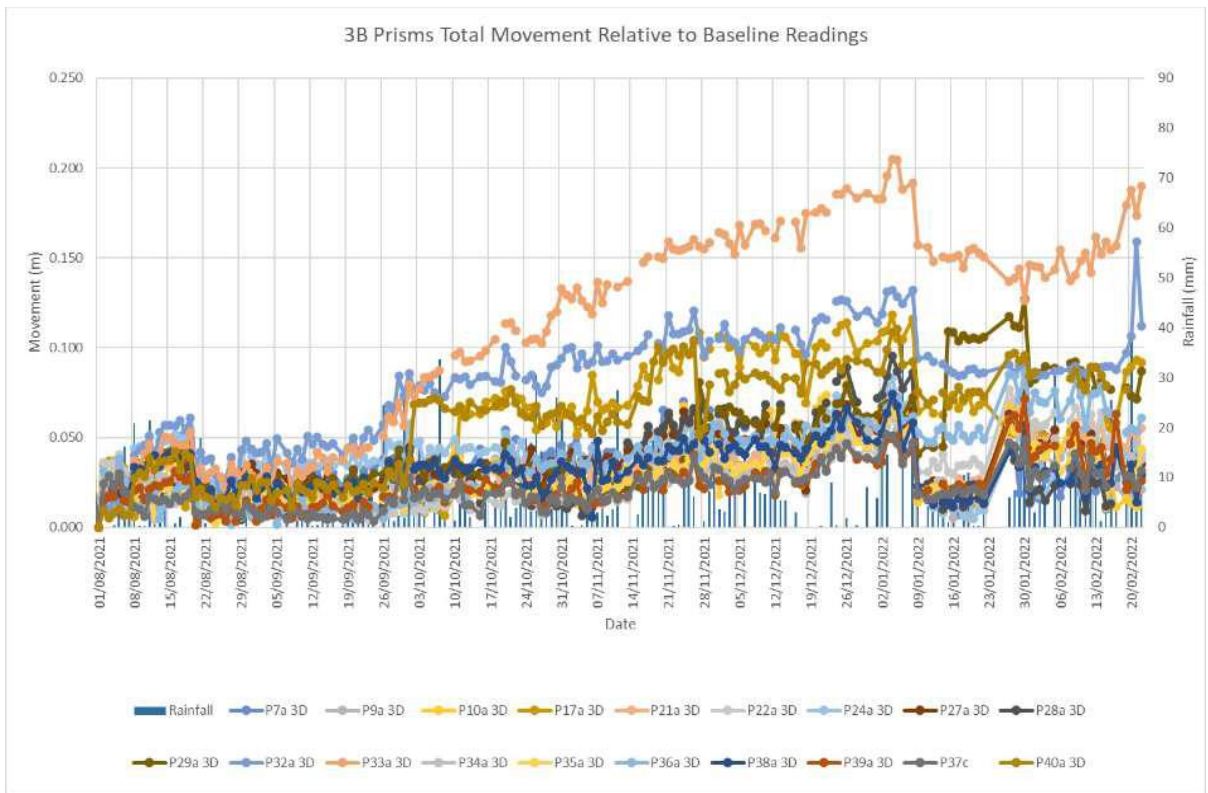
Image of graph showing 38 prisms total movement relative to baseline readings

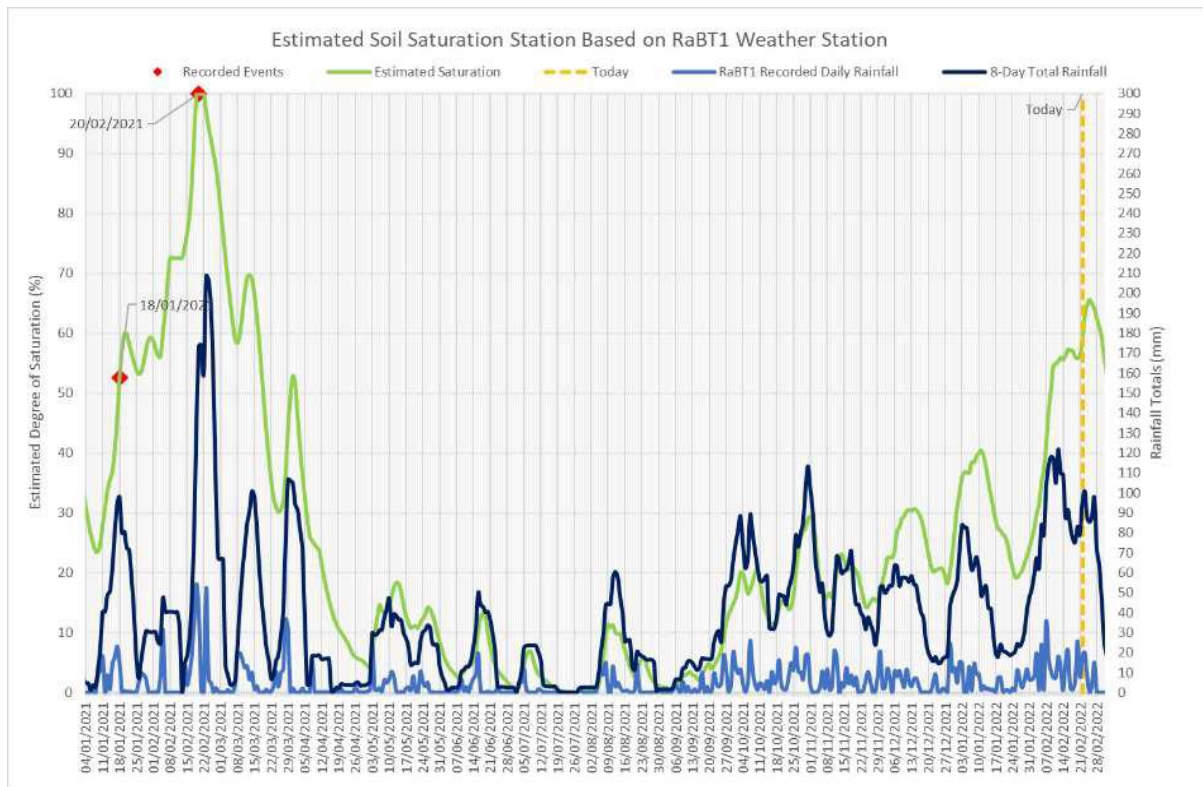
Image of graph showing estimated soil saturation based on RaBT1 Weather Station

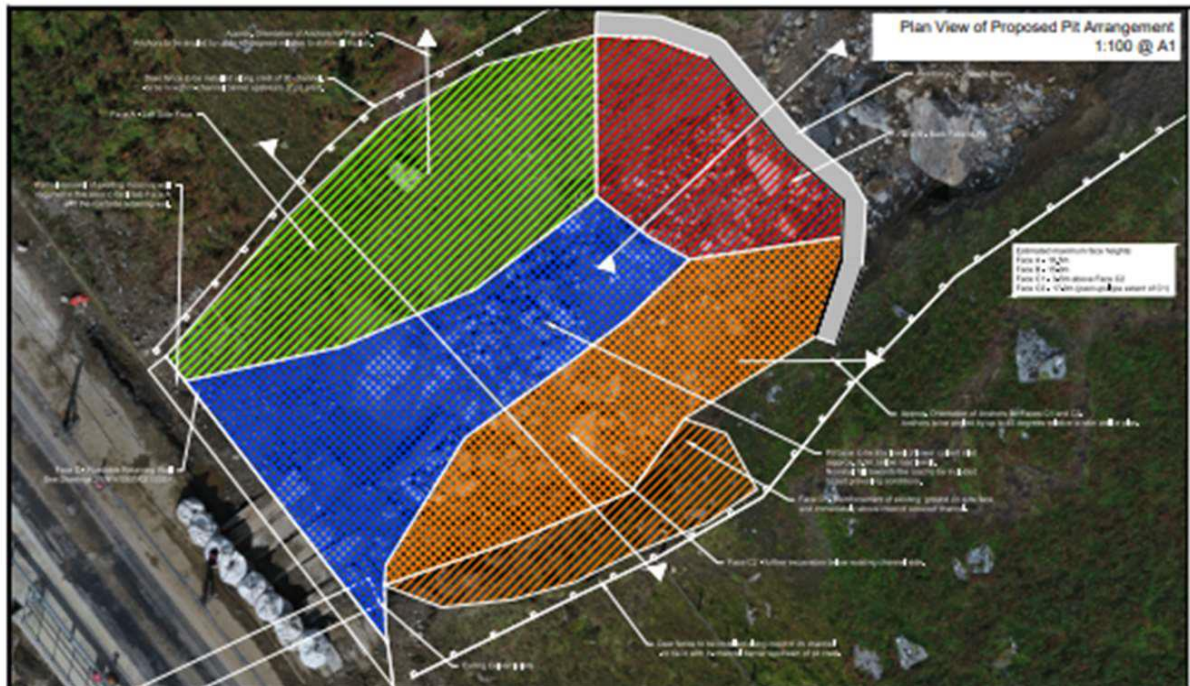
- Construction of 'Phase 3b' catch-pit commenced 7 September 2021.
- Catchpit is expected to be complete in Summer 2022, subject to weather and hillside conditions.
- Capacity is estimated at 1600 Tonnes.

- This £3.5M investment will be formed of reinforced concrete walls anchored into the hillside.

Image showing plan view of catch-pit arrangement

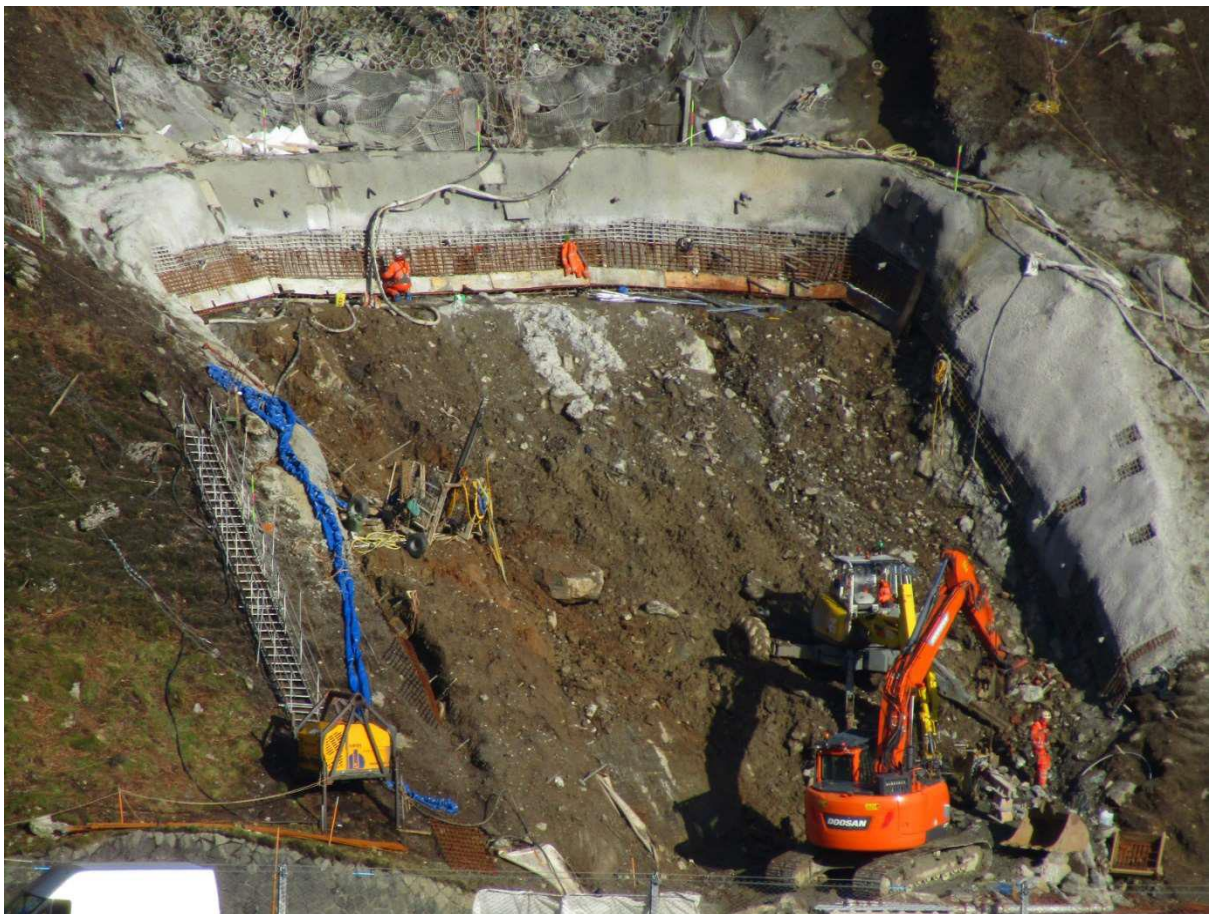
Image showing Channel 3B pit construction from A83

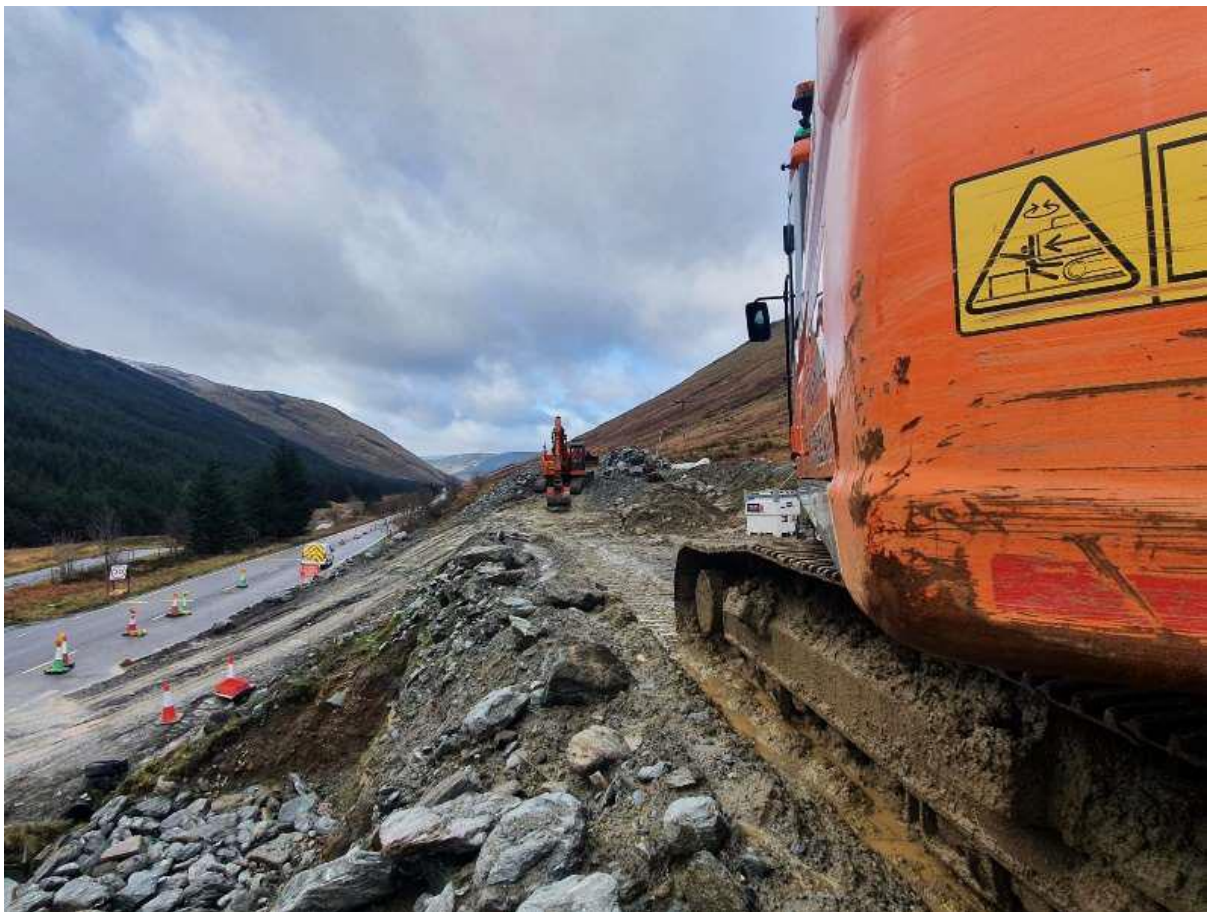
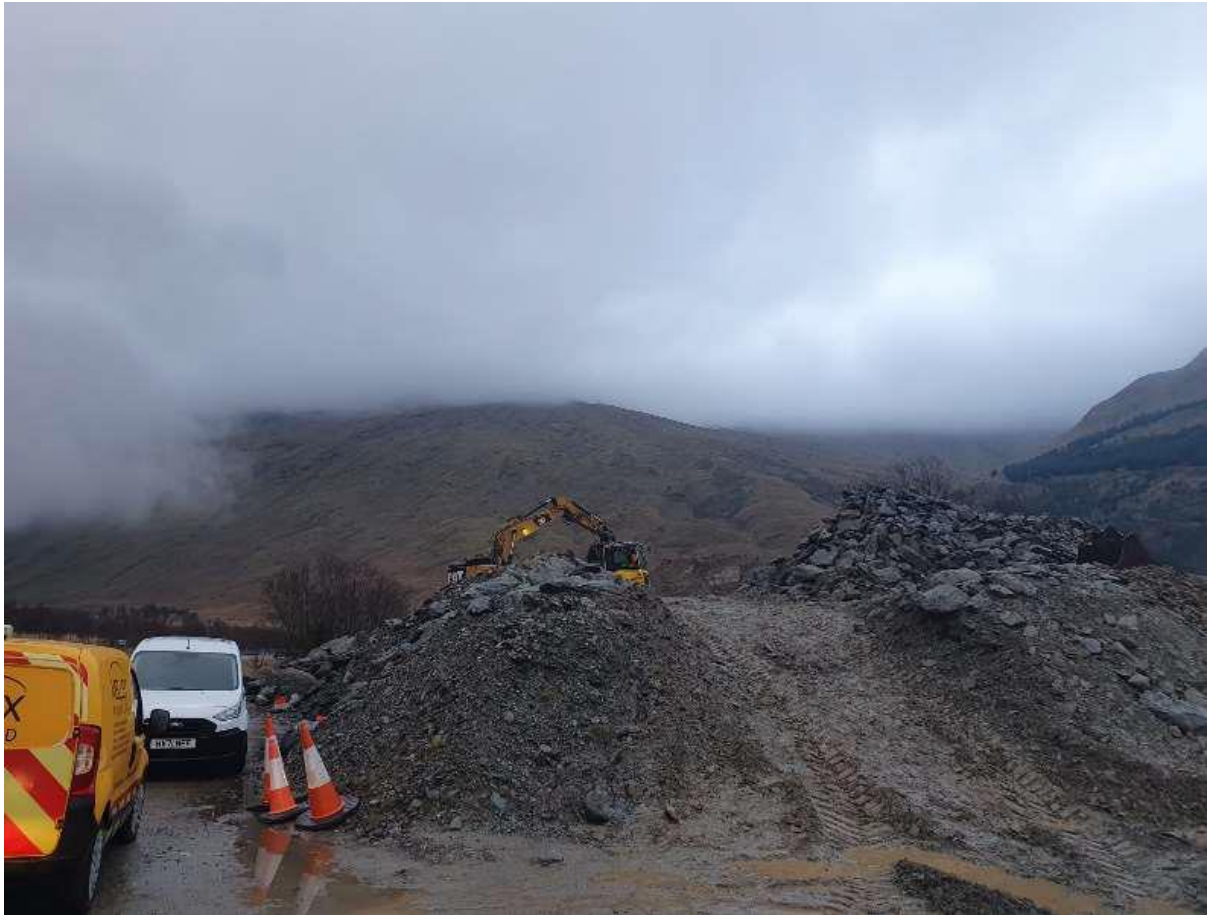
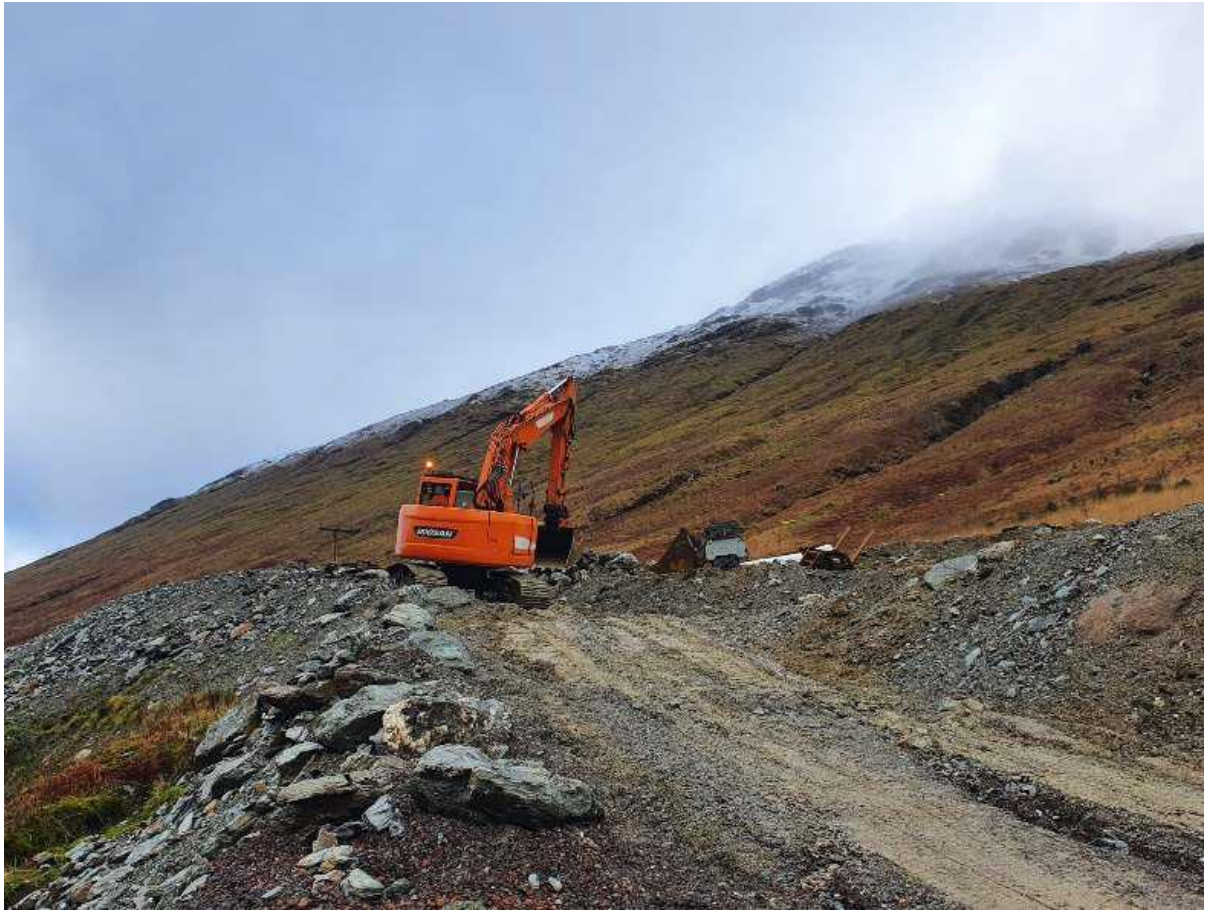
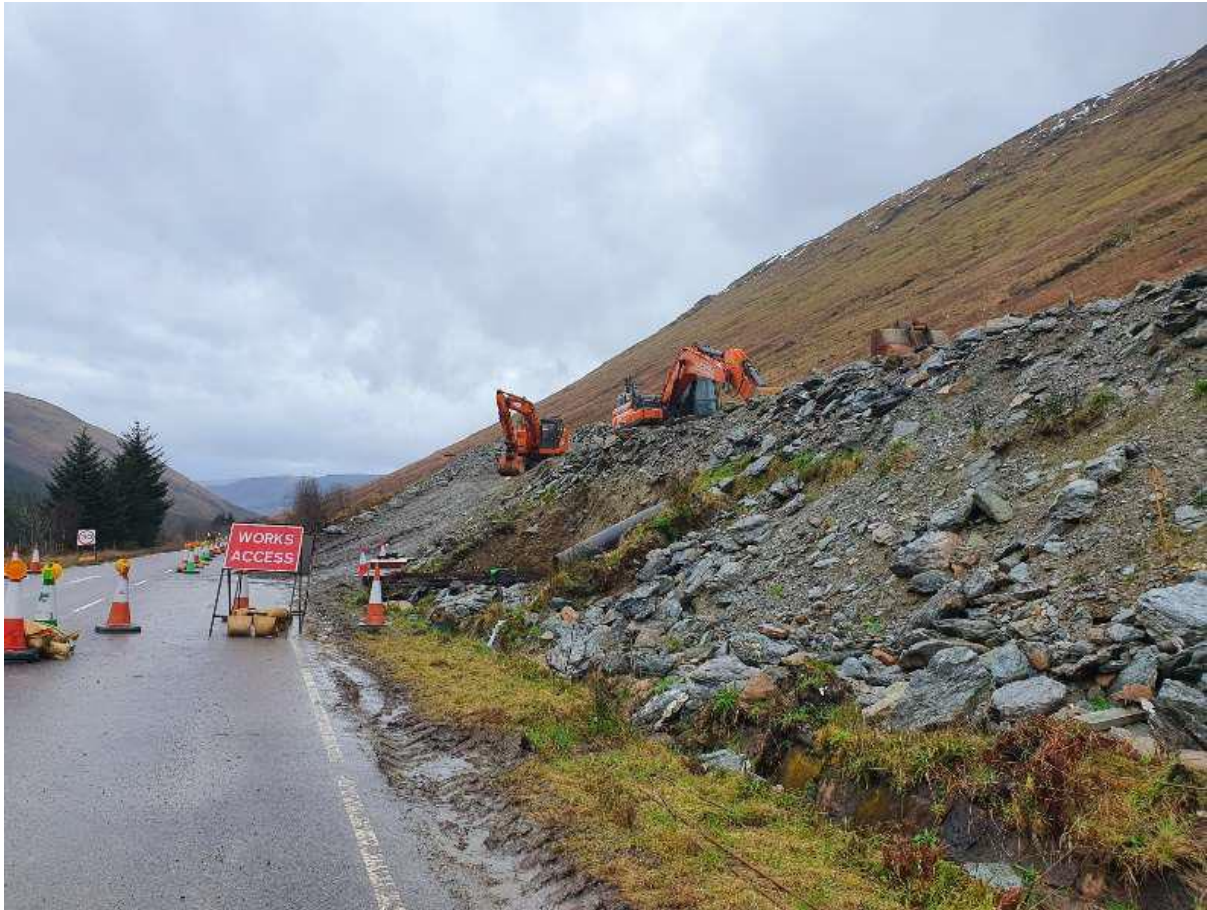
- New bund to be constructed from locally won material associated with catch-pit construction at Rest and be Thankful.
- Rock being stored at Butterbridge layby for processing and re-use.
- Testing before placement revealed material to be susceptible to grading and compaction requiring further investigation and re-design.
- Traffic management on A83 required due to proximity of work site to Trunk Road, and need for appropriate safety zone given site clearance undertaken.
- Material grading complete and bund construction to be concluded by summer 2022.

Image showing ongoing works at Glen Kinglas Bunds

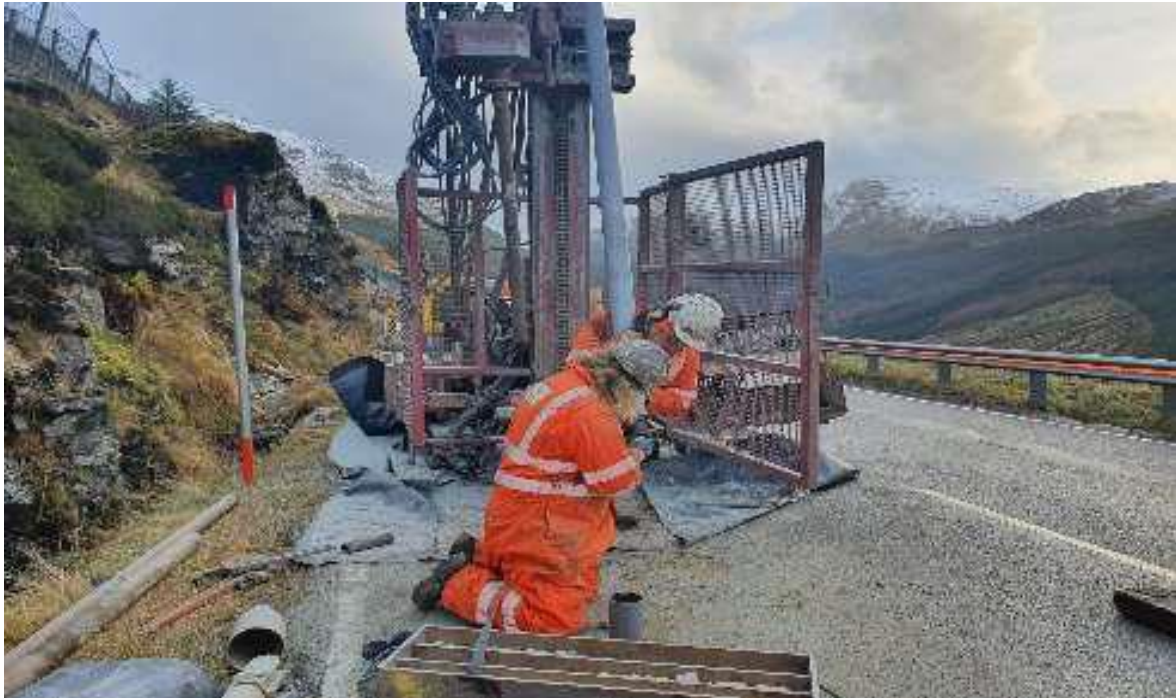
- Ground investigation at Phases 4 & 10 completed in January 2022.
- Investigation will help form detailed design of the Ph4 & 10 catchpits.
- Works involved pavement, soil and rock sampling, and in-situ testing.

Image showing Pavement sampled being obtained from A83.

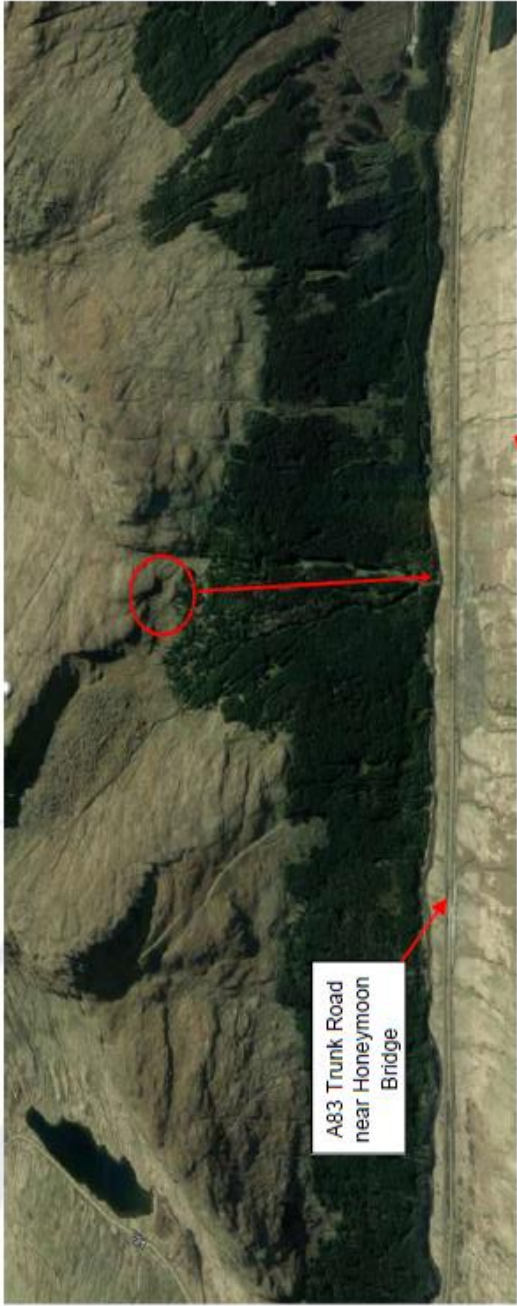
A83 Trunk Road
near Honeymoon
Bridge

Two nearby landslides occurred during recent heavy rainfall. These did not impact the Trunk Road.

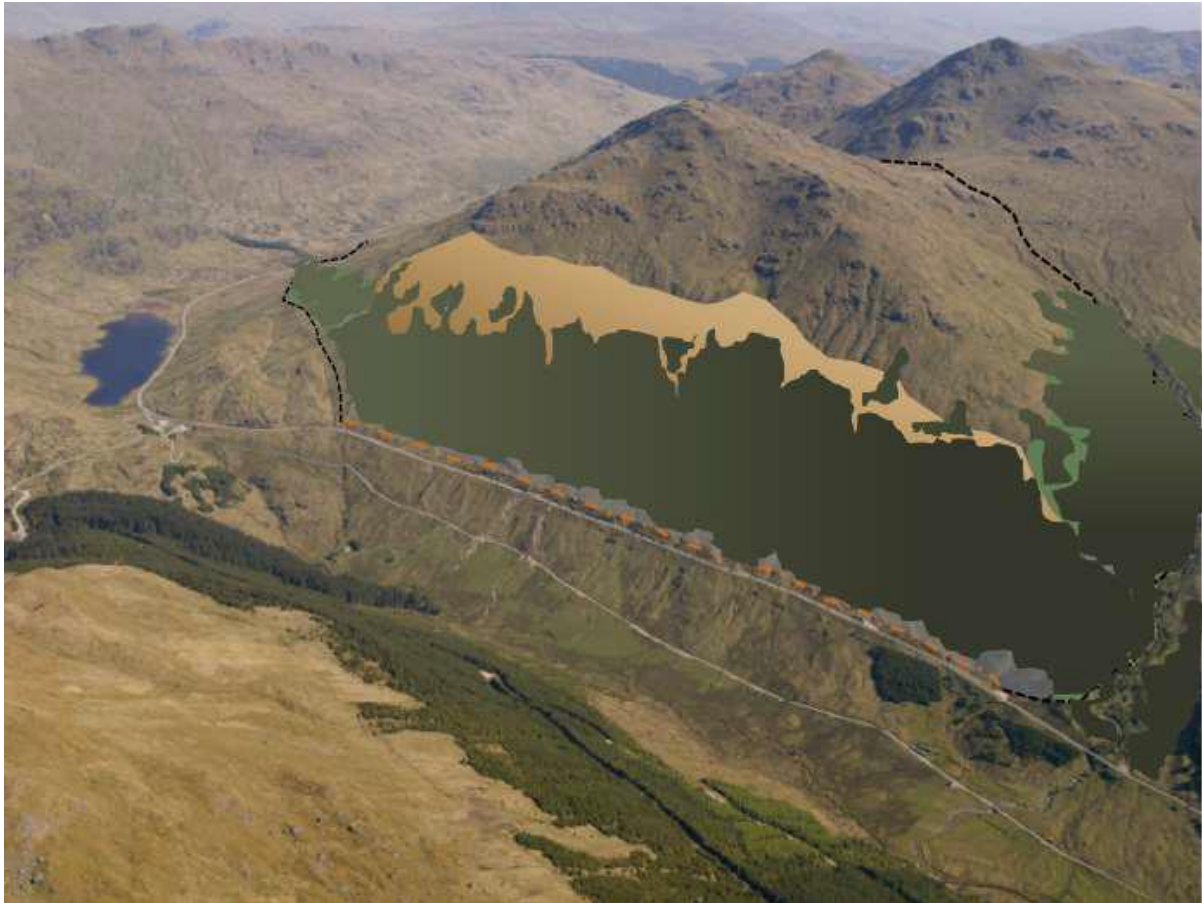
- The erection of deer fencing is complete on hillside above A83 with tree planting to commence March 2022.

Image showing location of proposed tree planting

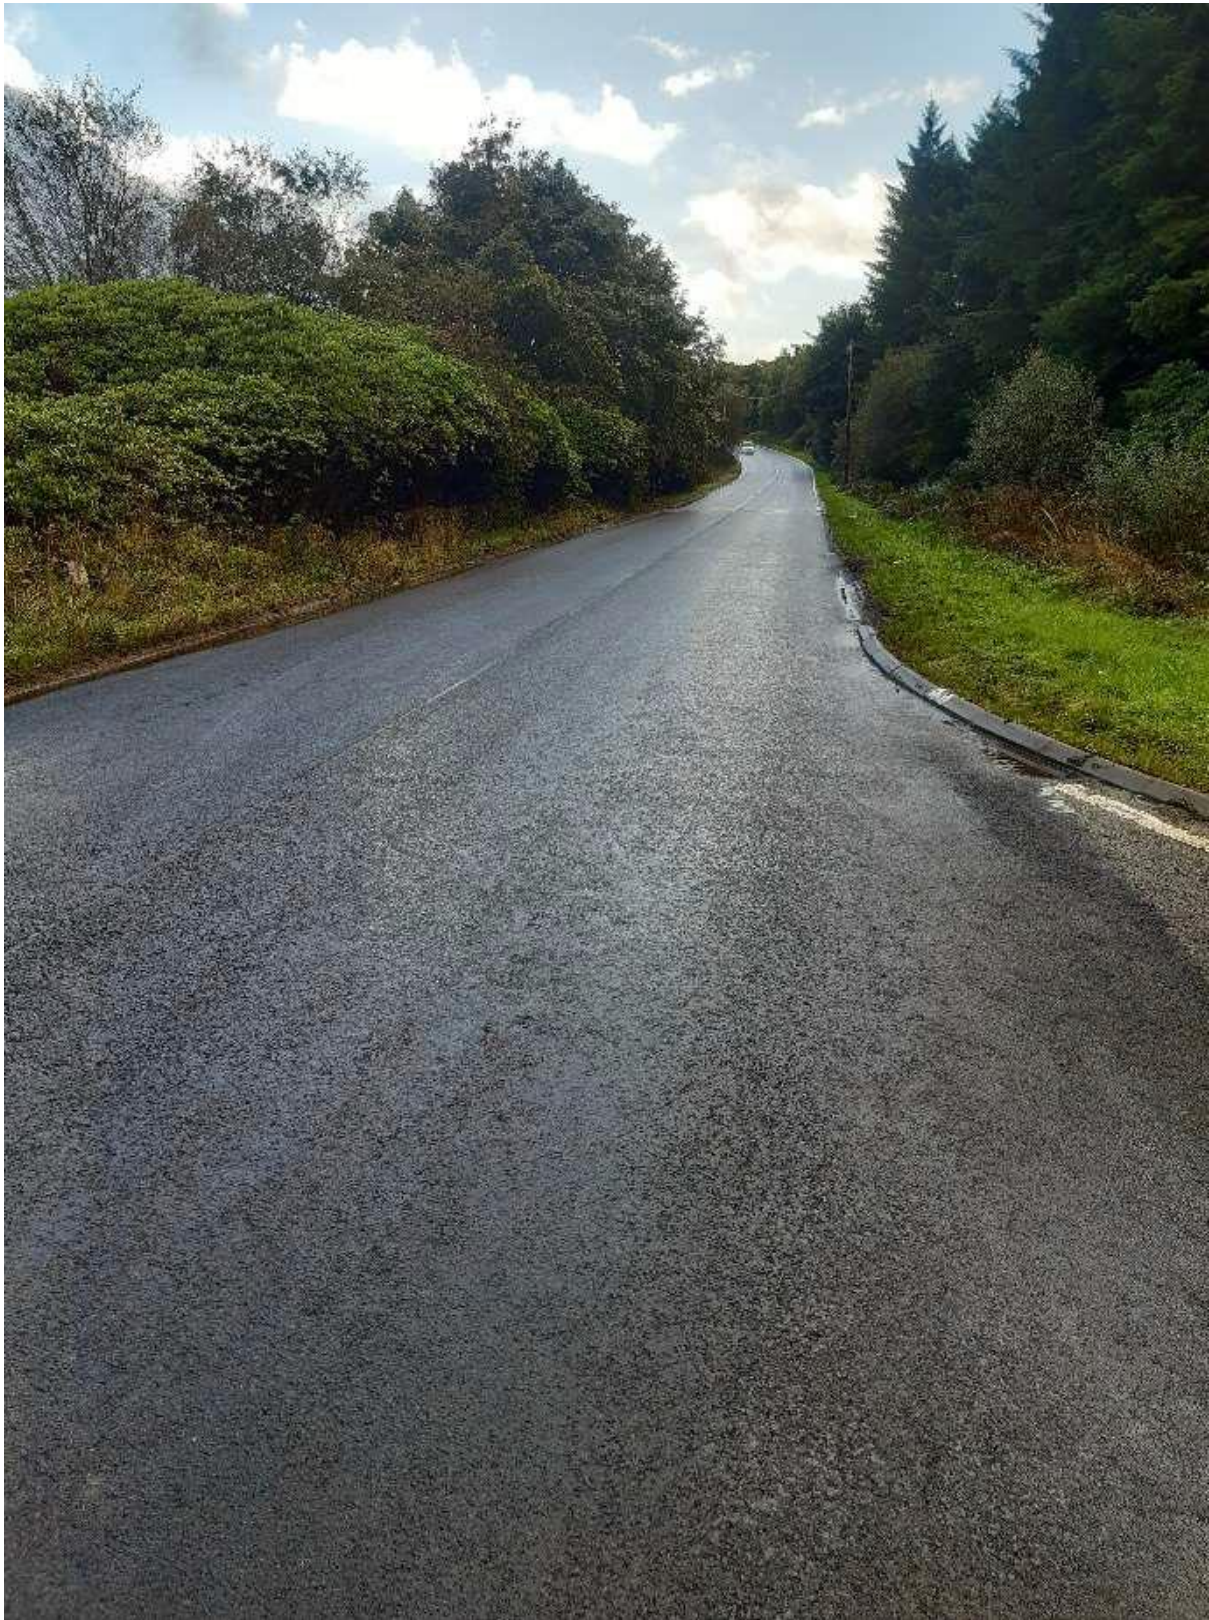
Image showing surfacing improvements South of Lochgilphead
