## Appendix I

### Selected Images from the Conflict Study – Tore Roundabout

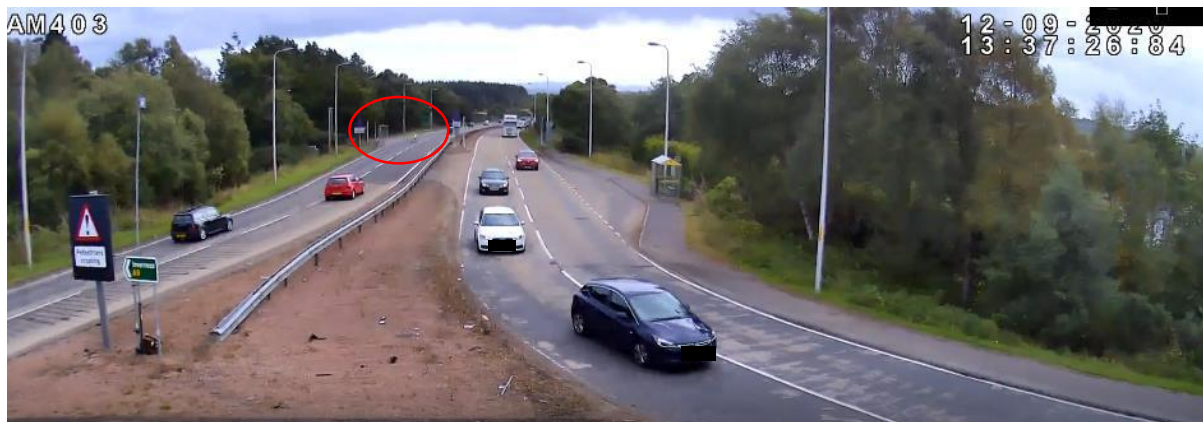
Location/time: A9 Tore Roundabout looking south – 12 September 2020

Description: NMU Crossing Point - Cyclist pushing bike quickly to cross the southbound carriageway

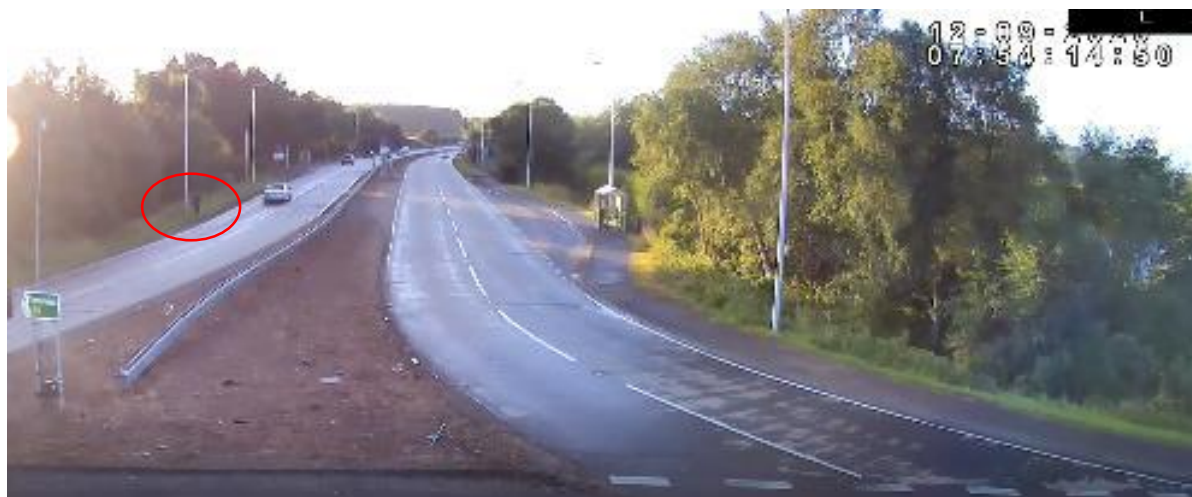
Location/time: A9 Tore Roundabout looking south 12 September 2020

Description: Pedestrian walking along southbound verge to Bus Lay-by

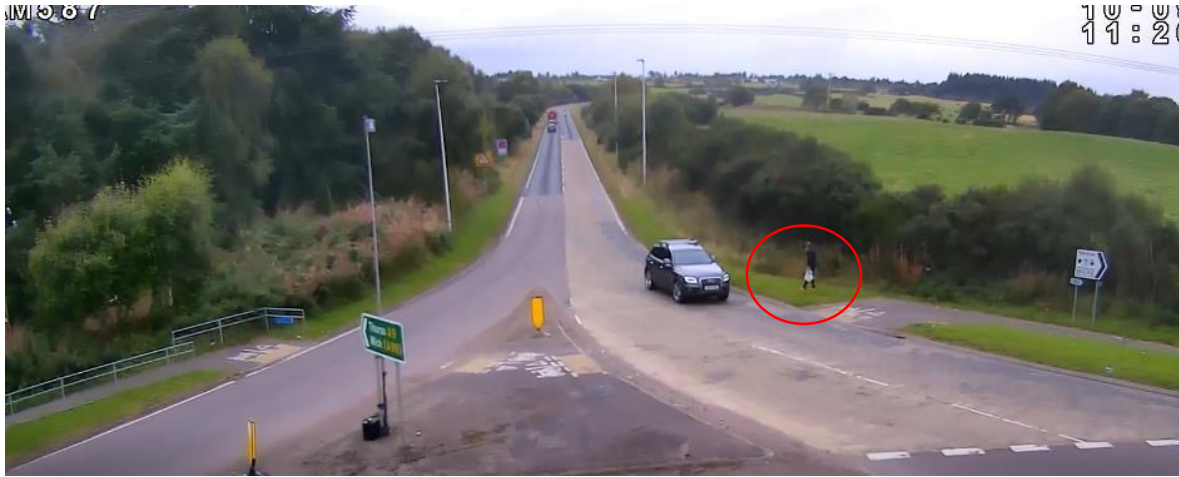
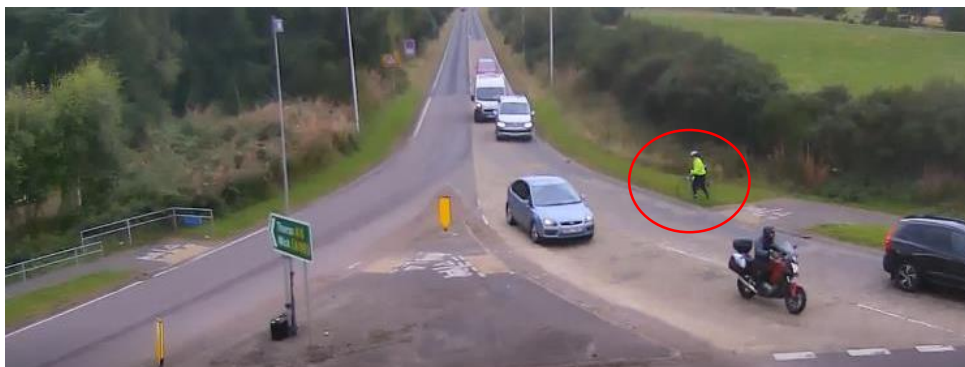
Location/time: A9 Tore Roundabout Looking north 10 September 2020 looking north

Description: Pedestrian and cyclist moving north of the crossing point to improve the visibility to the north

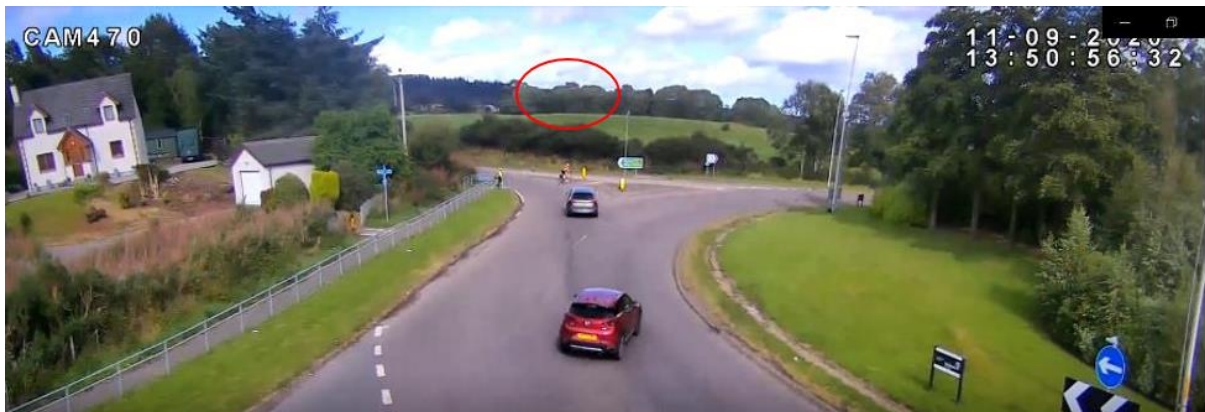
Location/time: A9 Tore Roundabout looking towards the A9 north exit 11 September 2020  
Description: Cyclist moved quickly to be avoid being hit by car

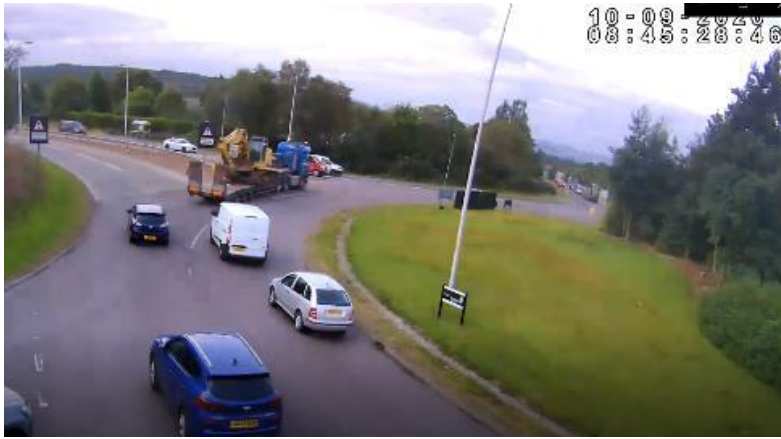
Location/time: A9 Tore Roundabout looking towards the A9 south exit 10 September 2020  
Description: Low-loader and tractor and trailer entered roundabout from A832(E) heading west causing southbound vehicles to brake

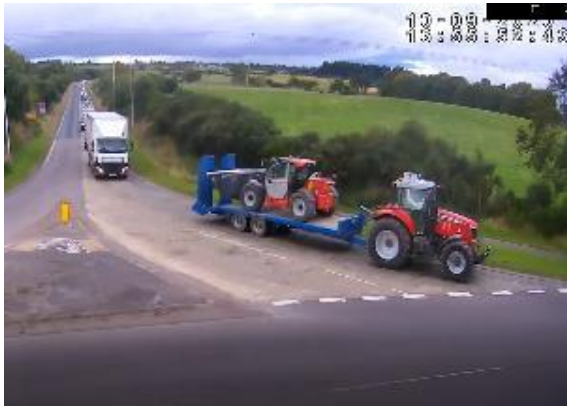
Location/time: A9 Tore Roundabout A9 Southbound 10 September 2020 16:55

Description: Longest queue of 29 vehicles stuck behind tractor and trailer

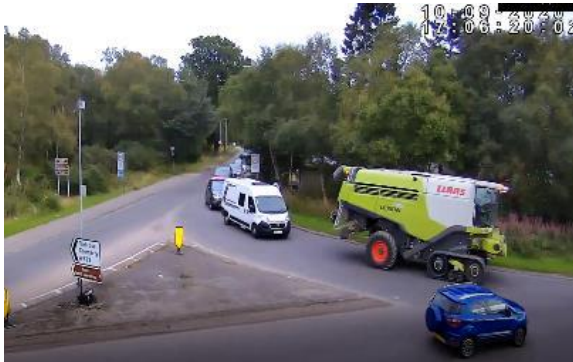
Location/time: A9 Tore Roundabout A823(E) 10 September 2020 17:09

Description: Longest queue of 19 vehicles stuck behind Combine Harvester

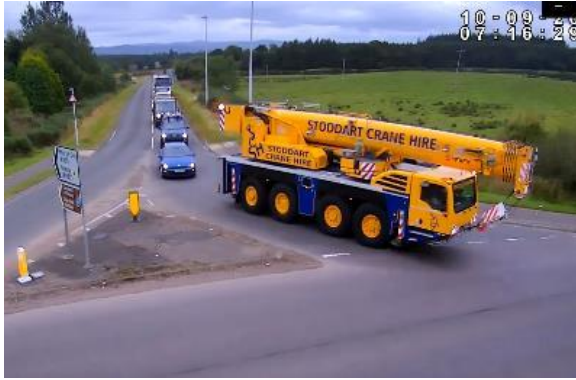
Location/time: A9 Tore Roundabout A823(W) 10 September 2020 07:16

Description: Longest queue of 20 vehicles stuck behind crane

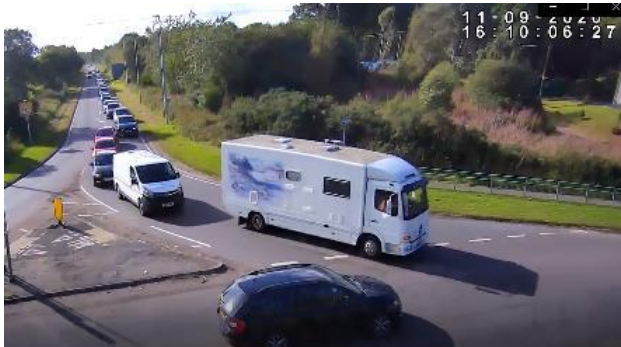
Location/time: A9 Tore Roundabout A835 11 September 2020 16:10

Description: Longest queue of 39 vehicles stuck behind horse box

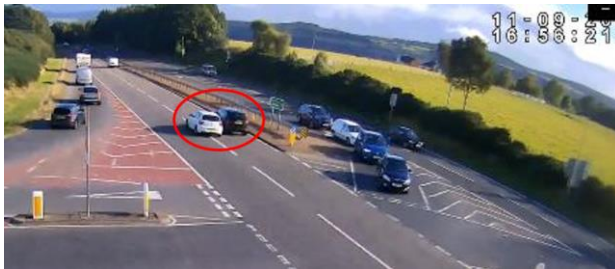
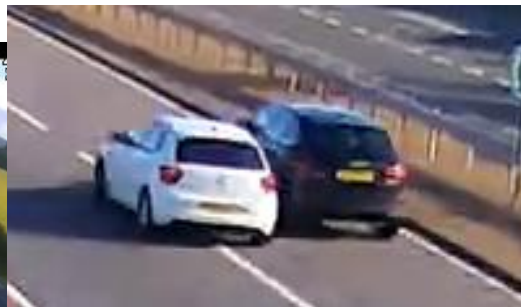
Location/time: A9 Munloch Junction looking south 11 September 2020

Description: Four vehicles merging and white car attempt to move to lane 2 but narrowly misses car in lane 2

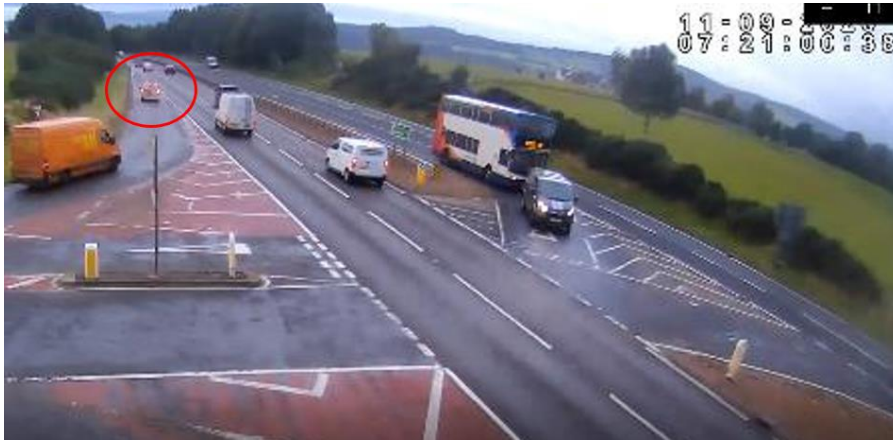
Location/time: A9 Munloch Junction looking south 11 September 2020

Description: Van has to break and stop on merge taper as van in lane 1 couldn't move into lane 2

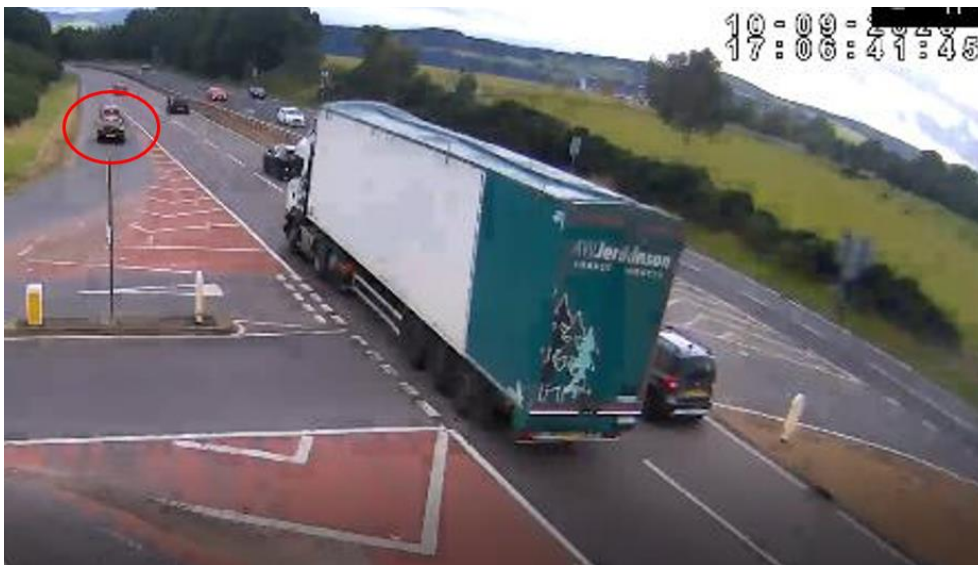
Location/time: A9 Munloch Junction looking south 10 September 2020

Description: Two cars have to break and stop on merge taper as HGV in lane 1 couldn't move into lane 2

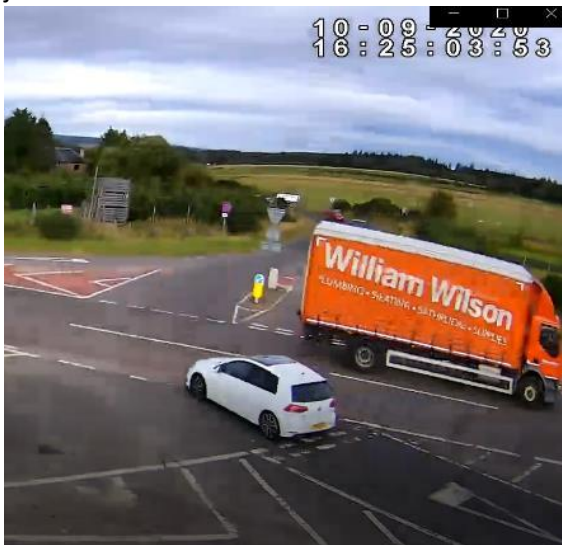
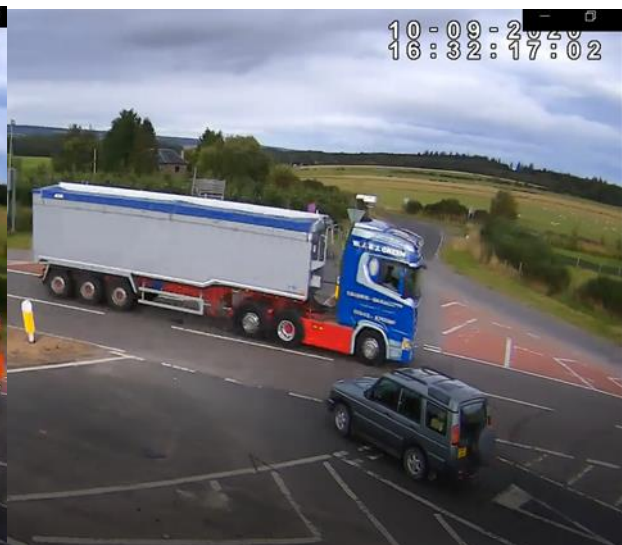
Location/time: A9 Munloch Junction looking east 10 September 2020

Description: Vehicles enter lane 2 prior to the vehicle in lane 1 of the southbound lane has past the junction

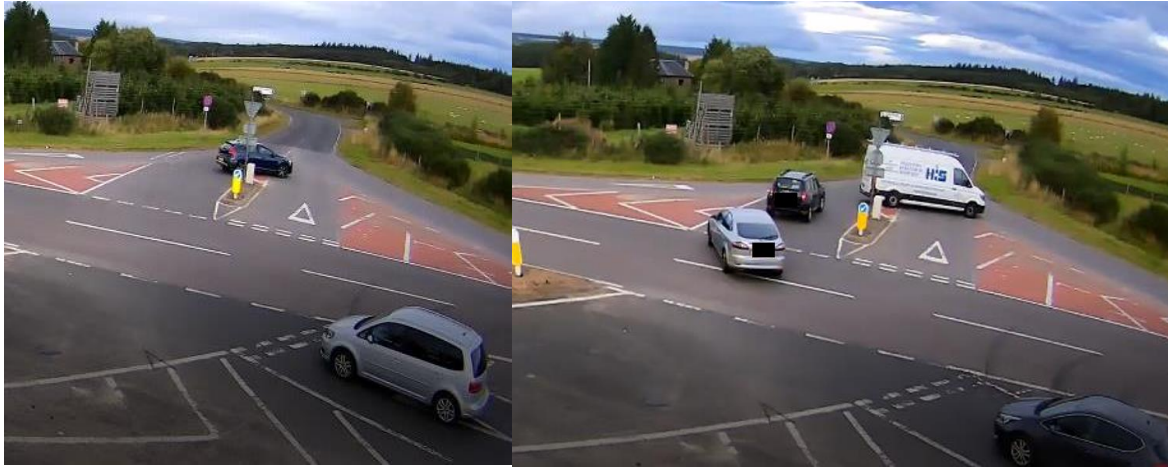
Location/time: A9 Munloch Junction looking east 10 September 2020

Description: Vehicles carrying out U-turns at Munloch junction

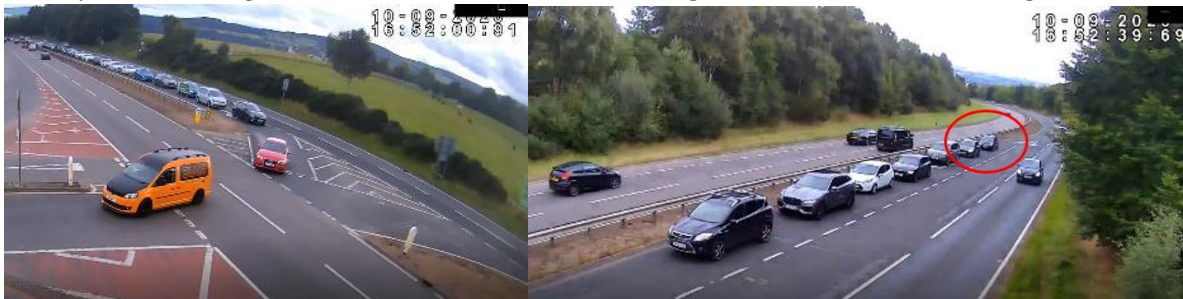
Location/time: A9 Munloch Junction looking south 10 September 2020

Description: Queuing traffic of 25 vehicles almost reaching back to full extent of the right turn lane

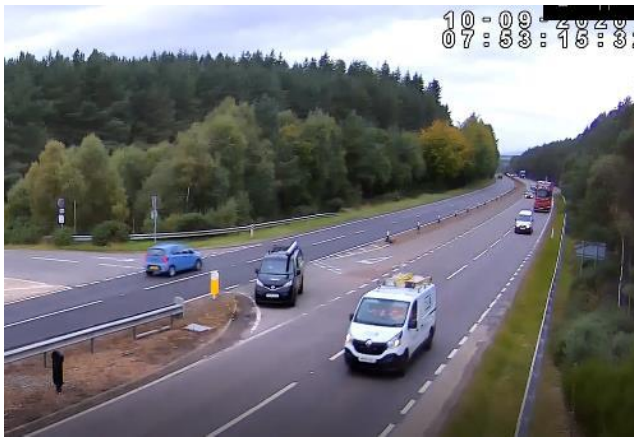
Location/time: A9 Artafeelie Junction 10 September 2020 07:53

Description: Vehicle having to sit at an angle to fit in central reservation

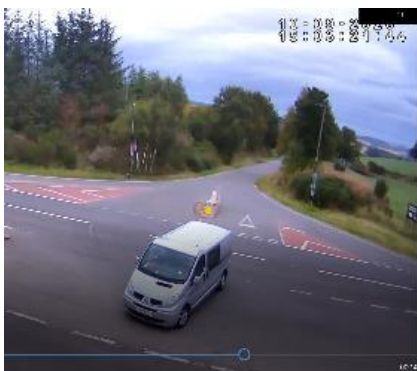
Location/time: A9 Allangrange Junction 12 September 2020 15:38

Description: Tractor and trailer people carrier waiting in central reservation with rear in lane 2 of southbound carriageway

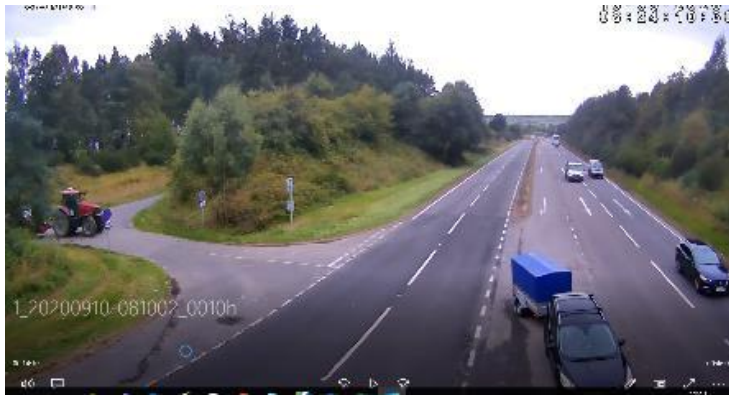
Location/time: A9 Glackmore Junction looking north - 10 September 2020

Description: Car and trailer having to wait parallel with road in central reservation
