A83 Rest and Be Thankful

LTS EIAR VOLUME 4, APPENDIX 19.3 - ROAD DRAINAGE AND
THE WATER ENVIRONMENT BASELINE

A83AAB-AWJ-EAC-LTS_GEN-RP-LE-000294

A19-3.Road Drainage and the Water Environment Baseline

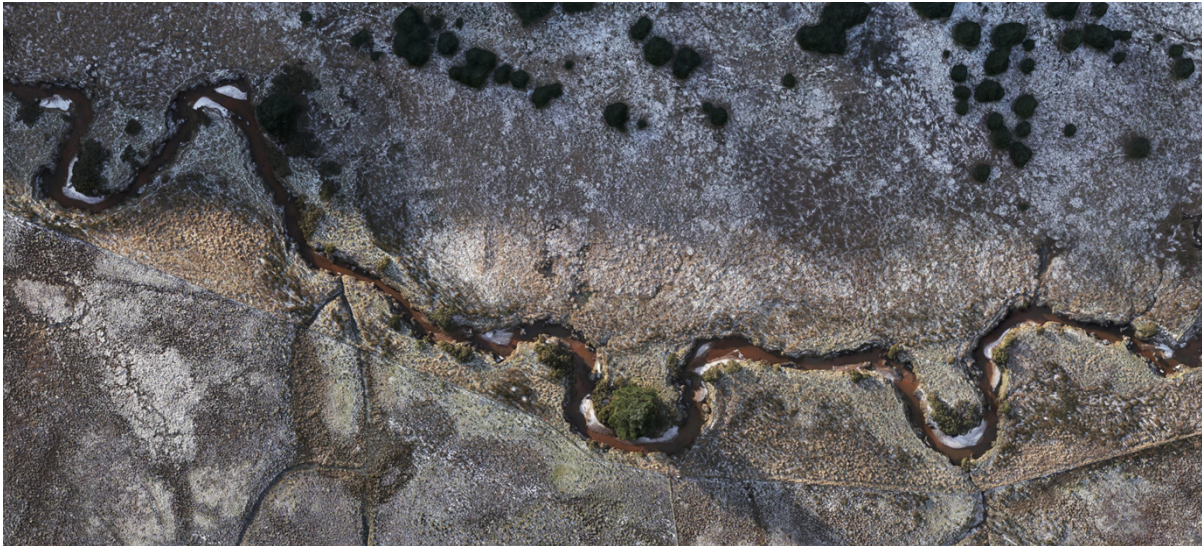
- A19-3.2.14. The Croe Water exhibits a range of morphological features with very little artificial modification as can be seen in Plate A19.3.1. The Croe Water, as designated by SEPA for the WFD, flows from north to south through the base of Glen Croe and is an active meandering channel with exposed cobbles and gravel bars (note that this is not as shown on Ordnance Survey mapping; which displays the Croe Water flowing under the A83 and OMR to the valley floor). The dominant riparian land use and cover is rough grassland. The channel slopes for the Croe Water are much shallower (~0.01 m/m) than they are for the watercourses draining the valley sides (~0.1 to 0.3 m/m where the watercourses cross the OMR).

Plate 19-3.1 Aerial Image of the Croe Water, showing river meanders on valley base

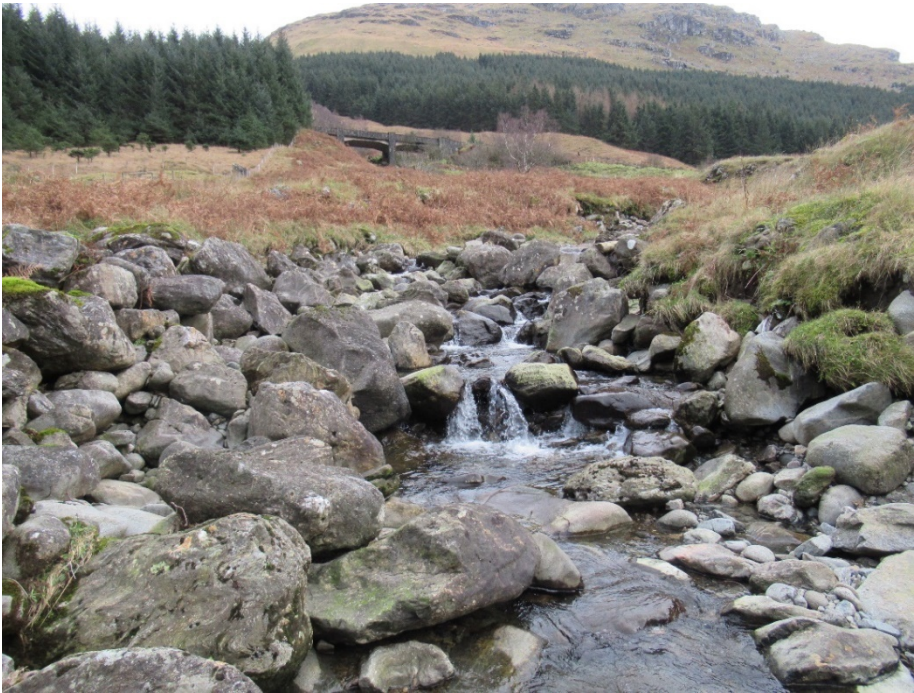
- A19-3.2.15. The most substantial lateral inflow to the WFD designated Croe Water drains a catchment area of approximately 3.4 km² (watercourse ID: A83_ML_015_000, identified as Croe Water on OS mapping). The watercourse is steep (0.085 m/m) and high energy, with the bed and banks dominated by large cobbles and boulders characterised as a cascading system (Plate A19.3.2 below). The watercourse has two bridge crossings associated with the existing A83 and the OMR.

Plate A19.3.2 Croe Water (A83_ML_015_000), looking upstream from the existing OMR bridge (Dated: 09 December 2022)

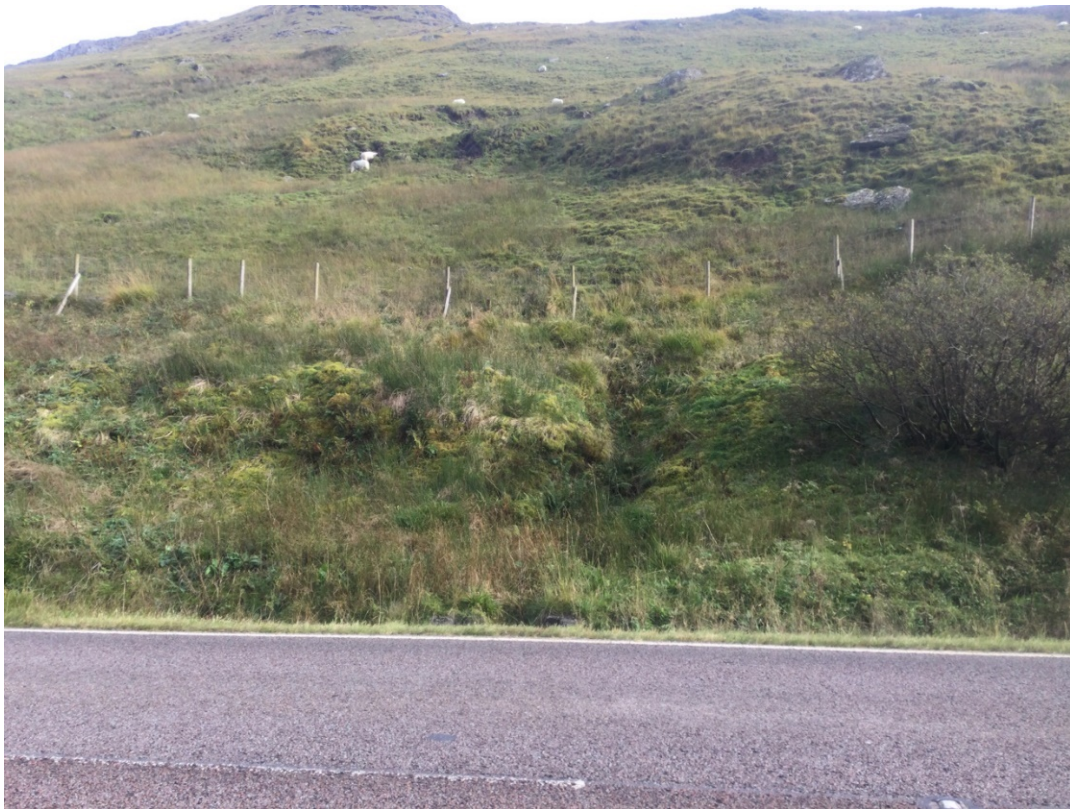
A19-3.2.19. Two watercourses, neither named on the OS 1:25,000 mapping, are located within the catchment of the Kinglas Water WFD water body. These watercourses drain the steep (~0.4 to 0.5 m/m), north-western slopes of Beinn Luibhean and discharge directly into Loch Restil. The channels are poorly defined upslope of the A83, with only a vegetated linear depression observable from the A83, suspected as providing intermittent, ephemeral flows (see Plate A19.3.4).

Plate A19.3.4 Image of A83_ML_035_000 that drains the north-western slopes of Beinn Luibhean to Loch Restil (Imagery Date: October 2023)

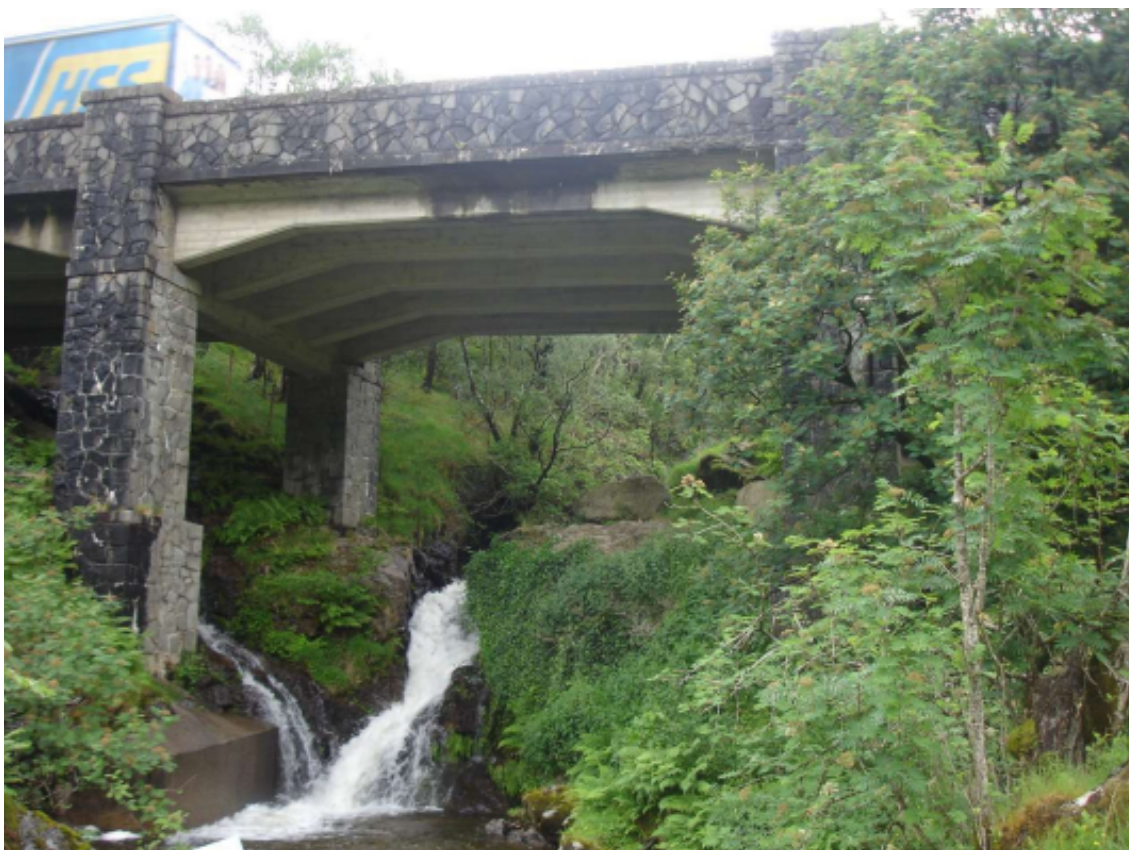
A19-3.2.20. There are four bridge structures present within the corridor of the A83 in the Study Area. The Cobbler bridge (A83_15 Bridge) carries the A83 over Croe Water (Plate A19.3.5), this is a three-span structure with four piers supporting the central span. The road elevation is at 165 mAOD at the northern abutment falling to 163 mAOD at the southern abutment. The A83 is considered to have a very low risk of flooding from fluvial sources at this location, as described in Section A19-3.5. At the southern extent of the Study Area there are two further bridges carrying the A83 over the Croe Water (A83_03 and A83_04 Bridges), these are outwith the area of the Proposed Development. The Kinglas Water is

Plate A19.3.5 A83_15 Bridge ('The Cobbler') across the Croe Water (A83_ML_015_000), looking upstream (Dated: 28 April 2022)

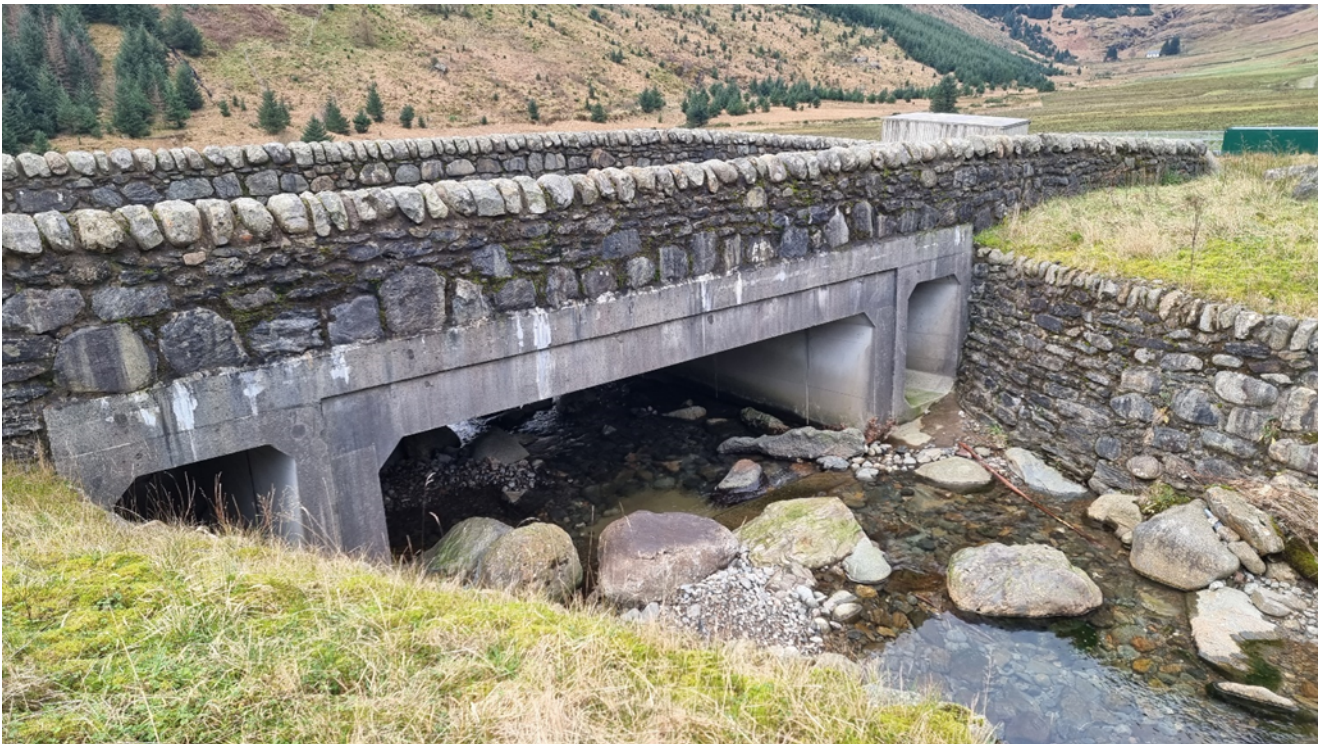
- A19-3.2.21. Thirty-six watercourse crossing points along the OMR alignment have been confirmed by site visits, all in Glen Croe and within the Croe Water catchment. Three of these OMR crossings are bridge structures, with the OMR crossing of the Croe Water (OMR_13 Bridge) approximately 170m downstream of the A83 crossing (A83_15 Bridge, Cobbler Bridge) and consisting of three openings; a main box culvert with two side flood relief culverts (Plate A19.3.6). The main box culvert (approximately 5.5 m wide x 0.7 m high) has a soffit level of 126.55 mAOD and the two flood relief culverts (each approximately 0.5 m wide x 0.6 m high) have a soffit level of 126.7 mAOD.

Plate A19.3.6 OMR crossing of the Croe Water (A83_ML_015_000), looking downstream at the inlet of the structure (Dated: 07 December 2022)

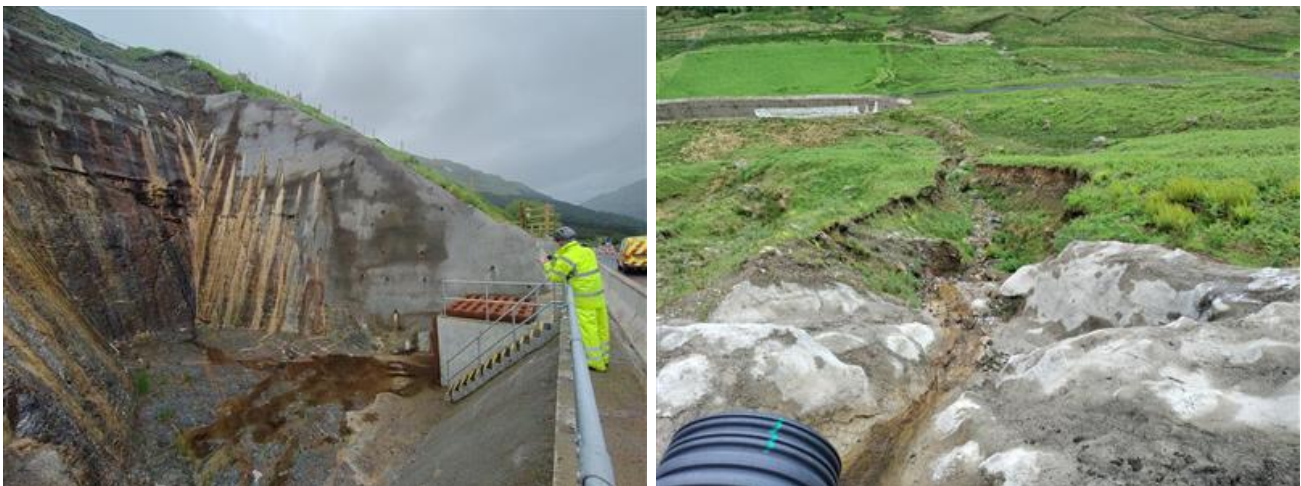
- A19-3.4.12. All watercourses are to some degree affected by anthropogenic pressures and modifications relating to bridge and culvert crossings of the A83 and/or OMR (as detailed in Table A19-3.2). There are, however, much more substantial modifications to the watercourses that have been implemented to provide protection and resilience from debris flows to the A83 and the downstream watercourses. These measures include catchpits upstream of the A83 and various types of downstream bed and bank protection and built cascades, including those presented in Plate A19.3.7 for watercourse A83_ML_023_000.

Plate A19.3.7 Examples of existing watercourse (A83_ML_023_000) modifications upstream and downstream of the A83 (Dated: 22 May 2024)

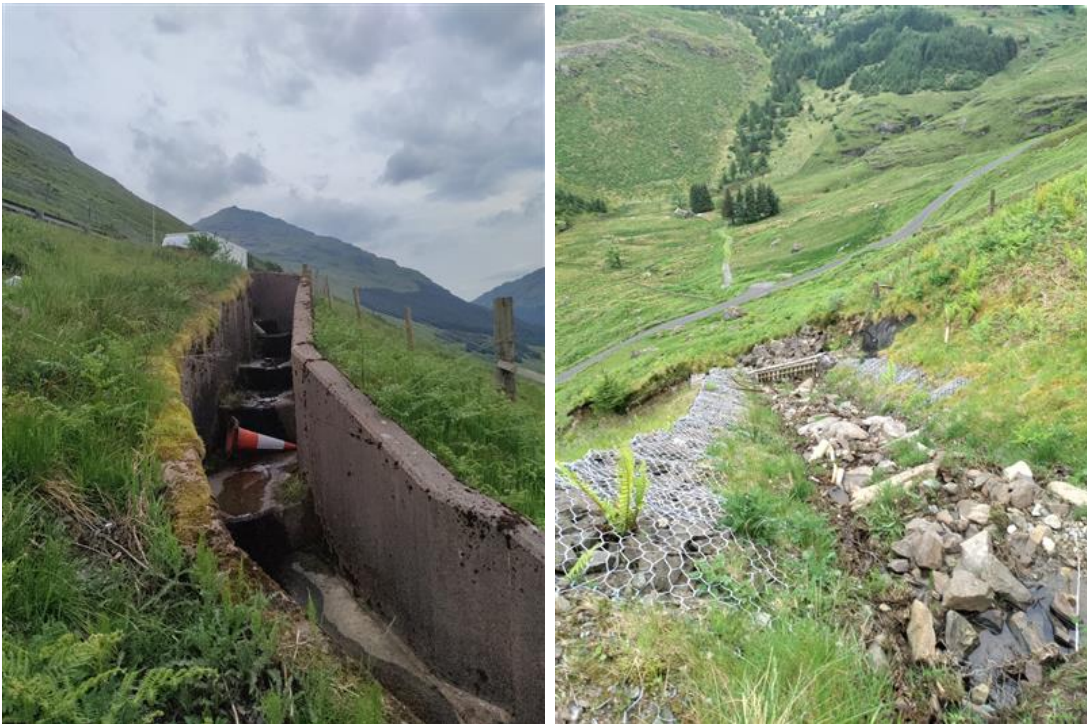
- A19-3.4.13. The downstream protection features affect numerous watercourses with a variety of different forms, including concrete bed and bank protection and rock filled mattresses, as presented in Plate A19.3.8 for watercourses A83_ML_029_000 and A83_ML_023_000 respectively.

Plate A19.3.8 Examples of downstream built cascade and bank protection to watercourse A83_ML_029_000 (left) and A83_ML_023_000 (right) (Dated: 22 May 2024)

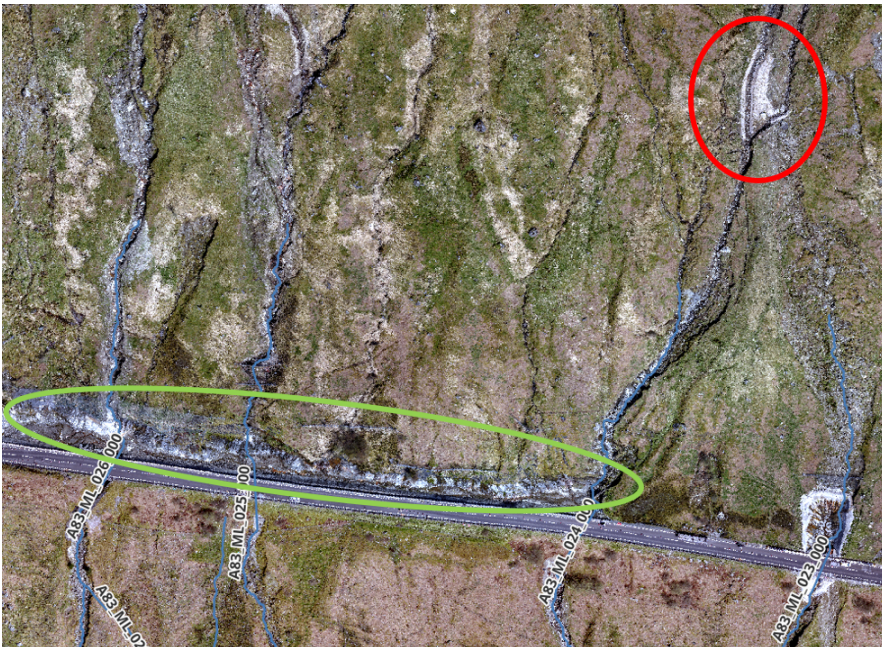
A19-3.4.14. It was observed during site walkovers that a number of watercourses connected via an upstream catchpit were partially bypassing their correct inlet and culvert structure beneath the A83 to discharge south through the adjacent culverts (Plate A19.3.9). Other instances of bypassing include A83_ML_016_000, where flow was observed to be bypassing the inlet to flow south adjacent to the A83 towards the Croe Water and Cobbler Bridge. Plate A19.3.10 shows the aforementioned catchpit that links watercourses A83_ML_026_000 to A83_ML_024_000 (green circle) and an engineered diversion upslope of the A83 which diverts flow from A83_ML_024_000 to A83_ML_023_000 to improve geotechnical slope stability.

Plate A19.3.10 Upstream channel diversions (circled red) and large A83 catchpit into which multiple watercourses flow (circled green) (Aerial imagery: April 2024)

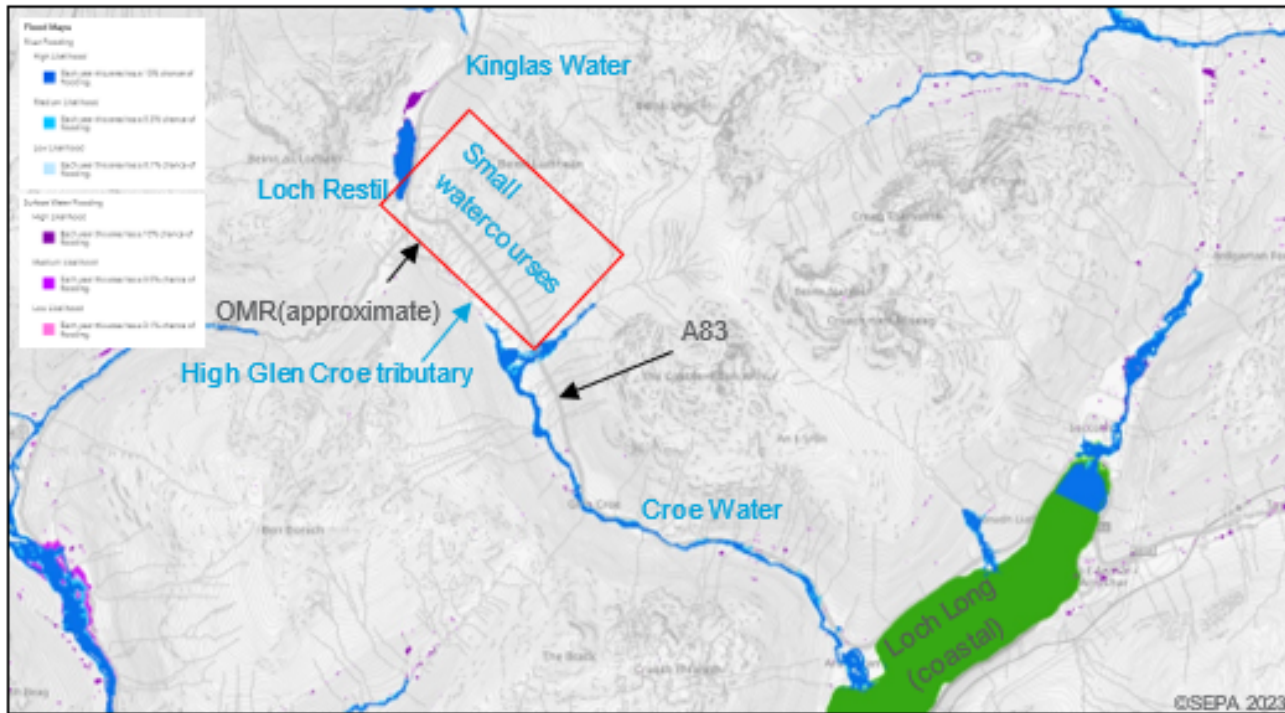
Plate A19.3.11 SEPA Flood Map for the Study Area, Annotated with Local Feature

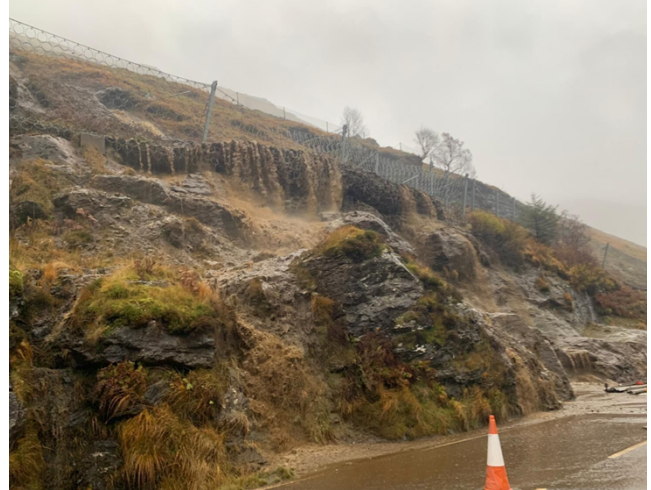
- A19-3.5.15. Correspondence from SEPA identified 10 records of pluvial flooding in the Rest and Be Thankful area since 2006, all related to flooding closing the A83 due to landslips following heavy rain.
- A19-3.5.16. A collection of images of various debris / flood events have been provided in Plates A19.3.19-22. These provide visual evidence of both overland flow and high flows within channels, both of which have caused A83 flooding.

Plate A19.3.20 – Overland flow passing onto the A83, outwith channels

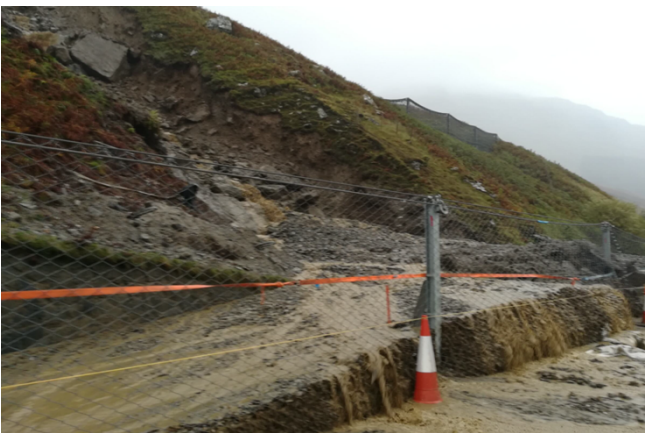
Plate A19.3.21 – Overland flow spilling onto A83

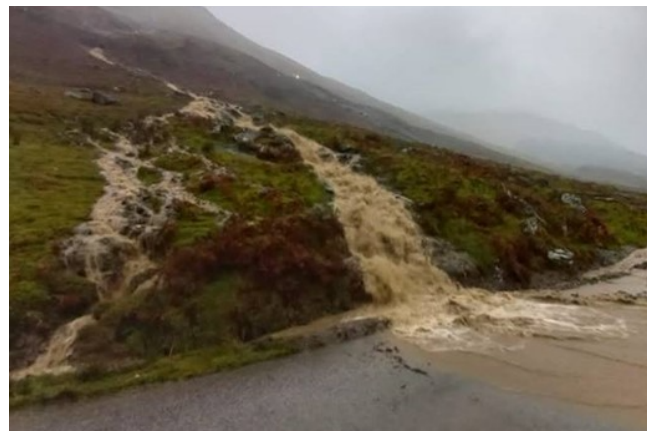
Plate 19.3.22 – Surface water flow spilling onto A83

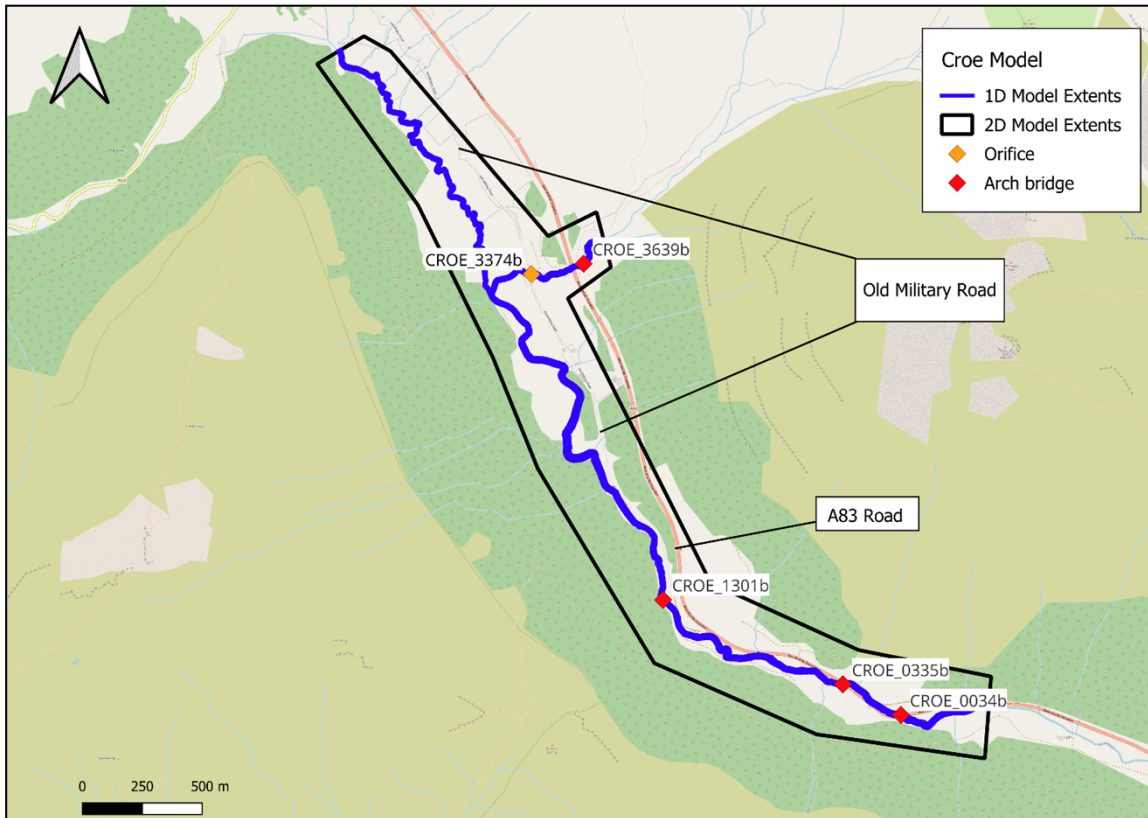
A19-3.5.23. The in-channel hydraulic structures included in the Croe valley are specified Table A19-3.7 and locations are shown on Plate A19.3.27.

Plate A19.3.27 – 1D structure locations located in the Croe valley

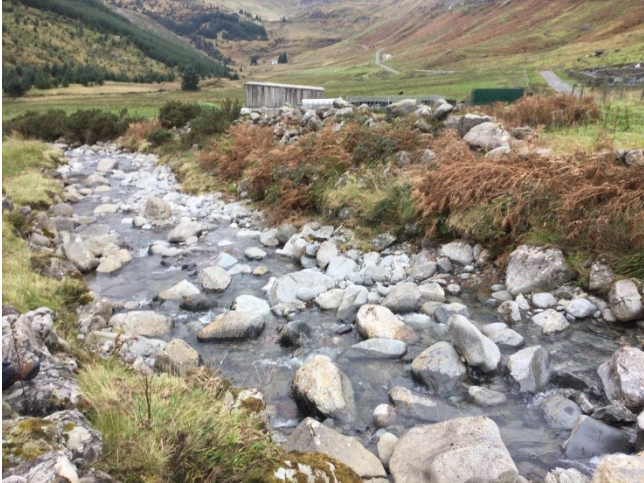
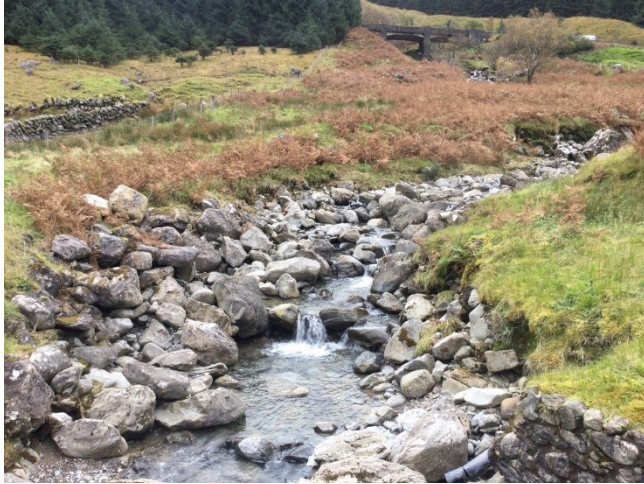
Watercourse ID	A83_ML_015_000
Corresponding OMR crossing ID	OMR_13
Watercourse categorisation	Major (On OS 1:50,000 scale map)
Geomorphological risk categorisation	Medium
WFD Catchment	The Croe Water (ID: 10215)
Catchment area to the A83 (km ²)	3.39
Watercourse length from A83 to OMR (m)	220
Existing A83 culvert (Capacity)	n/a (Cobbler Bridge)
Cascade to step-pool sequence downstream of the OMR (looking downstream)	Cascade to step-pool sequence upstream of the OMR (looking upstream towards the A83, the Cobbler bridge can be seen)

<p>Description: The A83 Cobbler Bridge crossing of the A83_ML_015_000 has two in channel piers. The watercourse is steep, with gradients of >23% (0.237 m/m) for the 100 m upstream of the A83/Cobbler bridge 17% (0.174 m/m) for the first 100m downstream of the A83/Cobbler Bridge. Approximately 35 m upstream of the Cobbler Bridge, there is a single-span footbridge. The reach upstream of the Cobbler Bridge consists of bedrock morphology, with numerous large boulders distributed along the reach and within the riparian area. Downstream of the Cobbler Bridge there is evidence of scour to both banks for approximately 9-10 m, in proximity to the bridge piers. The remainder of the downstream reach is largely stable, with some signs of erosion. The bankfull width was measured at 9.5 m downstream to the OMR.</p>

Processes: The existing bridge has sufficient capacity to convey flows larger than the bankfull. The Cobbler Bridge has not been surveyed due to access restrictions, but aerial imagery and terrain analysis do not indicate scour along the section downstream of the bridge. The section surveyed was immediately upstream of the OMR. Both upper and lower reaches comprise a mix of cascade and step-pool morphologies with a short section of bedrock channel below the Cobbler Bridge.

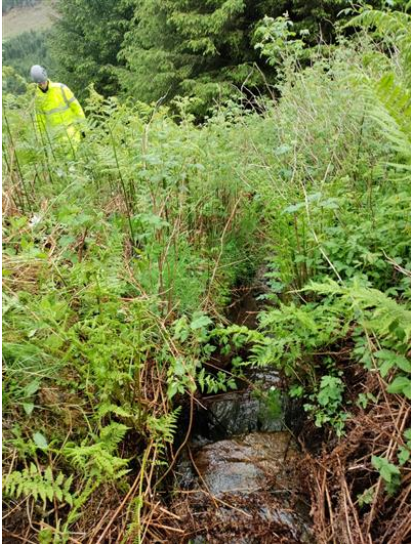
Watercourse ID	A83_ML_017_000
Corresponding OMR crossing ID	OMR_14
Watercourse categorisation	Minor A (On OS 1:25,000 scale map)
Geomorphological risk categorisation	Low
WFD Catchment	The Croe Water (ID: 10215)
Catchment area to the A83 (km ²)	0.094
Watercourse length from A83 to OMR (m)	260
Existing A83 culvert (Capacity)	Box culvert 0.9 m (W) x 1.0 m (H) (>200-yr fluvial event)
Looking downstream from the A83 culvert outlet for A83_ML_017_000

Processes: Though the channel immediately downstream of the A83 culvert outlet is heavily scoured (left hand picture above) no evidence of active scour was observed. The surveyed section, downstream from the confluence with the A83_ML_016_000, shows gravel aggradation. The upper reach, depicted in the left figure, features a step-pool sequence with no significant scour of the bed and banks. Conversely, the lower reach transitions to a riffle-pool and plane-bed channel with substantial gravel deposition around the OMR culvert.

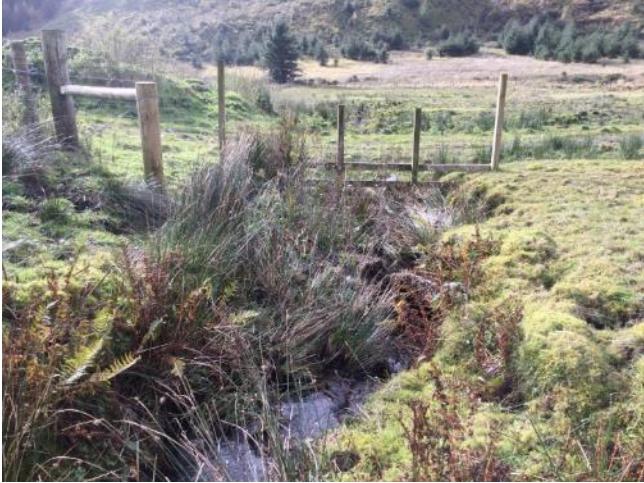
(<2-yr fluvial event)
<p>Step-pool sequence along the lower reach (looking downstream towards High Glencroe)</p>

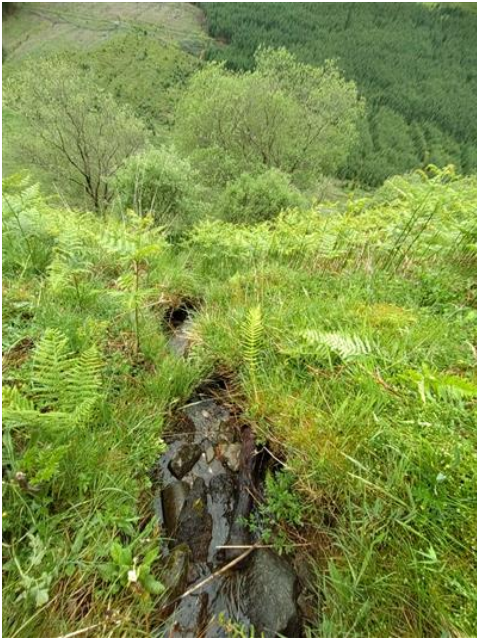
Watercourse ID	A83_ML_019_000
Corresponding OMR crossing ID	OMR_17
Watercourse categorisation	Minor A (On OS 1:25,000 scale map)
Geomorphological risk categorisation	Low
WFD Catchment	The Croe Water (ID: 10215)
Catchment area to the A83 (km ²)	0.039
Watercourse length from A83 to OMR (m)	223
Existing A83 culvert (Capacity)	Pipe culvert, 0.45 m diameter (~5-yr fluvial event)
Looking downstream from A83 culvert outlet

Processes: The A83 culvert can accommodate fluvial flows up to a 5-year event. The upper 20 m of reach below the A83 has a stable channel with well vegetated banks (left image). Below this is a fence which defines the boundary with sheep and cattle grazing land. The 185 m reach extending to the OMR (right photo) features heavily altered morphology due to cattle poaching. Below the OMR there is substantial gravel deposition, and a well-defined plane-bed channel. The riverbed substrate in the lower reach is consistent with a predominantly fluvial transport regime.

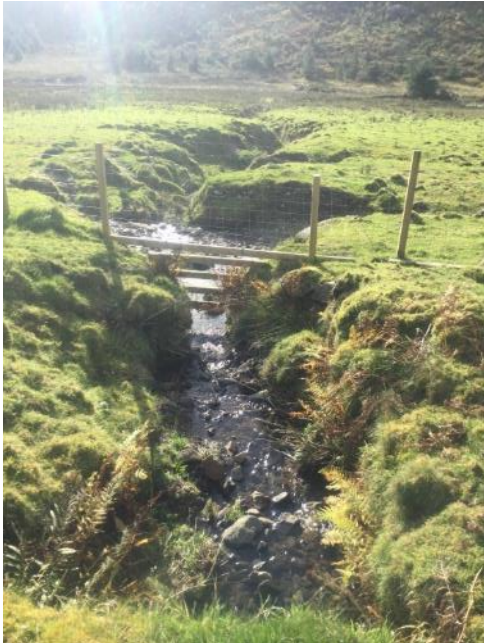
Plane-bed sequence along the lower reach (looking downstream towards the main channel)

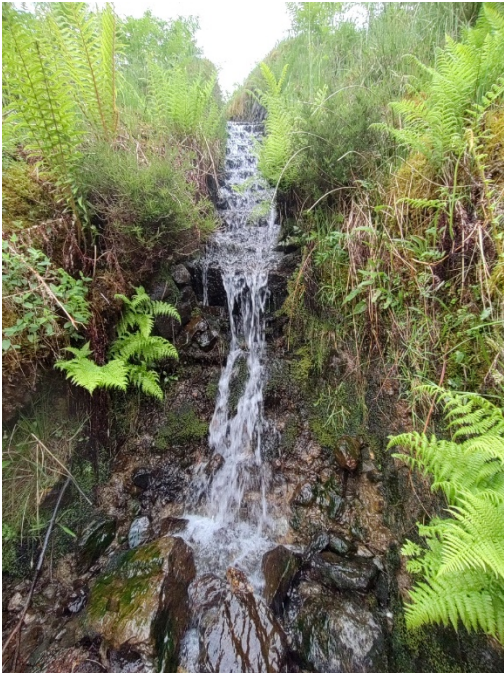
Existing A83 culvert (Capacity)	Pipe culvert, 0.6 m diameter (<2-yr fluvial event)
<p>Looking upstream from the confluence of A83_ML_021_000 and A83_ML_020_000 at the concrete steps and the drop off to the natural channel.</p>

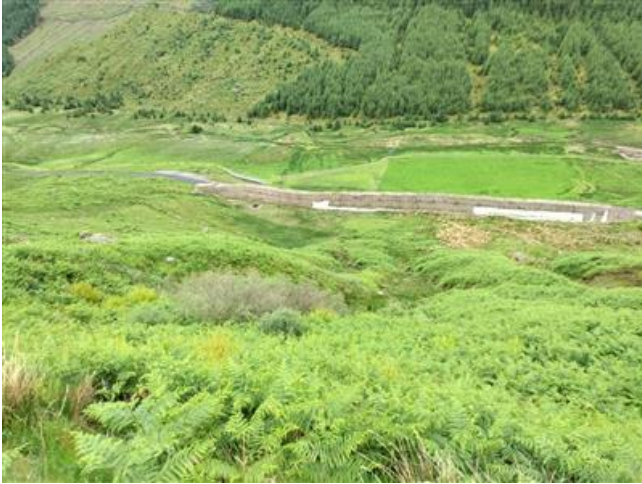
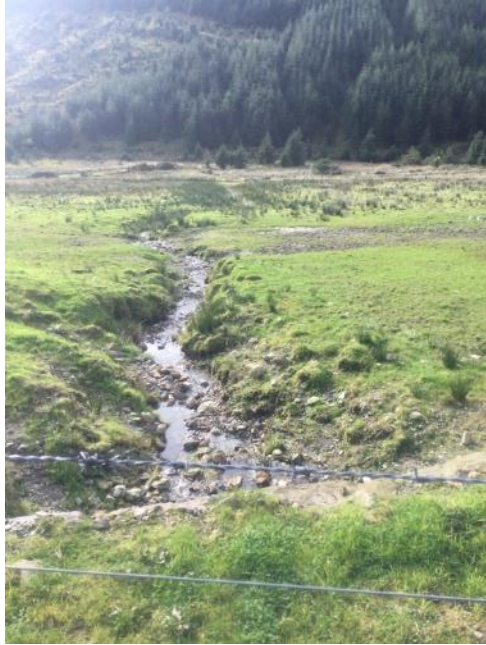
Watercourse ID	A83_ML_022_000
Corresponding OMR crossing ID	OMR_19
Watercourse categorisation	Minor B (Not on OS 1:25,000 scale map)
Geomorphological risk categorisation	Medium
WFD Catchment	The Croe Water (ID: 10215)
Catchment area to the A83 (km ²)	0.005
Watercourse length from A83 to OMR (m)	250
Existing A83 culvert (Capacity)	Pipe culvert, 0.375 m diameter (>200-yr + CC fluvial event)
View from the A83 down the watercourse towards the HESCO bund	Plane-bed/riffle-pool sequence along the lower reach and after the confluence with the A83_ML_023_000 (looking downstream towards the High Glencroe channel)

Processes: The current culvert can accommodate fluvial flows up to a 200-year event. Although direct surveying of the culvert has not been possible due to access restrictions, aerial imagery and terrain analysis show a defined channel downstream of the A83 culvert. The upper reach, depicted in the right figure, features a step-pool sequence. Similarly, the lower reach has evidence of confinement but with a plane-bed channel morphology.

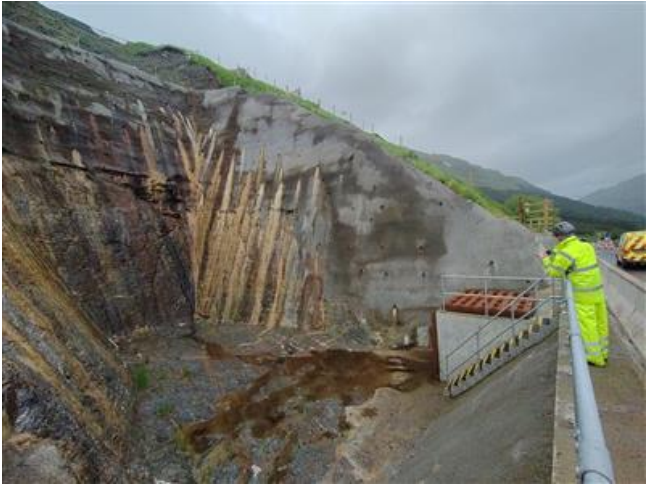
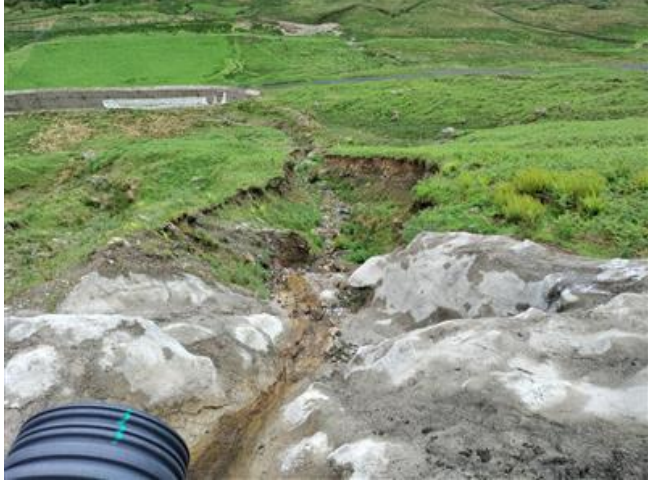
Watercourse ID	A83_ML_023_000
Corresponding OMR crossing ID	OMR_20
Watercourse categorisation	Minor A (On OS 1:25,000 scale map)
Geomorphological risk categorisation	High
WFD Catchment	The Croe Water (ID: 10215)
Catchment area to the A83 (km ²)	0.014
Watercourse length from A83 to OMR (m)	185
Existing A83 culvert (Capacity)	Pipe culvert, 0.45 m diameter (>200-yr fluvial event)
Catchpit upstream of the A83. Raised inlet with grated front and top face (Approx 3m x 3m with 190mm grate spacing).	Looking down the watercourse from the A83 at the spraycrete apron and the heavily incised channel.

<p>Description: Upslope of the A83 is a catchpit formed from bedrock and concrete (left image) which has been created to attenuate debris flows and provide resilience to the operation of the A83. The watercourse exhibits a steep gradient, with an average of 54% (up to 187%) in the section downstream of the A83 culvert. The A83 culvert outlet is a protruding plastic pipe that discharge to a 12 m spraycrete apron. The downstream watercourse is over widened and deepened due to the conveyance of debris flows extending to the OMR. The catchpit and downstream apron were installed following a large debris flow event in 2020 which caused headward erosion which started to undermine the A83. The morphology of the upper reach primarily features cascade/step-pool sequences. Upstream of the OMR, the</p>

Processes: The channel at the northern extent of the HESC bound features step-pool sequences within an over-widened, debris flow channel. The fluvial channel is well established with no evidence of erosion into the over deepened cross section of the debris flow channel. Historically this channel would have continued directly under the OMR, however, is now diverted south due to the presence of the HESCO bund. The historic, downstream channel is now grass lined (right-hand figure) due to a lack of fluvial erosion and deposition.

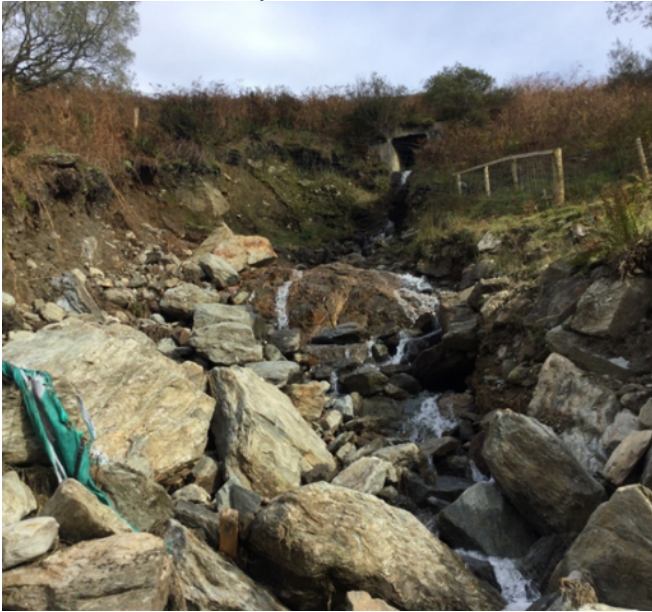
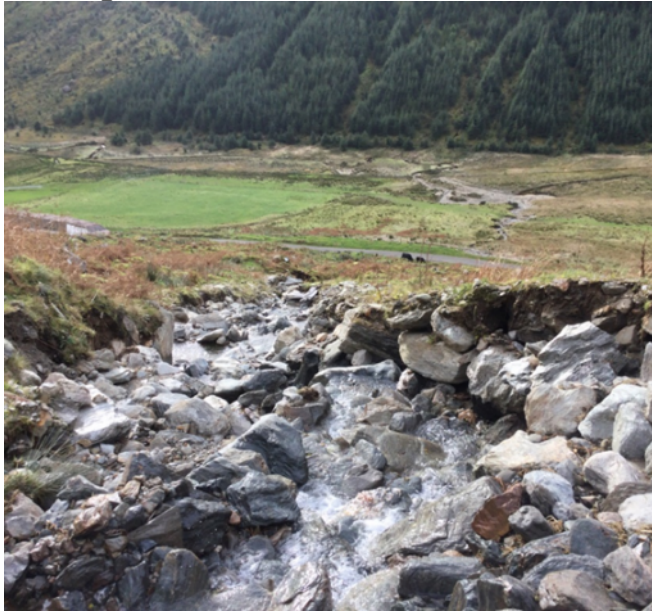
Watercourse ID	A83_ML_024_000
Corresponding OMR crossing ID	OMR_21
Watercourse categorisation	Major (On OS 1:50,000 scale map)
Geomorphological risk categorisation	High
WFD Catchment	The Croe Water (ID: 10215)
Catchment area to the A83 (km ²)	0.207
Watercourse length from A83 to OMR (m)	158
Existing A83 culvert (Capacity)	1.2 m (W) x 1.4 m (H) box (>200-yr fluvial event)
A83 culvert outlet perched due to scour	Looking down the watercourse towards OMR

Processes: The existing culvert has sufficient capacity to convey fluvial flows greater than the 200-year event, indicating that the jetting effects from hydrological flows at this culvert would most likely occur during very exceptional, infrequent, flood events. This watercourse is located within an active debris flow channel, with the last debris flow event experienced in October 2023. During debris flow events significant volumes of water and entrained sand and cobbles pass through the culvert causing the greatest rates of erosion and scour. This is exacerbated when a debris flow event blocks one or more culverts within the upstream catchpit meaning one culvert may have to convey flows that originate from multiple valleys/watercourses. This was the case in October 2023 with A83_ML_024_000 conveying three valleys worth of flow due to culvert blockages.

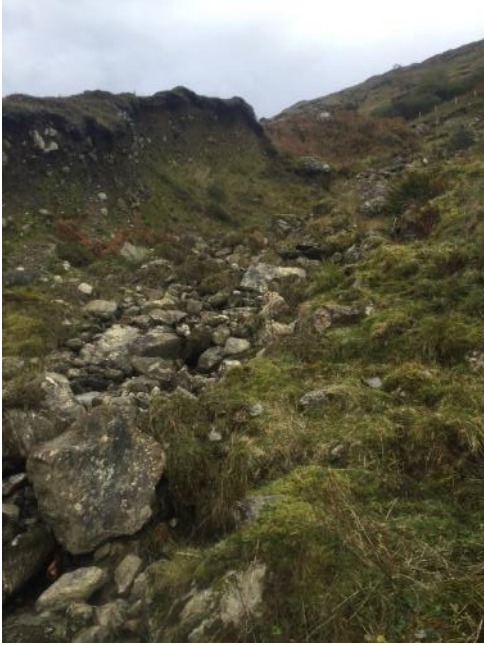
(~30-yr fluvial event)
<p>Looking upstream of the OMR towards the A83</p>

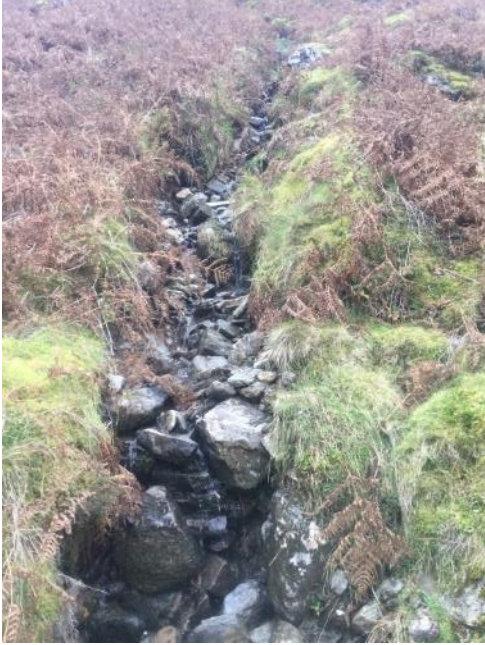
(<2-yr fluvial event)
<p>Upper reach seen from OMR (looking towards the A83)</p>

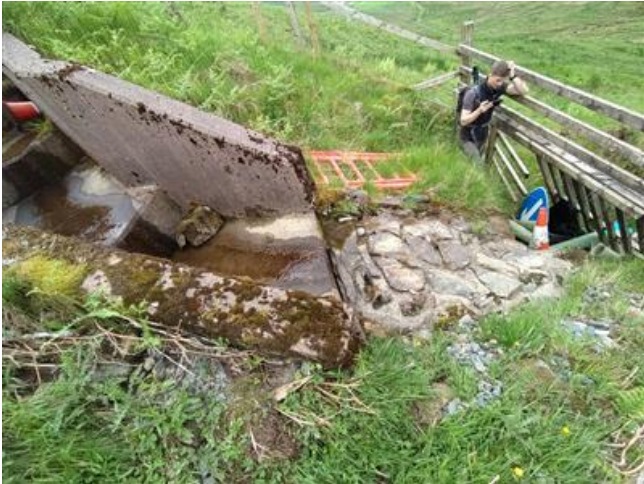
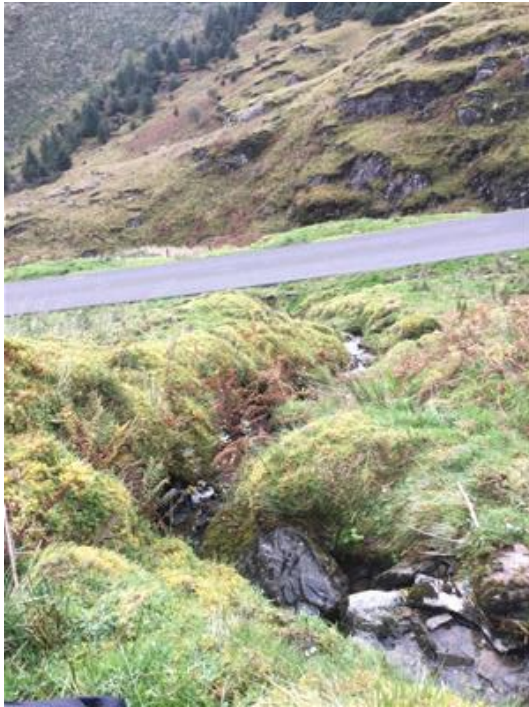
Watercourse ID	A83_ML_029_000
Corresponding OMR crossing ID	OMR_29
Watercourse categorisation	Minor A (On OS 1:25,000 scale map)
Geomorphological risk categorisation	Medium
WFD Catchment	The Croe Water (ID: 10215)
Catchment area to the A83 (km ²)	0.041
Watercourse length from A83 to OMR (m)	99
Existing A83 culvert (Capacity)	Box culvert 1.7 m (W) x 1.3 m (H) (>200-yr + CC fluvial event)
Upper reach, showing the transition from the cascade to the natural channel	Lower down the final third of the watercourse towards the OMR

<p>Description: This watercourse heavily modified both upstream and downstream of the A83 (left figure). Upstream of the A83 there is straight, 30 m, concrete cascade (1:1) that directs flow to the A83 culvert. Downstream of the A83 the culvert discharges to a ~17 m concrete cascade that doglegs flow to the north before a drop of approximately 1.5 m to the natural channel. The watercourse exhibits a steep gradient, with an average of 48% (0.48 m/m), up</p>

Processes: The current culvert can accommodate fluvial flows up to a 200-year event. As described above, the upper section of the watercourse from the A83 culvert outlet is heavily modified (left figure). The transition to the natural channel is abrupt, with a 1.5 m drop caused by historic erosion. This erosion does not seem to be on going and the remainder of the channel to the OMR is relatively stable, though there was evidence that high-flows may spill out of bank and flow over the grassed surface. Downstream of the OMR shows less steep morphology. The upper reach, depicted in the right figure, features a step-pool sequence.

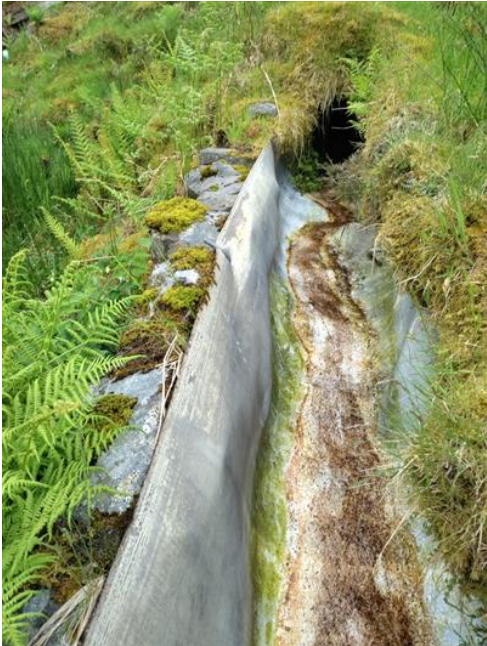
(~2-yr fluvial event)
<p>A83 culvert outlet</p>

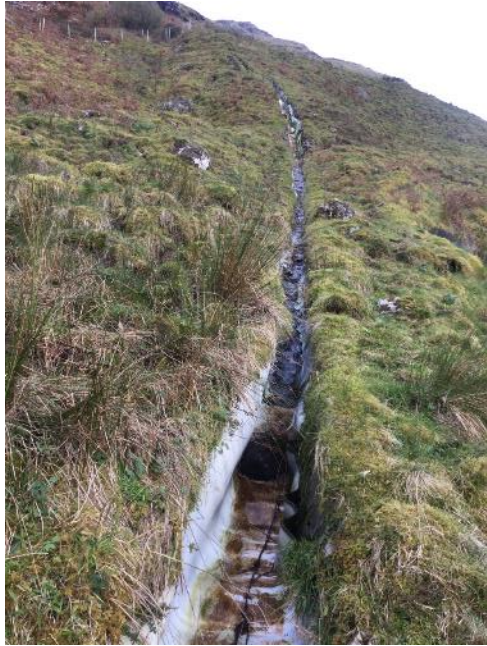
<p>Looking upstream towards the A83</p>

<p>Description: The whole reach of this watercourse, between the A83 and OMR, consists of a fibreglass channel with a continuous lining of the bed and banks. The watercourse exhibits a steep gradient, with an average of 42% (0.42 m/m) and peaks over 100% (1.2 m/m) in the upper reach, above the OMR. This watercourse has a confluence with A83_ML_031_000 immediately upstream of the OMR. The watercourse downstream of the OMR is as described for A83_ML_031_000.</p> <p>Processes: The current A83 culvert can only accommodate fluvial flows up to the 2-year event. There are no signs of jetted flows through the A83 culvert. As described previously, the channel is lined by fibreglass and is very steep so there are no natural processes at all within this channel between the A83 and OMR.</p>

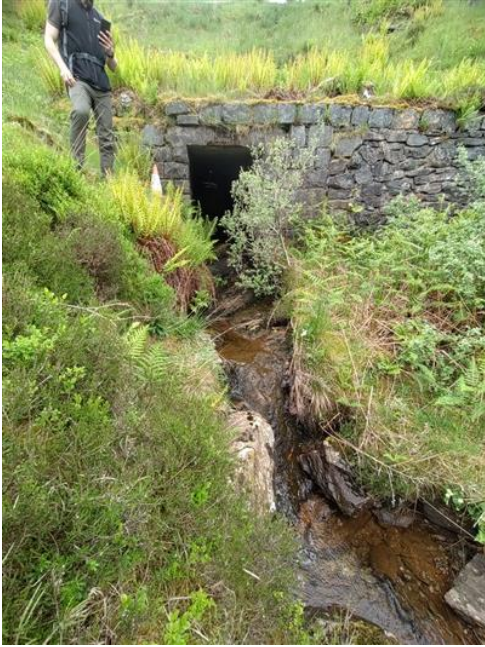
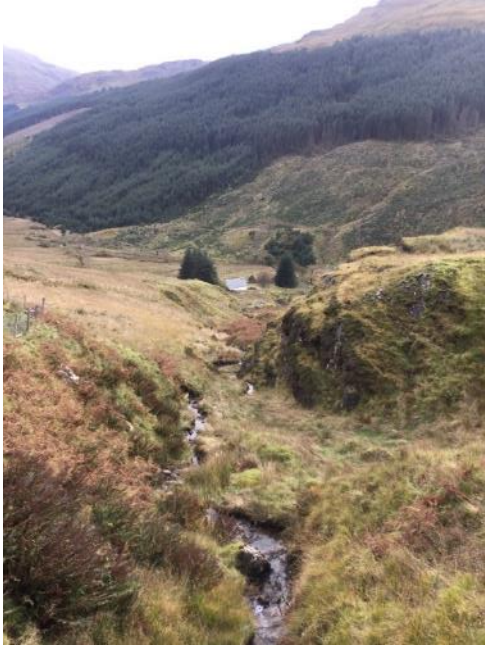
Watercourse ID	A83_ML_031_000
Corresponding OMR crossing ID	OMR_30
Watercourse categorisation	Major (On OS 1:50,000 scale map)
Geomorphological risk categorisation	Medium
WFD Catchment	The Croe Water (ID: 10215)
Catchment area to the A83 (km ²)	0.129
Watercourse length from A83 to OMR (m)	109
Existing A83 culvert (Capacity)	Box culvert 1.2 m (W) x 1.5 m (H) (>200-yr + CC fluvial event)
Upper reach (looking upstream towards the A83)	Lower reach (looking downstream towards the main channel)

<p>Description: There is a box culvert beneath the A83 that is constructed from stone blocks and has a bedrock base. This culvert discharges to a bedrock cascade, which is the dominant morphology of the upper reach between the A83 and OMR culvert. The watercourse is very steep, with an average gradient of 36% (0.36 m/m) and peaks of more than 200% (2 m/m) in the upper reach. This watercourse has a confluence with A83_ML_030_000 immediately upstream of the OMR bridge crossing. The reach below the</p>

Processes: The A83 culvert can accommodate fluvial flows up to a 200-year event. The culvert discharges to a sequence of step-pool cascades, consisting of large 1.5 m steps at 4 m interval. Within the 4 m interval, smaller, 0.4 m, steps were observed at approximately 1 m to 1.5 m spacing. The lower reach downstream of the OMR shows a less steep morphology (compared to upstream), with step pool sequences, as shown in the right-hand figure. Other than the culvert and OMR bridge crossing, the watercourse is natural and is not experiencing excessive scour/ erosion.

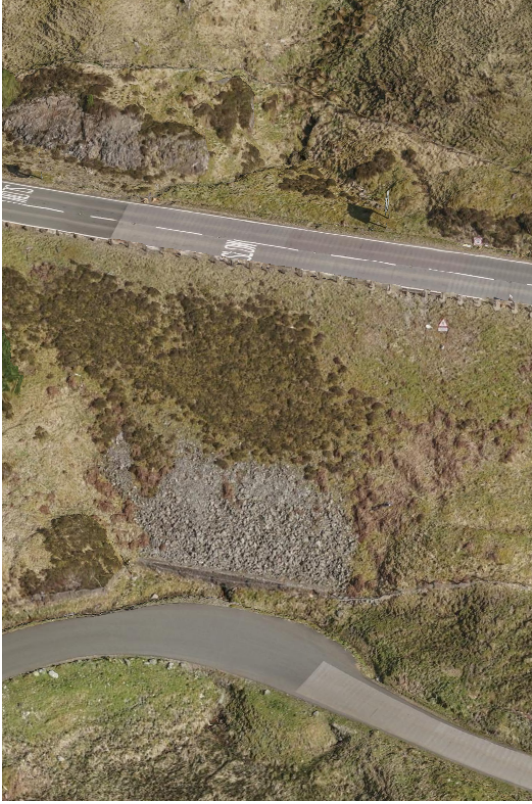
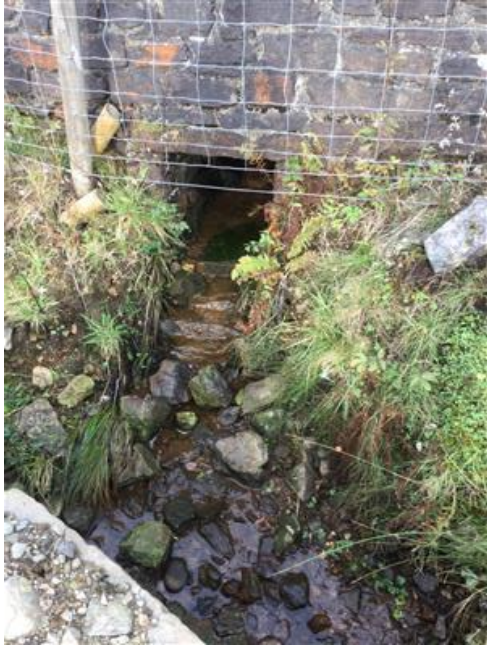
Watercourse	Sensitivity	Justification
A83_ML_033_000	Low	This watercourse is culverted the entire distance from upstream of the A83 to the OMR. The culvert discharges to an artificial drainage channel for approximately 2 m before it then enters a second culvert below the OMR. A defined channel does not begin until approximately 22 m downstream of the OMR (as observed from aerial imagery).
A83_ML_033_B02	Low	There is culvert draining beneath the OMR with a very small upstream area which includes the RaBT carpark. From the available photographic evidence there appears to be limited sediment being transported through the culvert so a catchpit is deemed unnecessary.
A83_ML_033_B03	Low	There is a culvert beneath the OMR which is draining a very small triangle of land within the hairpin bend of the OMR, discharging to a vegetated area of land.
A83_ML_034_000	Low	The A83 culvert inlet is located within a poorly-defined drainage channel that runs in parallel to the A83. It was not possible to locate the inlet during a site visit due to the vegetation and detritus within the drainage ditch. The buildup of in-channel vegetation is likely to be impacting the efficiency of the conveyance of flows into the culvert. The culvert outlet was observed to have collapsed.

Watercourse ID	A83_ML_033_000
Corresponding OMR crossing ID	OMR_34
Watercourse categorisation	Minor B (Not on OS 1:25,000 scale map)
Geomorphological risk categorisation	Low
WFD Catchment	The Croe Water (ID: 10215)
Catchment area to the A83 (km ²)	0.02
Watercourse length from A83 to OMR (m)	Approximately 25 m and wholly culverted
Existing A83 culvert (Capacity)	Pipe culvert, 0.4 m diameter (~25-yr fluvial event)
Aerial image of A83_ML_033_000 with the A83 and OMR shown	A83 culvert outlet, immediately upstream of the OMR culvert inlet

Description: This watercourse is wholly culverted from upstream of the A83 to the OMR. The culvert discharges to an artificial drainage channel, where the flow is 'open' to the daylight for approximately 2 m before it then enters a second culvert below the OMR.

Processes: The current culvert can accommodate fluvial flows up to a 25-year event. As outlined above, the watercourse is culverted for nearly the whole of the reach beneath the A83 through to the downstream of the OMR, with only a short, 2 m, section of daylighted watercourse. Within the 2 m section of daylighted channel there is a variety of substrate from sands through to cobbles (Right hand picture), though the sediments were not assessed in detail for this watercourse. Upslope of the A83 there is no well-defined channel, rather there is a wet/boggy, vegetated, thalweg that drains to the A83 (As observed from aerial imagery). The OMR culvert on this watercourse does not discharge to a well-defined channel, it discharges to a wet boggy area, which is at a comparatively low gradient of 13% (0.127 m/m). A formal, defined, channel does not begin until approximately 22 m downstream of the OMR (As observed from aerial imagery).
