A83 Rest and Be Thankful

LTS EIAR VOLUME 4, APPENDIX 19.3 - ROAD DRAINAGE AND
THE WATER ENVIRONMENT BASELINE

A83AAB-AWJ-EAC-LTS_GEN-RP-LE-000294

A19-3.Road Drainage and the Water Environment Baseline

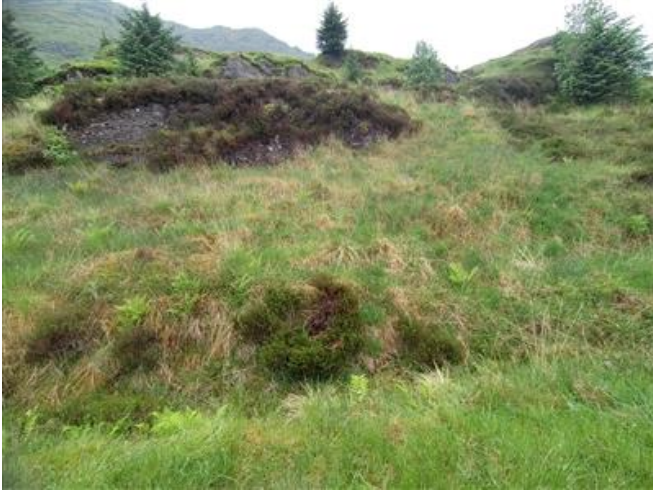
<p>Description: This crossing beneath the B828 consists of a 650 mm corrugated plastic pipe. The upstream channel has a gradient of approximately 10% (0.0986 m/m) with a much lower gradient of 0.16% (0.00165 m/m) over the first 20 m downstream of the culvert. The main upstream fluvial channel is joined by an artificial drainage ditch that runs in parallel to the B828 from the north-east capturing the upslope runoff. The bed substrate consists of cobbles and sands. The culvert is running clear and there is no deposition of material upstream or through the culvert barrel. The channel is well defined, both upstream and down, with well vegetated banks and no obvious signs of scour erosion.</p>

Watercourse ID	A83_B8_002_000
Corresponding OMR crossing ID	n/a
Watercourse categorisation	Minor B (Not on OS 1:25,000 scale map)
Geomorphological risk categorisation	Low
WFD Catchment	The Croe Water (ID: 10215)
Catchment area to the B828 (km ²)	
Watercourse length from A83 to OMR (m)	n/a
Existing A83 culvert (Capacity)	n/a
Photo looking upstream.

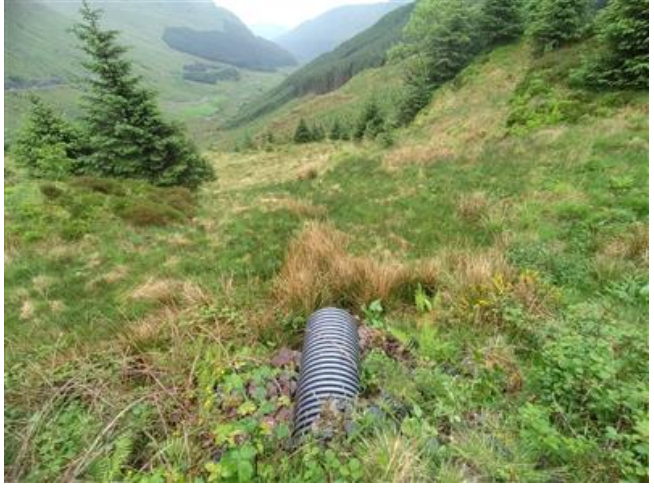
<p>Description: This crossing beneath the B828 consists of 450 mm corrugated plastic pipe. The channels upstream and downstream are poorly defined, though, there is an artificial drainage ditch approx. 0.5 m deep, 1 m wide running in parallel with the B828 that crosses the slope, running to the south west, and intercepting any upslope runoff. There is likely a bend or kink in the culvert alignment as no daylight could be seen through it. The culvert outlet protrudes by approximately 5 m from road embankment. The culvert outlet is elevated/perched by approximately 1 m from the underlying ground. There are boulders and cobbles at the outlet where the flows drop to, however, there is no significant evidence of scour erosion.</p>

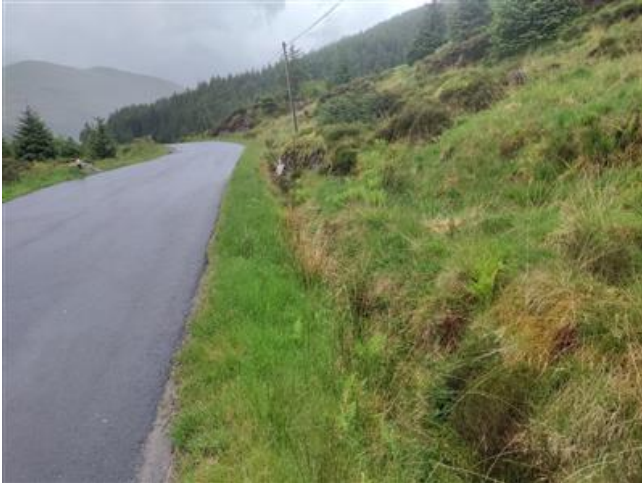
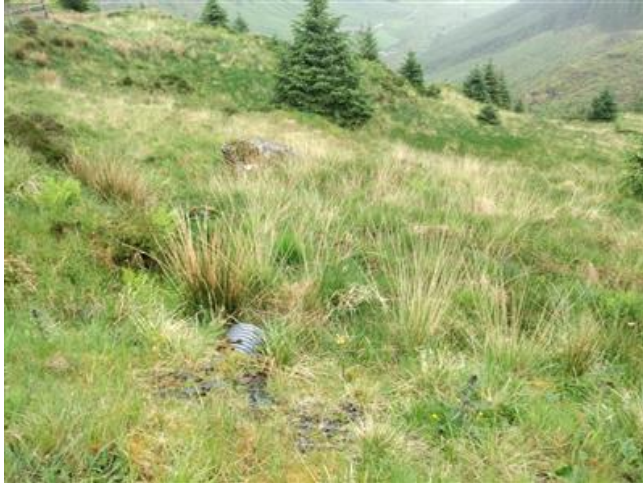
Watercourse ID	A83_B8_003_000
Corresponding OMR crossing ID	n/a
Watercourse categorisation	Minor B (Not on OS 1:25,000 scale map)
Geomorphological risk categorisation	Low
WFD Catchment	The Croe Water (ID: 10215)
Catchment area to the A83 (km ²)	
Watercourse length from A83 to OMR (m)	N/A
Existing A83 culvert (Capacity)	
Upstream channel/drainage ditch	Culvert outlet and downslope.

<p>Description: This crossing beneath the B828 consists of 300 mm corrugated plastic pipe. The channels upstream and downstream are poorly defined, though, there is an artificial drainage ditch approx. 0.5 m deep, 1 m wide running in parallel with the B828 that crosses the slope, running to the south west, and intercepting any upslope runoff. No 'in channel' sediment to characterise as upslope and downslope are vegetated extensively.</p>

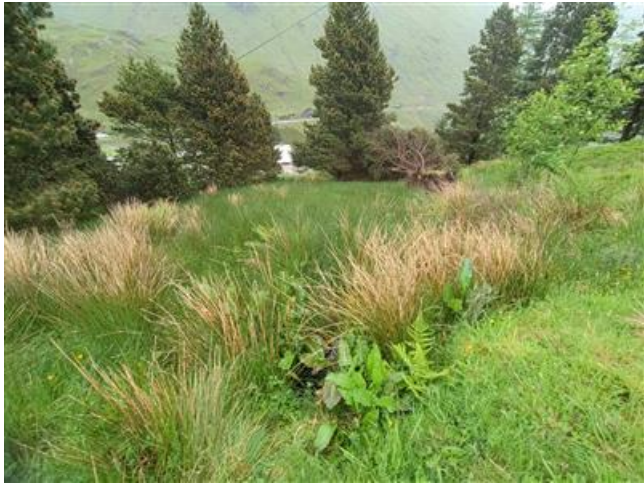
Watercourse ID	A83_B8_004_000
Corresponding OMR crossing ID	n/a
Watercourse categorisation	Minor B (Not on OS 1:25,000 scale map)
Geomorphological risk categorisation	Low
WFD Catchment	The Croe Water (ID: 10215)
Catchment area to the A83 (km ²)	
Watercourse length from A83 to OMR (m)	N/A
Existing A83 culvert (Capacity)	
Culvert Inlet	Culvert outlet

<p>Description: This crossing beneath the B828 consists of a 500 mm corrugated plastic pipe. poorly defined outlet. disperses across the slope making a boggy area. The channels upstream and downstream are poorly defined, though, there is an artificial drainage ditch approx. 0.5 m deep, 1 m wide running in parallel with the B828 that crosses the slope, running south to north, and intercepting any upslope runoff. No 'in channel' sediment to characterise as upslope and downslope are vegetated extensively.</p>

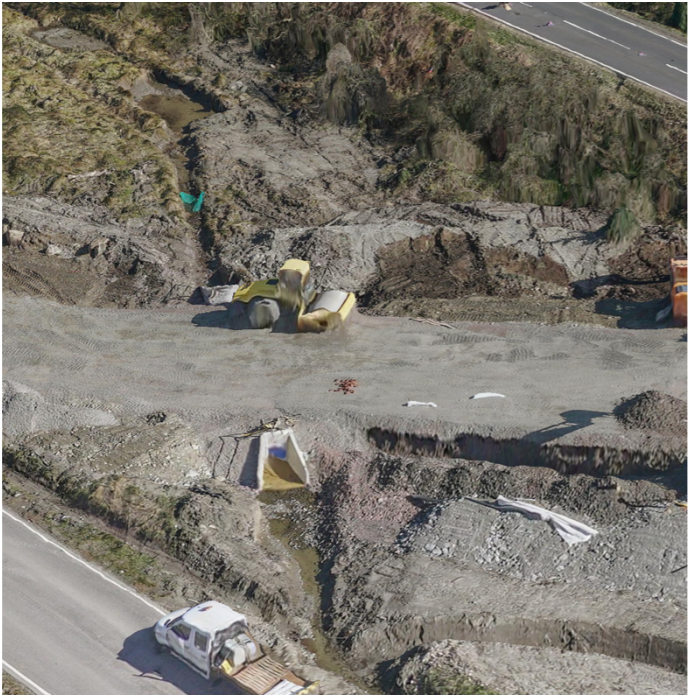
Watercourse ID (OMR Culvert reference)	Watercourse photo or aerial image	Watercourse characterisation and improvements to the OMR that could impact the watercourse
A83_ML_Z05_B01 (OMR_01)

<p>This watercourse has been modified by works that have already been undertaken to increase the resilience of the OMR to flooding. This work has included the construction of a new access road, approximately 85 m north of the existing access that links the A83 to the southern extent of the OMR. The watercourse has had to be realigned both in plan form and vertically to accommodate the new road and convey the water through a new culvert. These works are now complete (completed in 2024).</p> <p>The realigned watercourse consists of a two-stage channel cross section upstream of the culvert crossing that can accommodate lower/moderate flows and higher flows without excessive erosion. Boulder bed checks (250-300 mm) have been included, buried (flush with the bed), and installed every 3-4 m to minimise the risk of a knick point migration.</p> <p>The watercourse has been assessed as unsuitable for fish and otters.</p>

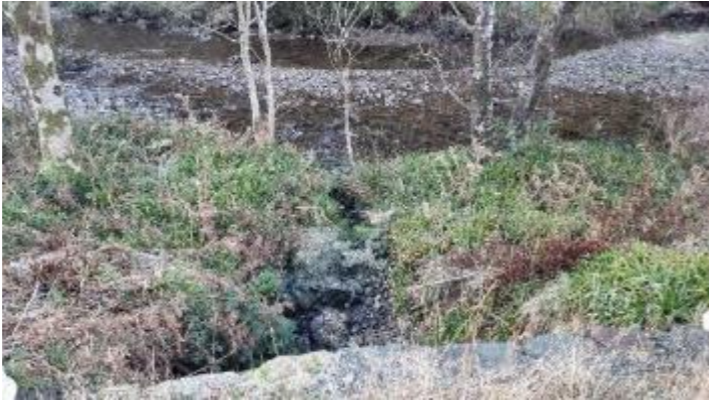
A83_ML_Z05_B02 (OMR_02)

<p>The channels are well vegetated, there are no obvious signs of erosion or deposition within the channel. The culvert is not being resized and is not affected by a build-up of material within the barrel, as long as the current level of maintenance is continued there is no need for additional measures. The culvert outlet is approximately 2 m to the Croe Water. The watercourse is unsuitable for fish and otters.</p>

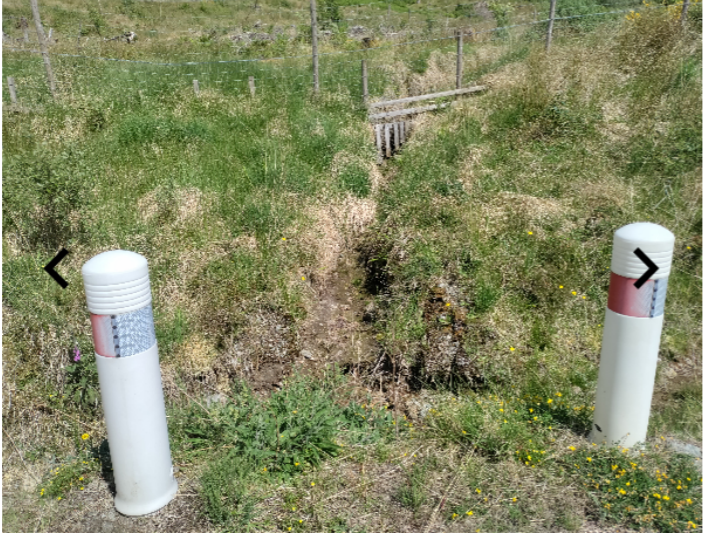
Watercourse ID (OMR Culvert reference)	Watercourse photo or aerial image	Watercourse characterisation and improvements to the OMR that could impact the watercourse
A83_ML_Z05_B03 (OMR_03)

<p>No improvements to the OMR are proposed that will affect this watercourse.</p> <p>The channels are well vegetated, there are no obvious signs of erosion or deposition within the channel. The culvert is not being resized and is not affected by a build-up of material within the barrel, as long as the current level of maintenance is continued there is no need for additional measures. There is only 6 m of channel from the culvert outlet to the Croe Water. The watercourse is unsuitable for fish and otters.</p>
A83_ML_Z05_B04 (OMR_04)

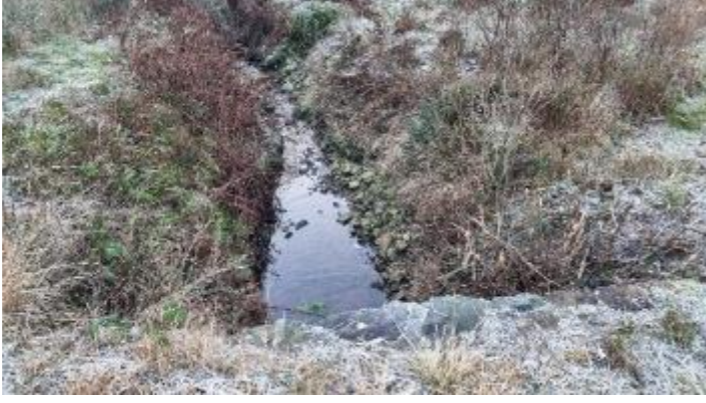
<p>No improvements to the OMR are proposed that will affect this watercourse.</p> <p>The channel is well vegetated, there are no obvious signs of erosion or deposition within the channel. The culvert is not being resized and is not affected by a build-up of material within the barrel, as long as the current level of maintenance is continued there is no need for additional measures. The watercourse is unsuitable for fish and otters.</p>

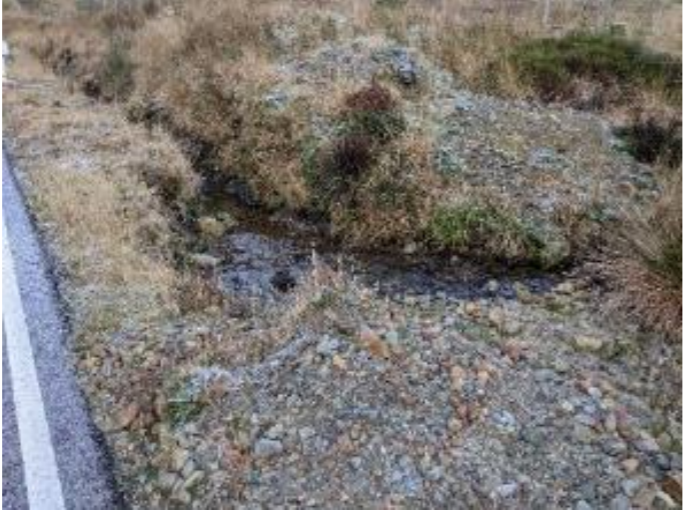
Watercourse ID (OMR Culvert reference)	Watercourse photo or aerial image	Watercourse characterisation and improvements to the OMR that could impact the watercourse
A83_ML_Z05_B05 (OMR_05)

<p>No improvements to the OMR are proposed that will affect this watercourse.</p> <p>The channels are well vegetated, there are no obvious signs of erosion within the channel. However, the upstream photo show a lot of deposited material that looks like it has been removed from the channel, close to the culvert entrance. The culvert is not being resized and is not affected by a build-up of material within the barrel, as long as the current level of maintenance is continued at the upstream of the culvert there is no need for additional measures. The watercourse is unsuitable for fish and otters.</p>
A83_ML_Z05_B06 (OMR_06)

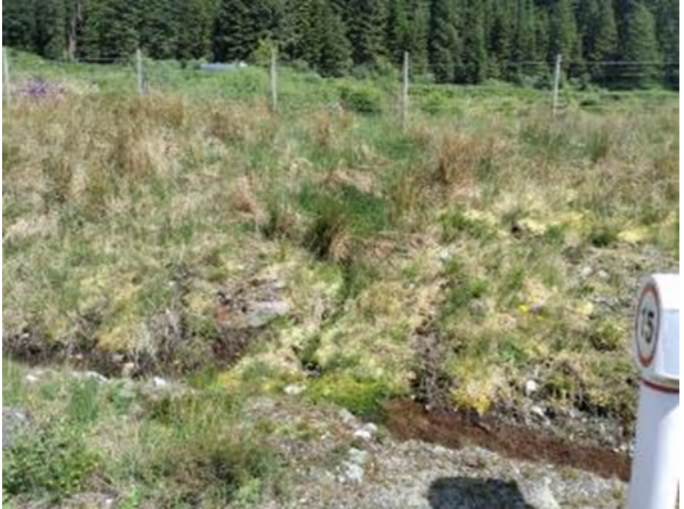
<p>No improvements to the OMR are proposed that will affect this watercourse.</p> <p>The channel is well vegetated, there are no obvious signs of erosion or deposition within the downstream channel. Upstream, in June, there was a lot of in channel vegetation that potentially needs managing to ensure culvert capacity is maintained if there were to be a high intensity summer storm. The culvert is not being resized and is not affected by a build-up of material within the barrel, therefore no need for additional measures. The watercourse is unsuitable for fish and otters.</p>

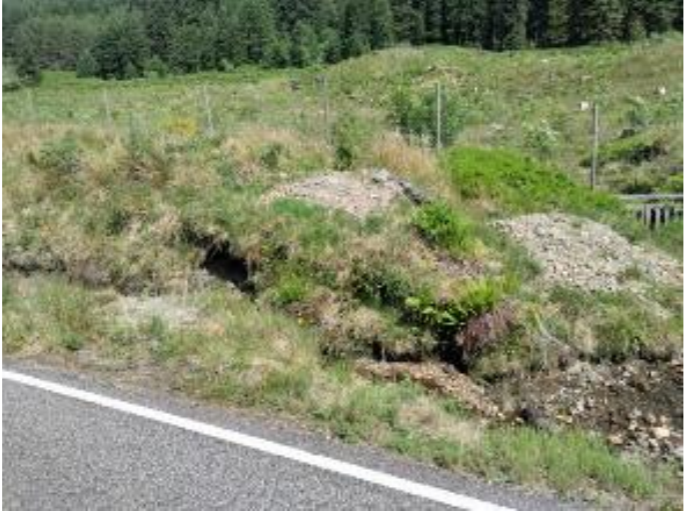
Watercourse ID (OMR Culvert reference)	Watercourse photo or aerial image	Watercourse characterisation and improvements to the OMR that could impact the watercourse
A83_ML_008_A01 (OMR_07)

<p>No improvements to the OMR are proposed that will affect this watercourse.</p> <p>The channel is well vegetated, there are no obvious signs of erosion within the channel. The culvert is not being resized and is not affected by a build-up of material within the barrel. However, there was evidence that the upstream is maintained with sediment being removed and deposited on the bank. Either this continues to be managed to maintain culvert capacity or therefore no need for additional measures to ensure the resilience of the OMR.</p> <p>Electric fishing surveys undertaken in August 2023 recorded 35 brown trout in a 100 m² section below the OMR (preliminary data - age class / length not currently known). Upstream of the OMR fish habitat is poor, with low flows and high gradient (~ 19% average slope) which makes this section unsuitable for fish. Watercourse has suitability for otters.</p>

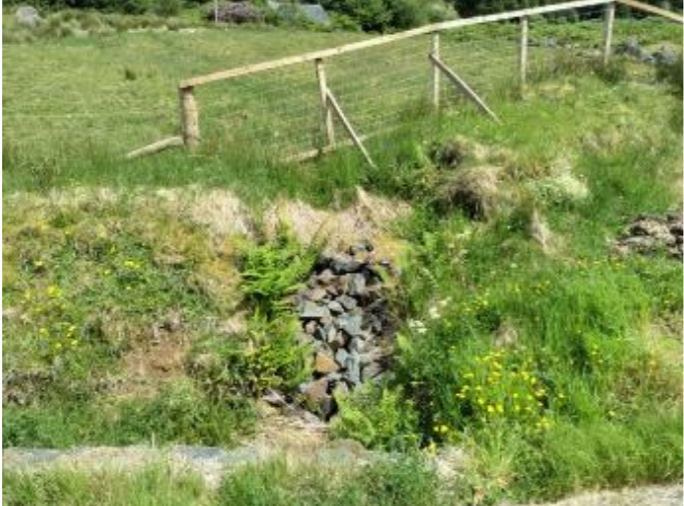
A83_ML_010_B02 (OMR_08)

<p>The OMR and therefore the culvert that passes beneath it will be widened/lengthened in the upslope direction.</p> <p>The channels are well vegetated, there are no obvious signs of erosion or deposition within the downstream channel. Large cobbles have been placed in the upstream approach likely to mitigate a scour issue. Other than the drain in parallel to the OMR there is no well-defined watercourse draining to the culvert. Rather, the culvert has been installed to coincide with the thalweg in the upslope field in which overland flows will concentrate. Historically there looks to have been some erosion where the thalweg joins the drain which has now been infilled with cobbles/larger material. There is no evidence of ongoing scour but this should be monitored.</p> <p>The watercourse is unsuitable for fish and otters.</p>

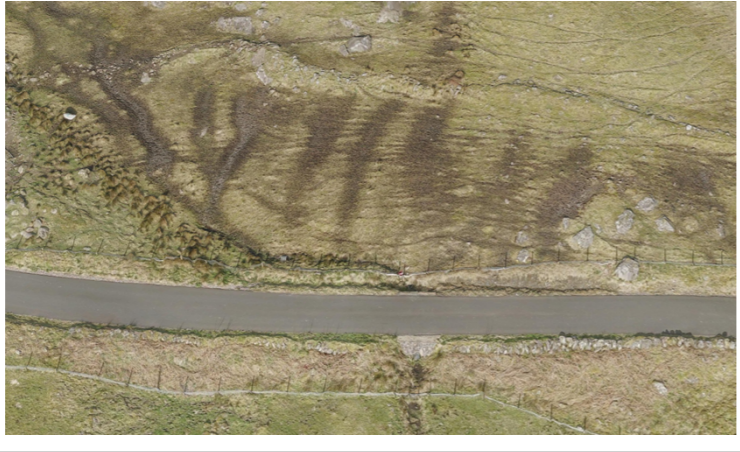
Watercourse ID (OMR Culvert reference)	Watercourse photo or aerial image	Watercourse characterisation and improvements to the OMR that could impact the watercourse
A83_ML_012_B03 (OMR_12)

<p>This culvert is being extended in both the upstream (3.88 m) and downstream (4.81 m) directions. The upstream extension and earth works associated with the widening of the OMR requires the drainage ditch that currently runs in parallel with the OMR to be realigned. There is no significant inflowing channel to this culvert, rather, the drainage ditch captures the overland flows from the toe of the slope between the OMR and A83. There is no evidence of bed material being deposited upstream or within the culvert. No catchpit required. The channel downstream is well vegetated and there is no significant erosion, however modelled outlet velocities are high so d/s scour protection is recommended.</p> <p>The watercourse is unsuitable for fish and otters.</p>

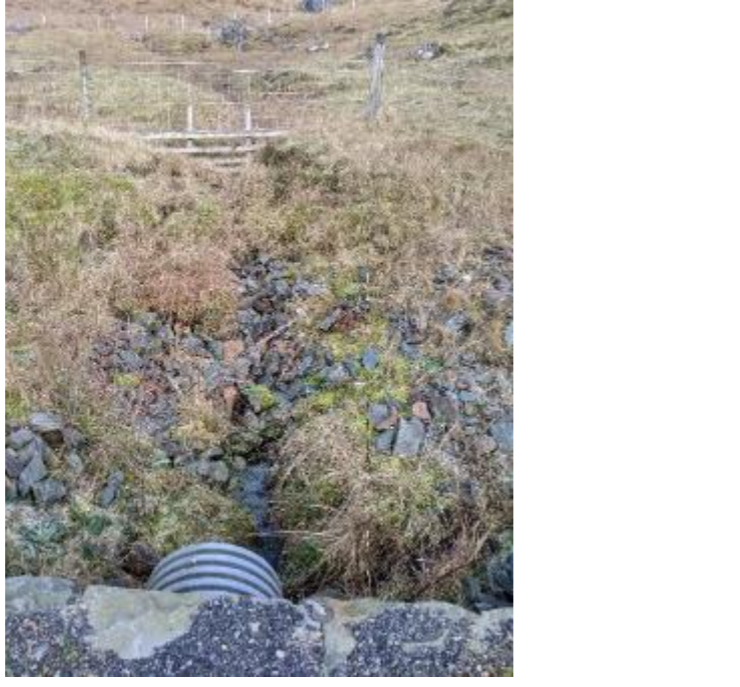
A83_ML_017_B01 (OMR_15)

<p>This culvert is not being upsized, however is being extended by 14.35 m downslope. There doesn't seem to be an issue with upstream deposition and the barrel of the culvert is running clear, therefore no catchpit required. The channel downstream is incised but no erosion issue evident so no need for downstream protection. Large cobbles have been placed upstream, likely to mitigate scour effects.</p> <p>The watercourse is unsuitable for fish and otters.</p>

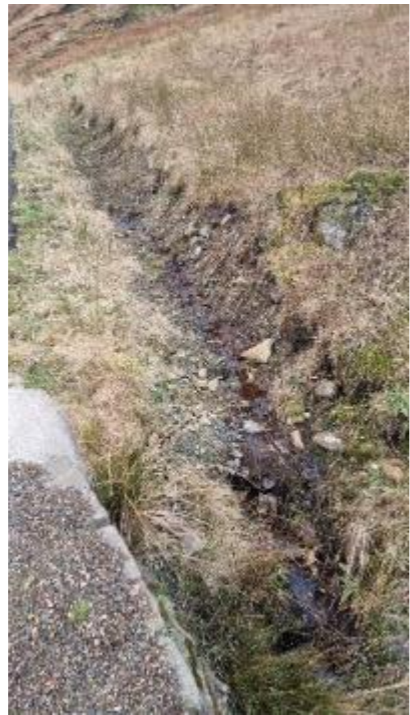
Watercourse ID (OMR Culvert reference)	Watercourse photo or aerial image	Watercourse characterisation and improvements to the OMR that could impact the watercourse
A83_ML_024_B01 (OMR_22)

<p>The channel upstream of the OMR is a very straight maintained drainage ditch with a uniform profile which collects overland flows from between the A83 and OMR. Downstream of the culvert the channel seems to be well vegetated and there does not seem to be an obvious issue with erosion or deposition of bed material.</p> <p>The watercourse is unsuitable for fish and otters.</p>
A83_ML_026_B01 (OMR_24)

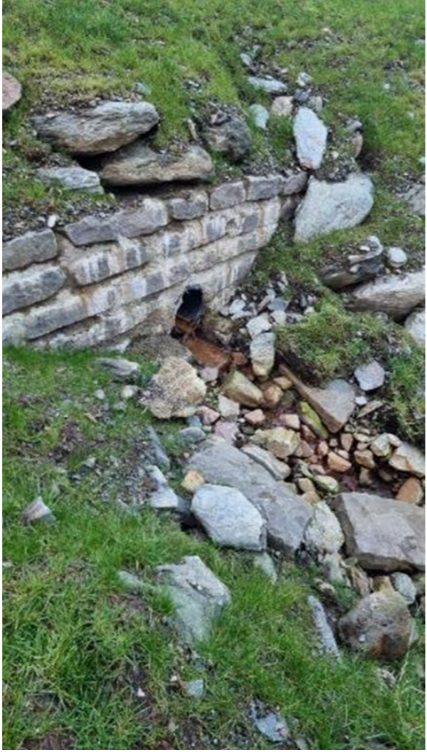
Watercourse ID (OMR Culvert reference)	Watercourse photo or aerial image	Watercourse characterisation and improvements to the OMR that could impact the watercourse
A83_ML_033_B02 (OMR_35)

<p>This culvert drains a very small upstream area, which includes the RaBT carpark, and from the available photographs there looks to be limited sediment/bed material being transported through the culvert and the barrel of the culvert appears to be free from any build-up of material. The modelling of this culvert indicates the exit velocities from the culvert are high at 1.46 m/s for the 50 year flow, which has the potential to cause erosion, therefore the placing of larger cobble/boulder material over the first 2/3 m at the culvert exit would help to dissipate the energy in the flow. The culvert is being dropped by 0.04 m to maintain the required depth of material between the culvert crown and the road deck, this will not require upstream watercourse realignments.</p> <p>The watercourse is unsuitable for fish and otters.</p>

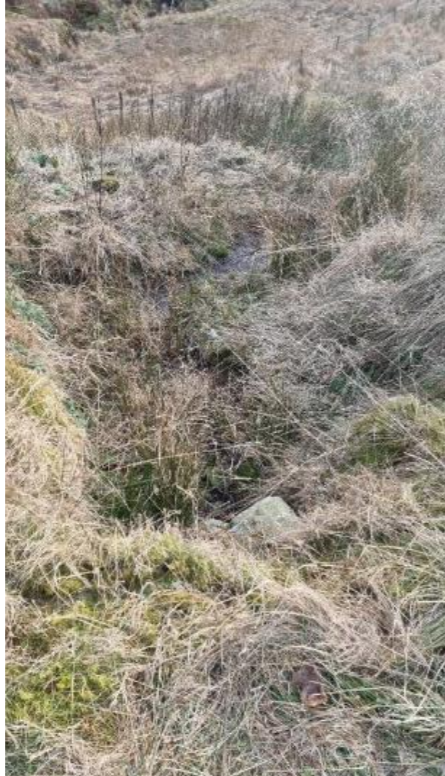
Watercourse ID (OMR Culvert reference)	Watercourse photo or aerial image	Watercourse characterisation and improvements to the OMR that could impact the watercourse
A83_ML_033_B03 (OMR_36)

<p>This watercourse appears to be draining a very small triangle of land within the hairpin bend of the OMR. On a site visit there was no evidence of significant sediment being transported through the OMR culvert. The channel downstream of the OMR culvert is well vegetated and there doesn't seem to be a significant amount of active erosion, based on the site photos.</p> <p>The watercourse is unsuitable for fish and otters.</p>
