Scottish Road Research Board

EARLY LIFE PAVEMENT FAILURES

PROJECT NO. TS/TRBO/SER/2017/04/12

DATE: MARCH 2024

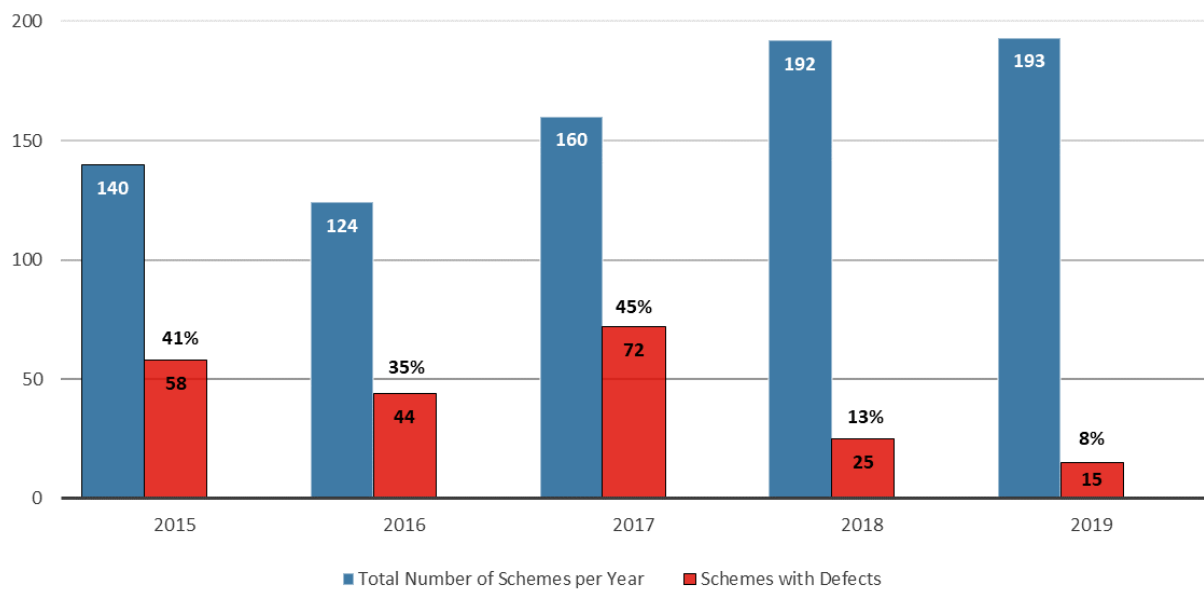
Figure 2-1 – Annual number of schemes and proportion with defects (2015-2019)

Figure 2-1 shows the annual number of structural maintenance schemes (coloured blue) that were completed in each year between 2015 and 2019. The histogram also shows the associated number of schemes where Cat 1 and Cat 2 defects were recorded (coloured red) over the five-year period.

The number of schemes with defects is aggregated over the five-year period, so it is expected that older schemes will record more defects than the younger schemes. However, it is notable that schemes constructed in 2017 recorded a comparably higher number of defects.

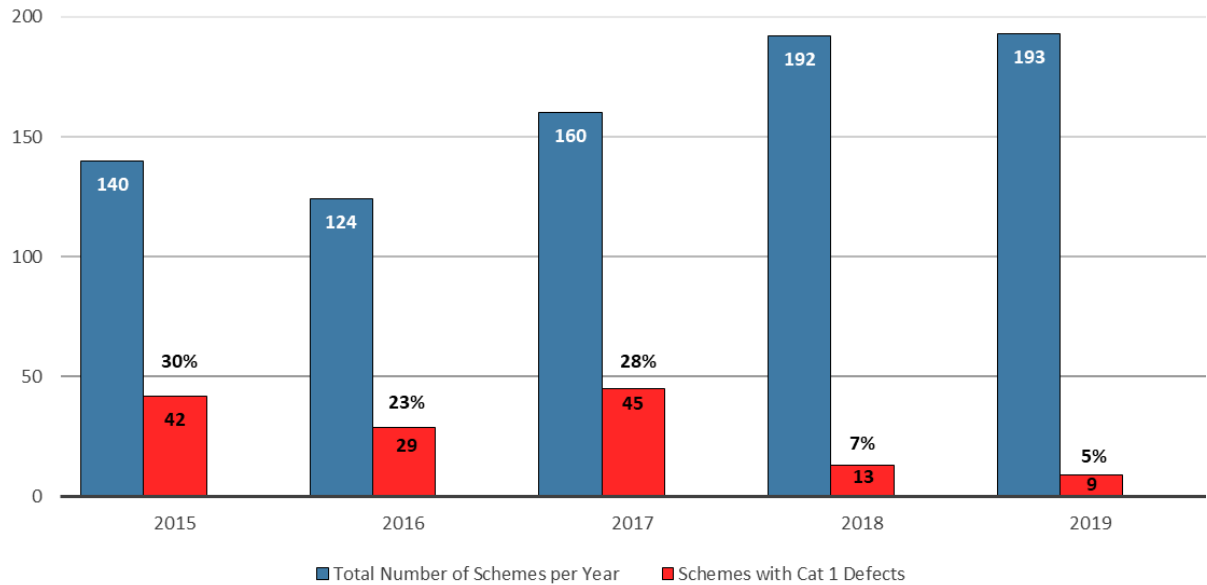
Figure 2-2 - Annual number of schemes and proportion with Cat 1 defects (2015-2019)

The histogram in Figure 2-2 shows the number of schemes that recorded Cat 1 defects over the five-year period. It can be seen that the percentage of schemes with defects has reduced when compared to Figure 2-1, which includes Cat 1 and Cat 2. The figure shows that five per cent of schemes constructed in 2019 exhibited Cat 1 defects, i.e. nine schemes exhibited two or more

significant defects shortly after completion and within one year. The graph also shows that 30%, or 42 schemes constructed in 2015 had recorded a Cat 1 defect over the five-year period.

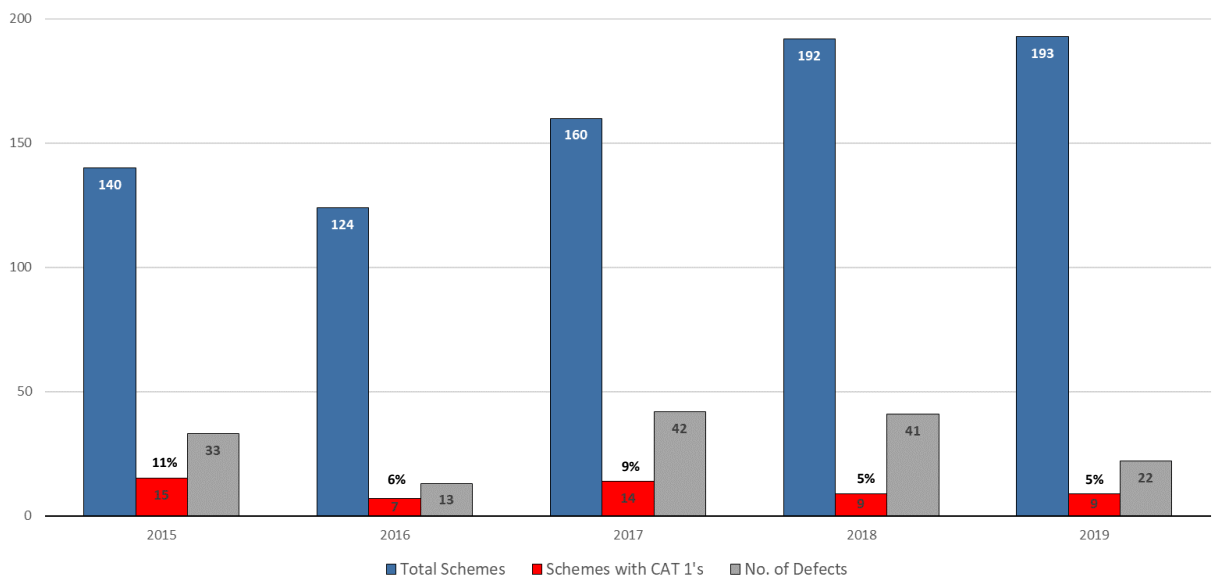
Figure 2-3 - Cat 1 records in first year of construction (2015-2019)

In an attempt to gauge whether the occurrence of defects has been increasing or decreasing over the five-year period of the study, the database was analysed to determine the number of schemes that recorded Cat 1 and Cat 2 defects within the first year of construction. Figure 2-3 shows the total number of schemes constructed each year along with the number of schemes that recorded Cat 1 defects and the number defect records. In percentage terms, the proportion of schemes affected in the first year ranges between 5% and 11%.

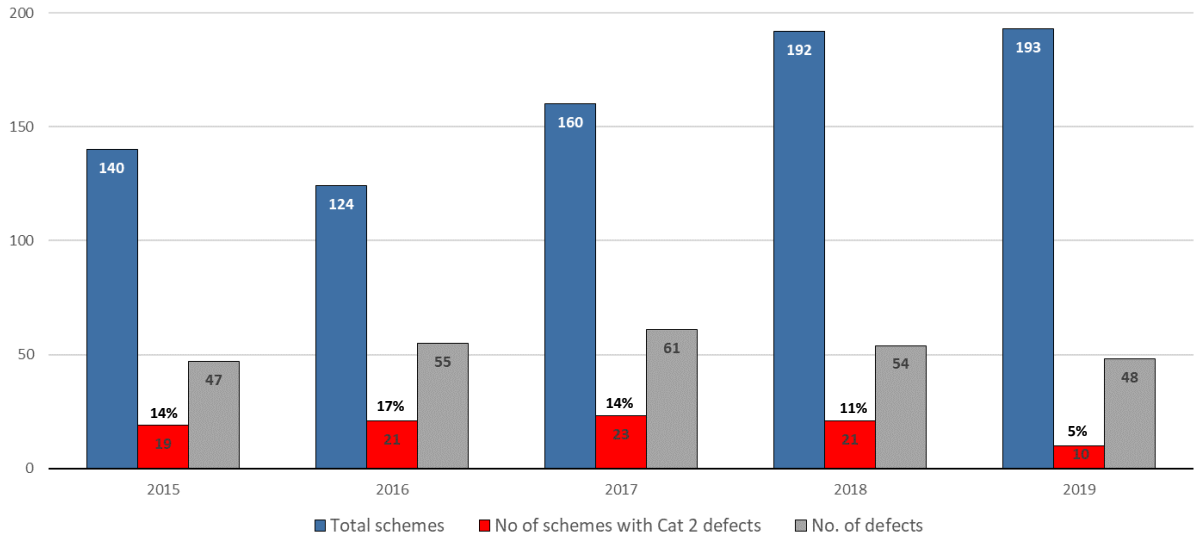
Figure 2-4 - Cat 2 records in first year of construction (2015-2019)

Figure 2-4 shows a similar graph for schemes that recorded Cat 2 defects within the first year of construction, including the number of defect records. In percentage terms, the proportion of schemes affected in the first year was slightly higher than Cat 1 ranging between 5% (2019) and 17% (2016).

The results in Figure 2-4 are interesting in that Cat 2 defects are commonly associated with wear and tear of the road materials and would be expected to occur later in the life of the surfacing. However, Cat 2 defects include faults such as fretting, chip loss and open joints and these are known to occur early in the life of a surfacing.

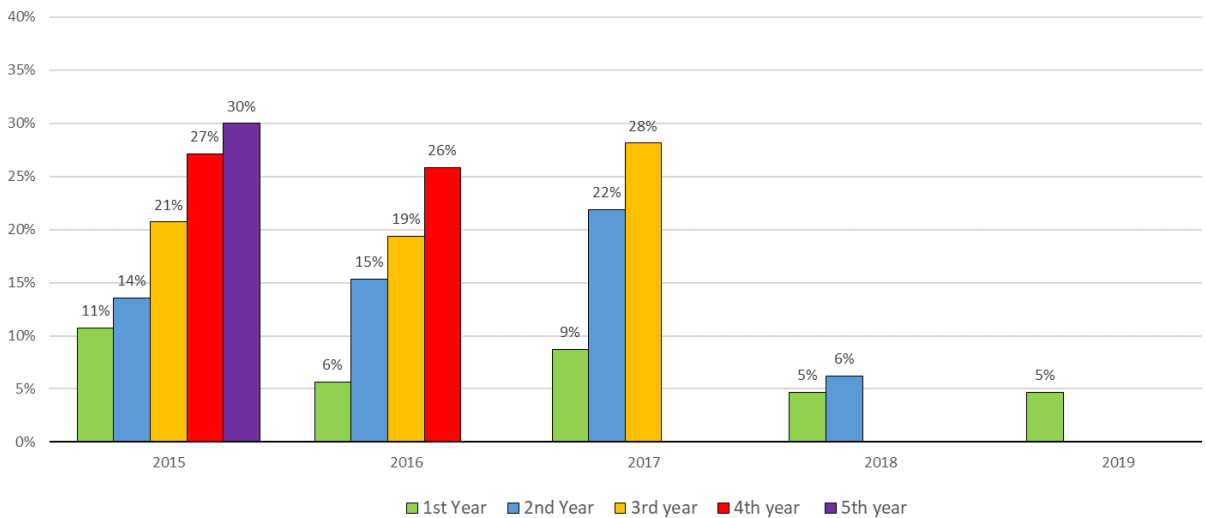
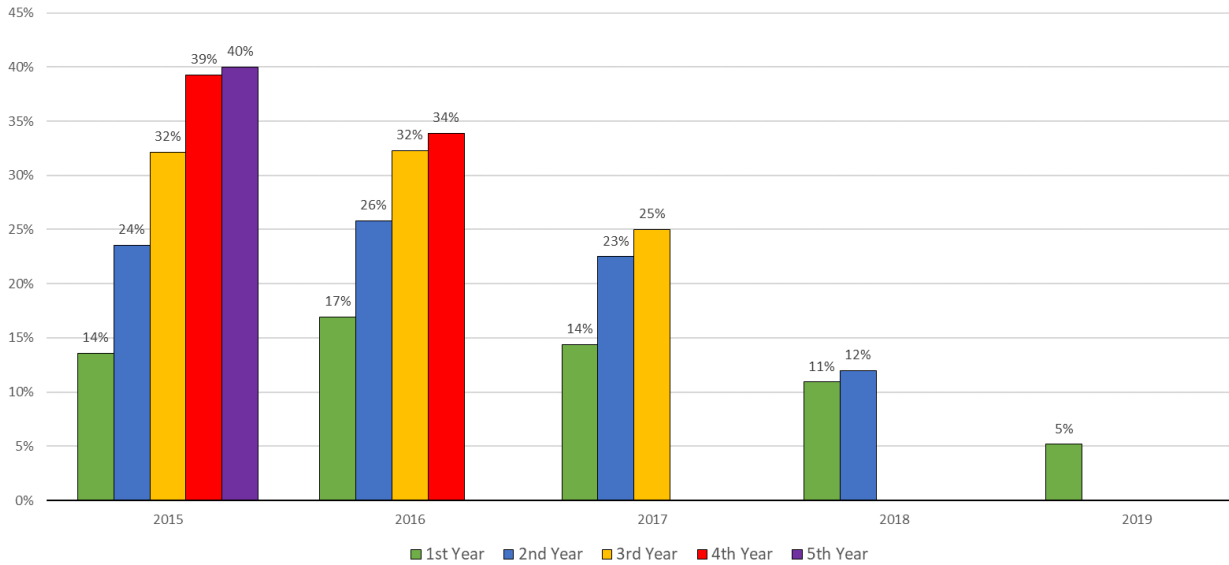
It was decided to investigate the development of both Cat 1 and Cat 2 defects over the five-year period of the study. The development of Cat 1 and Cat 2 defects is shown in Figure 2-5 and Figure 2-6, respectively.

The development of the defects can be seen and compared, particularly for the older schemes which possess more data. It can be seen from Figure 2-6 that after five years in service, 40% of the 2015 schemes have recorded Cat 2 defects, this compares to 30% of Cat 1 defects over the same period (Figure 2-5).

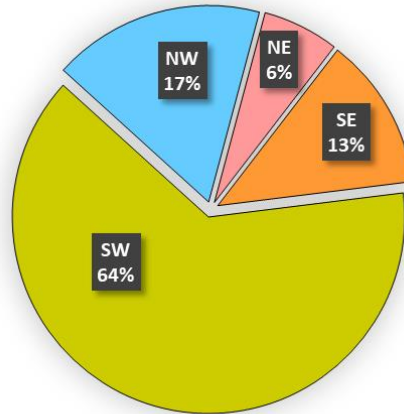
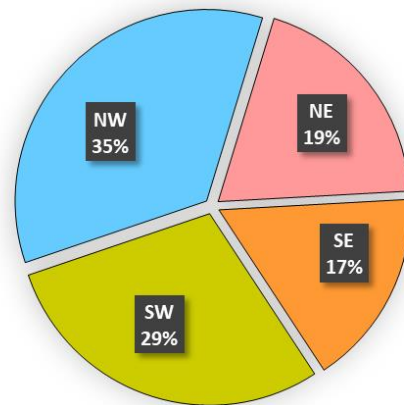
The pie charts in Figure 2-7 and Figure 2-8 show the proportion of Cat 1 and Cat 2 defects recorded in the OC areas between 2015 and 2019, respectively. Figure 2-7 highlights that the highest number of Cat 1 defects was recorded in the SW and the lowest in the NE. Figure 2-8 shows a slightly more even distribution for Cat 2 defects recorded across the trunk road network with the highest number recorded in the NW. However, the picture changes if we look at the number of schemes that contain defects by OC area. Figure 2-9 illustrates the fact that some individual schemes attract a much higher number of defects compared to others, e.g. although the SW attracted the highest number of Cat 1 defects overall, the number of schemes affected was the same as the NW.

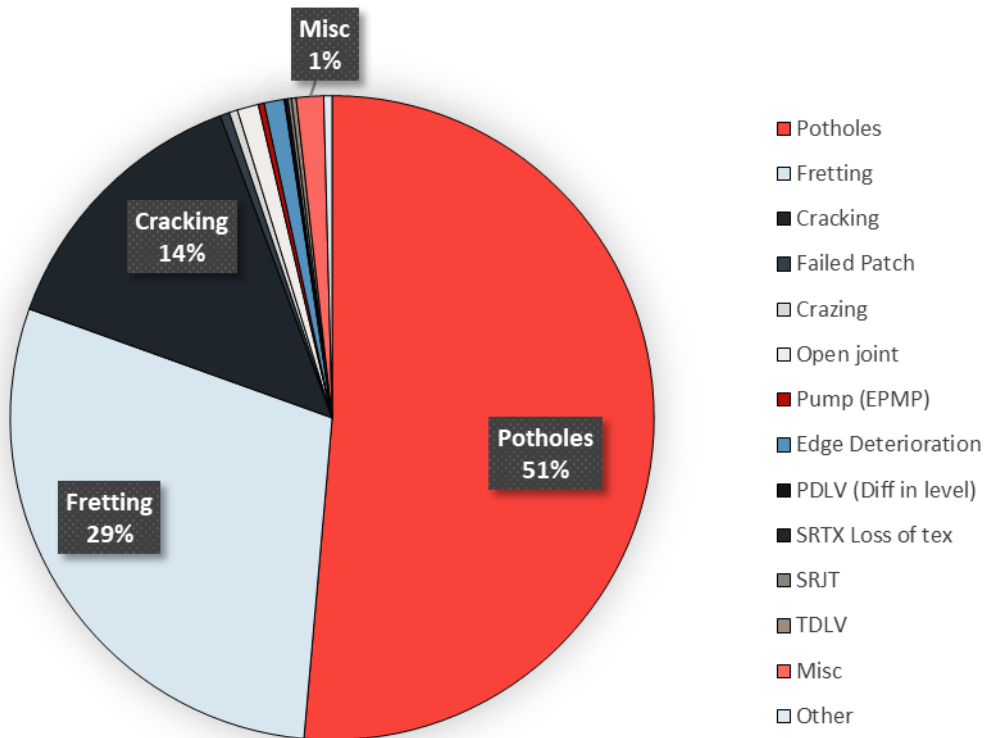
Figure 2-10 - Breakdown of defect type recorded on entire network (2015-2019)

Figure 2-10 shows the type and proportion of surface defects recorded across the entire Scottish road network maintained by the OCs between 2015 and 2019.

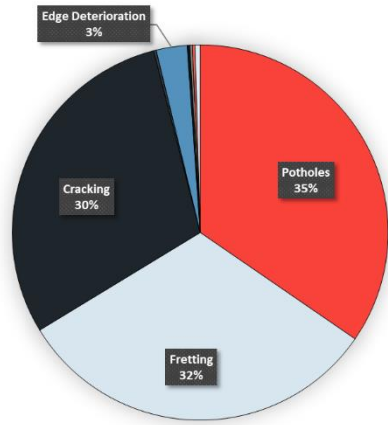
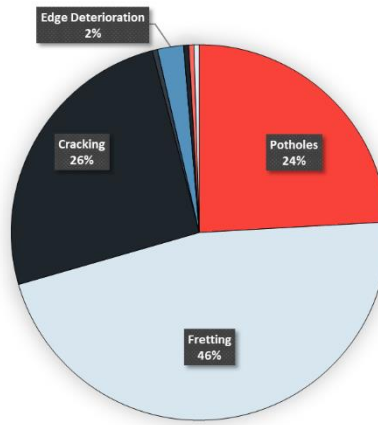
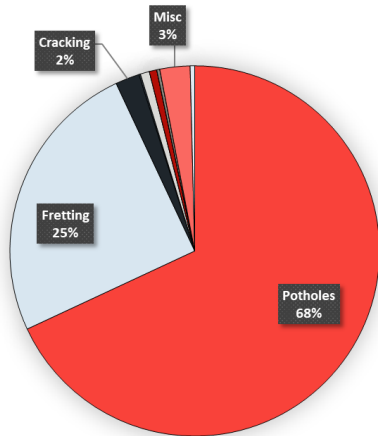
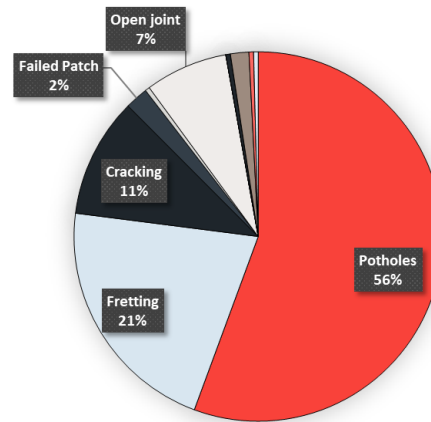
Figure 2-11 – Proportion of recorded defect types in each OC area

To investigate how defect types are influenced by geographical area, i.e. NW, NE, SW and SE, the data collected by the four operating units was separated and is shown side by side in Figure 2-11. It can be seen that both fretting and cracking, and to a lesser extent edge deterioration, appear to be the dominant defects recorded in the northern parts of Scotland. In contrast, the occurrence of potholes is the major defect recorded in the south.

A possible explanation for the increased presence of fretting in the NW and NE could be related to different material configurations. It is known that mixtures with a larger nominal aggregate size (14mm) are more common in the north of Scotland and these materials are known to fret under high stress situations (McHale *et al*, 2017). Cracking and edge deterioration could be related to factors such as narrower road construction, leading to vehicle overrun, and a poorer provision of road drainage. It is unclear why the pothole count is high in the south but it is likely that this could be related to the higher traffic levels experienced in the SE and SW units, which include the main central commuting belt within Scotland.

Nearly 100% of the Cat 1 defects recorded across the OC operating areas were related to potholes or failed patches which required immediate attention. Figure 2-11 shows that they occur more in the SW of Scotland, with 64% of Cat 1 defects being recorded in this area. However, it is important to note that this high number of Cat 1 defects does not mean that more schemes were affected in the SW than elsewhere, rather some individual schemes in the SW attracted a very high number of Cat 1 defects. It is unclear why the Cat 1 count is so high in the SW, but the wetter climate on the west coast and the fact that the area contains Glasgow, which has the largest traffic volume of Scotland's major cities, may be two related factors.

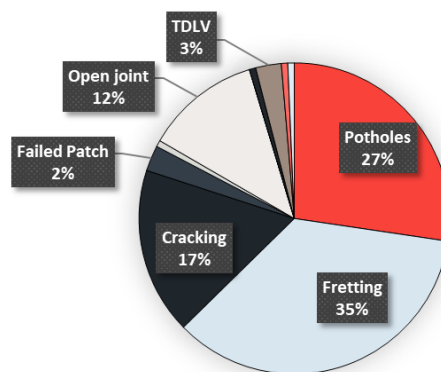
Figure 2-12 - Type of Cat 2 defects for SE

Figure 2-12 highlights that a significant number of Cat 2 defects were recorded as potholes in the SE over the five year period. Across the four OC units, the proportion of CAT 2 defects with the description 'pothole' was small apart from the SE, viz. 6% (NW), 3% (NE) and 8% (SW). It is unclear why the pothole description was used so much in the SE. It is possible that some entries were erroneous or that the inspector deemed certain types of potholes did not pose a risk to road users, but this does not explain the high usage of this type of Cat 2 defect.

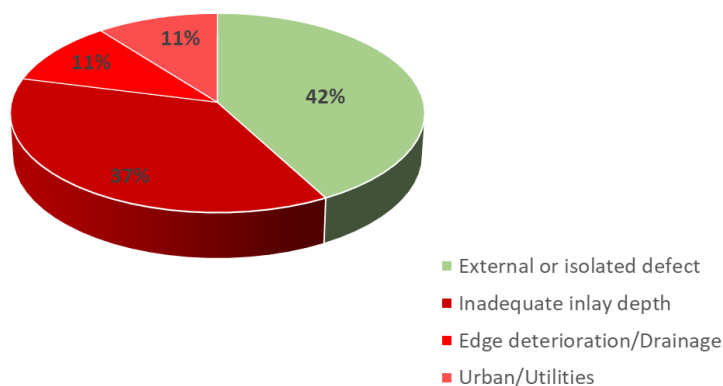
Figure 3-1 – Summary of site assessment findings

- External or isolated defect
- Inadequate inlay depth
- Edge deterioration/Drainage
- Urban/Utilities

Figure 3-1 shows the proportion of sites that fell into these four groups and the findings of the site visits under these categories are discussed in more detail below.

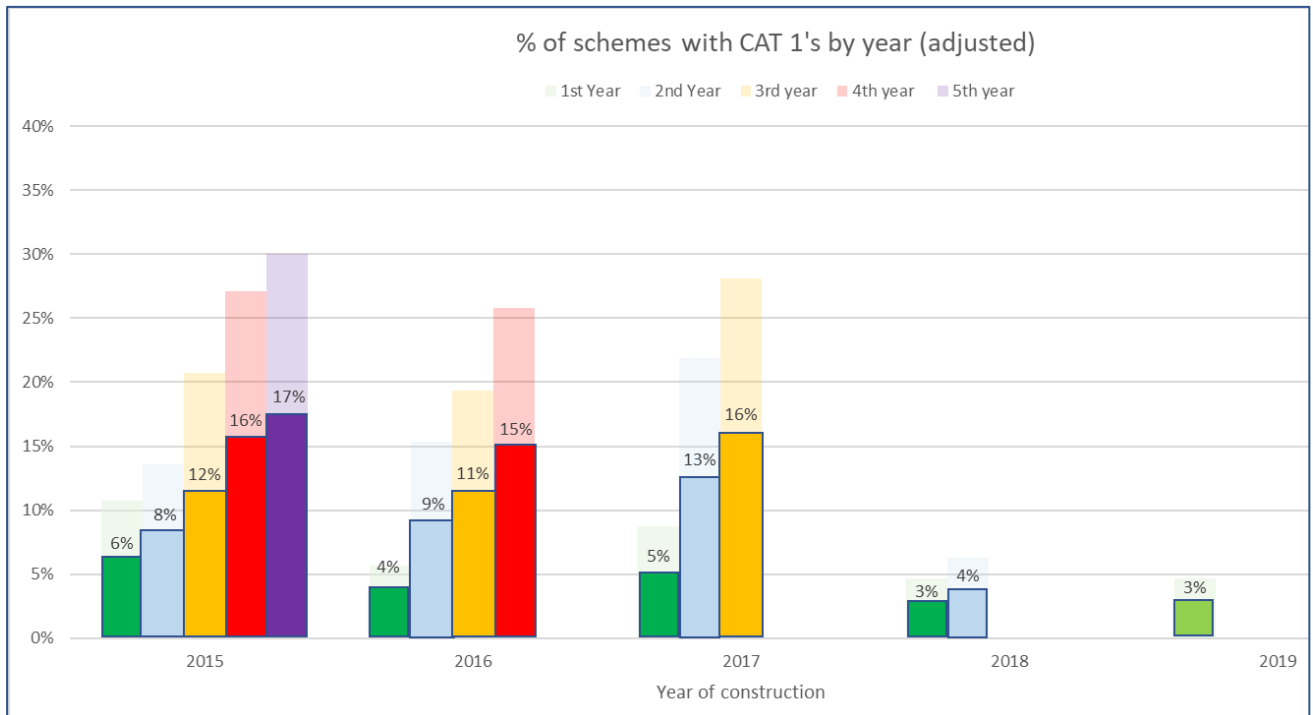
Figure 4-1 - Schemes constructed in 2015 with correction factor applied

Further analysis was undertaken to examine those locations where schemes were constructed in 2015 and Cat 1 defects had been recorded in order to determine whether further treatment was required over subsequent years. The collected data showed that 30% of the sites where CAT 1 defects had been repaired required no further maintenance treatment. This provides additional evidence that supports the site visit observations, i.e. that the recorded defects were exceptional and did not represent the overall condition of the maintenance scheme.

Figure 4-1 shows that if the above findings were applied as a general correction factor, then it would significantly reduce the apparent incidence of early life defects. For schemes originally completed in 2015, the incidence of Cat 1 defects occurring within the extents of a maintenance scheme would fall from 30% to 17% after five years in service. A similar exercise would show that the incidence of Cat 2 defects falls from 40% to 24%. Similarly, the annual frequency of Cat 1 defects recorded in the first year of construction falls from 6% to 3% and from 11% to 5% for Cat 2.
