Appendix A11.1 Baseline Conditions

1 Introduction

- 1.1.1 This Appendix provides a detailed description of the baseline conditions of the water features (WF) referred to in Chapter 11 (Road Drainage and the Water Environment) and as shown on Figures 11.1 and 11.2.

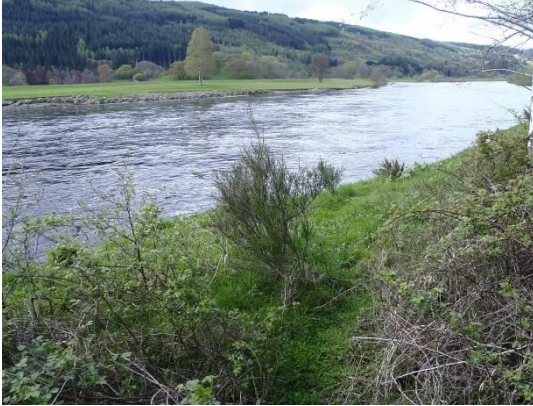
Table 1: WF6 River Tay (Reach: R Tummel to R Isla confluences)

Water feature type: Major watercourse
	Catchment area: 2,955km ²
	Key hydraulic connections: Principal watercourse within the study area. All water features within the study area form part of the River Tay catchment, with the majority being direct tributaries.
	Surrounding land use: Arable, rough pasture and commercial forestry.
	SEPA Overall Status: Good ecological potential (2016)
Description of Specific Baseline Conditions	
Hydrology and Flood Risk	Sensitivity
<p>The River Tay flows in a generally southerly direction through the study area and has a catchment area of 2,955km² to the southern end of the proposed scheme. The River Tay does not cross the existing A9 in the study area. The River Tay passes in close proximity to a number of settlements including (north to south) Ballinluig, Kindallachan, Guay and Dowally. The River Tay itself is a SAC and the Shingle Islands are a SSSI and SAC.</p> <p>SEPA Flood Maps (2015) indicate fluvial flood risk from the 0.5% AEP (200-year) event to properties on the west bank of the Tay including: Easter Dalguise Farm; two properties off the B898 in Ballicock; and Burnside Cottage further north off National Route 77. To the north, the Mill of Logierait and a number of residential properties and the Logierait Hotel within Logierait are shown as 'at risk'. On the east bank of the Tay, Haugh of Kilmorich and commercial units in Dowally between the existing A9 and Dowally Burn are predicted to be at risk. The maps indicate that the majority of the existing A9 road between the Tay Crossing and Ballinluig is located just to the east of the predicted 0.5% AEP (200-year) flood extent. This is with the exception of short lengths between Dowally to Ballinluig, Dowally to Guay and Kindallachan to Ballinluig that run through the eastern functional floodplain (area with greater than 0.5% probability of flooding in any year) of the River Tay.</p> <p>Stage 3 baseline hydraulic modelling of the 0.5% AEP (200-year) flood event and the SEPA Flood Maps have similar flood extents in some areas, however there are areas where the flood extents differ:</p> <ul style="list-style-type: none"> • current scheme modelling predicts additional flooding close to Ballinluig junction, including overtopping of the A9; • modelling predicts additional flooding from the River Tay between the Highland Main Line railway and the A9 which passes under the Highland Main Line railway via drain culverts and underpasses; • the A9 is predicted to overtop approximately 200m north of A9 crossing over Kindallachan Burn; • the model predicts overtopping of the A9 over a longer length immediately north of Guay; • the model predicts a smaller area of overtopping of the A9 to the north of Dowally Burn, the modelling predicts the River Tay floodwaters overtop the A9; and • the model indicates that the A9 is not at risk of flooding from Dowally Burn, but that tailwaters from the River Tay backup into the lower section of the water feature leading to flooding of Dowally Farm & Farmhouse. <p>SEPA flood maps and Stage 3 modelled extents indicate a risk of flooding to the A9 itself, the B898 and the Highland Main Line railway in addition to local roads.</p> <p>South of WF36, downstream of the A9, Clachan More standing stones are a Scheduled Monument and Dalguise Viaduct is a Category A listed building which fall within the 0.5% AEP (200-year) modelled extents from the River Tay.</p> <p>The SEPA Surface Water (pluvial) Flood Map shows scattered areas identified as at risk of flooding in a 10% (10-year) flood event within the River Tay Floodplain. The majority of these areas are north of Kindallachan, in areas east of the Highland Main Line railway and west of the A9. There are also large areas east of the A9 north of Guay and between the Highland Main Line and the A9 north of Dowally. No properties are shown as being at risk, however flooding to the A9 is predicted near Haugh of Kilmorich and Westhaugh of Tulliemet.</p>	Very High

Description of Specific Baseline Conditions	Sensitivity
Fluvial Geomorphology	
<p>WFD hydromorphology status: River Tay (R Tummel to R Isla Confluences) Moderate (2016).</p> <p>The River Tay has a predominantly meandering planform with a single-thread channel, with some evidence of a previously wandering gravel-bed system due to the presence of palaeochannels and side-arms present within the floodplain and active erosion and deposition at several locations.</p> <p>Numerous large pebble/cobble deposits are present throughout the study area including point bars, side bars and mid-channel bars (both vegetated and unvegetated). The riparian corridor is composed of mainly agricultural fields (pasture and arable), with localised patches of scrub and forestry.</p> <p>Historical maps from 1867 indicate active channel change at the confluence with River Tummel (Richard's Island) (NN 977 511) and at Kindallachan (Lamb Island and Big Island) (NN 988 502). In addition, channel change in the vicinity of Dowally is also noted post 1867 with a southerly migration of the meander bend.</p> <p>Bank instability was noted along the River Tay: between ch1650 and ch1900; and ch3600 and ch3800. Between ch1650 and ch1900, undercutting of the bank toe was observed with an engineered reprofiled bank face with a steep gradient, which was resectioned during the construction of the existing A9. Bathymetric data revealed a deeply incised channel near to the outside of the meander bend, with a shallow shelf up to the eroded bank toe. Above the bank toe, the bank appeared to have some evidence of slip planes and was well vegetated with grasses, shrubs and trees. Slope failure is a risk due to the gradient, in particular if the material making up the engineered bank face becomes saturated. In addition, future potential fluvial erosion could cause additional undercutting, which could trigger bank instability, especially given the steep gradient of the resectioned bank face, which may compromise the integrity of the existing A9 and the proposed scheme.</p> <p>The bank instability between ch3600 and cxh3800 is likely to be due to tree fall, possibly caused by windthrow. Here, evidence of bank instability is localised around fallen trees, where the root ball has dislodged volumes of bank material. In addition, the banks are composed of sand and gravels, with cobbles, thus the banks are susceptible to soil erosion during tree fall. The fallen trees, however, provide localised natural bank protection from fluvial erosion at the bank toe. Despite localised pockets of bare earth due to these processes, the bank face is well vegetated with trees, grasses and shrubs; thus indicative of a low fluvial disturbance regime.</p>	High

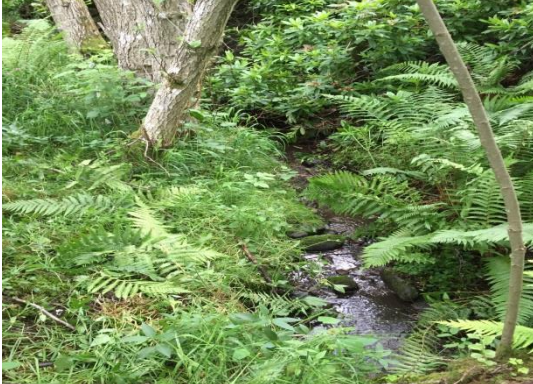
Table 2: WF16

Water feature type: Minor watercourse
	Catchment Area: 0.29km ²
	Key hydraulic connections: Issues within forestry upstream of General Wade's Military Road and discharges into the River Tay
	Surrounding land use: Forestry
Description of Specific Baseline Conditions	
Hydrology and Flood Risk	
<p>This watercourse has a catchment area less than 3km² so is not included in the SEPA Flood Map.</p> <p>The culvert capacity assessment indicates that the watercourse is out of bank upstream of the A9 in the design 0.5% AEP (200-year) plus climate change (CC) event, however the A9 culvert capacity is greater than the 0.5% AEP (200-year) plus CC peak flow and there is 600mm freeboard to the A9 and therefore the flood risk is considered low.</p> <p>The watercourse flows through an area of ancient woodland upstream of the A9 and is considered to have minimal hydrological importance to the woodland and therefore the sensitivity is considered low.</p>	Low

Fluvial Geomorphology	
<p>WFD hydromorphology status: not classified.</p> <p>The water feature has a sinuous planform and is culverted beneath existing A9 and General Wade's Military Road.</p>	Low
Water Quality	
<p>SEPA physico-chem/specific pollutants status: not classified.</p> <p>Potential pollutant sources:</p> <ul style="list-style-type: none"> • diffuse run-off of contaminants associated with A9 traffic; and • diffuse rural sources including suspended sediment from forestry operations. <p>Due to the small catchment size, low and likely intermittent flow regime, limited contribution in terms of flows and habitat to the downstream SAC, and lack of intrinsically linked receptors such as water supplies or aquatic ecology, this watercourse is considered to exhibit a low quality on a local scale. In line with DMRB HD45/09, it is therefore assigned a low sensitivity for this attribute.</p>	Low

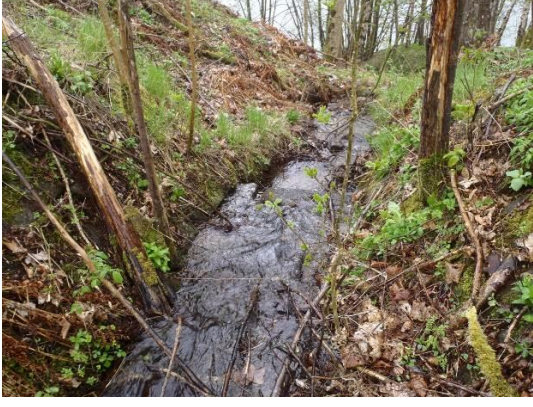
Table 3: WF18

<p>Photograph 3: WF18 – view downstream of existing A9 culvert.</p>	Water feature type: Minor watercourse
	Catchment Area: 0.17km ²
	Key hydraulic connections: Issues in upland forestry upstream of General Wade's Military Road and discharges into the River Tay
	Surrounding land use: Forestry
Description of Specific Baseline Conditions	Sensitivity
Hydrology and Flood Risk	
<p>This watercourse has a catchment area less than 3km² so is not included in the SEPA Flood Map. Stage 3 analysis of the existing A9 culvert indicates that the water feature is in bank at the culvert in the 0.5% AEP (200-year) plus CC event, although the culvert is surcharged.</p> <p>Stage 3 baseline modelling of the 0.5% AEP (200-year) plus CC flood extent from the River Tay indicates that the culvert under the existing A9 is flooded on the downstream (western) side of the road due to flooding from the River Tay. Hydraulic modelling of the watercourse indicates that the watercourse is in bank in the 0.5% AEP (200-year) plus CC event and flood risk to the A9 is considered low.</p> <p>The watercourse flows through an area of ancient woodland upstream of the A9 and is considered to have minimal hydrological importance to the woodland and therefore the sensitivity is considered low.</p>	Low

Fluvial Geomorphology	
<p>WFD hydromorphology status: not classified.</p> <p>The watercourse has a sinuous planform and is culverted beneath existing A9 and General Wade's Military Road. The channel has gravel and pebble substrate; channel width is approximately 0.8m with step-pool sequences.</p>	Low
Water Quality	
<p>SEPA physico-chem/specific pollutants status: not classified.</p> <p>Potential pollutant sources:</p> <ul style="list-style-type: none"> • diffuse run-off of contaminants associated with A9 traffic; and • diffuse rural sources including suspended sediment from forestry and biological pollutants from grazing livestock. <p>Due to the small catchment size, low and likely intermittent flow regime, limited contribution in terms of flows and habitat to the downstream SAC, and lack of intrinsically linked receptors such as water supplies or aquatic ecology, this watercourse is considered to exhibit a low quality on a local scale. In line with DMRB HD45/09, it is therefore assigned a low sensitivity for this attribute.</p>	Low

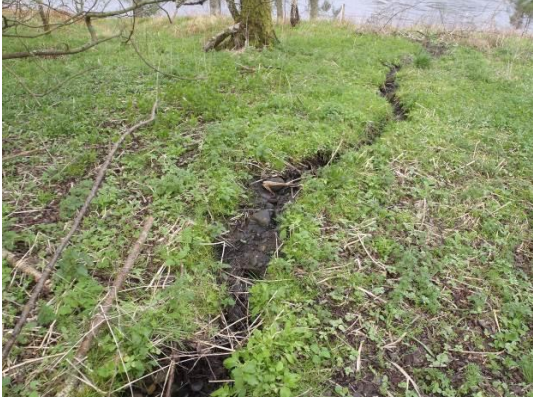
Table 4: WF19

<p>Photograph 4: WF19 – view downstream of existing A9 culvert towards the River Tay.</p>	Water feature type: Drainage channel
	Catchment Area: 0.19km ²
	Key hydraulic connections: Drains agricultural land/rough pasture downstream of General Wade's Military Road and discharges into the River Tay
	Surrounding land use: Forestry
Description of Specific Baseline Conditions	
Hydrology and Flood Risk	
<p>This watercourse has a catchment area less than 3km² so is not included in the SEPA Flood Map. There is one property located within 70m of the watercourse, upstream of the A9.</p> <p>Stage 3 baseline modelling of the 0.5% AEP (200-year) plus CC flood extent indicates that the watercourse culvert under the A9 is outside the modelled flood extents from the River Tay.</p> <p>Stage 3 analysis of the existing A9 culvert indicates there is a risk of flooding to the A9 from this watercourse because it is out of bank at the A9 culvert in the 0.5% AEP (200-year) plus CC event. The minimum freeboard to the A9 during such an event is 0.15m. The existing headwall to the culvert increases this freeboard level immediately adjacent to the watercourse to 0.76m, however equivalent water levels north or south of the headwall could have reduced freeboard to the A9.</p> <p>The watercourse flows through an area of ancient woodland upstream of the A9 and is considered to have minimal hydrological importance to the woodland.</p>	Very High

Fluvial Geomorphology	
<p>WFD hydromorphology status: not classified.</p> <p>The watercourse is an ephemeral channel beginning at an altitude of 100m above ordnance datum (AOD) and is culverted beneath the existing A9 flowing to the River Tay.</p> <p>Downstream of the existing A9, the channel has a silt bed, with reinforced banks present.</p>	Low
Water Quality	
<p>SEPA physico-chem/specific pollutants status: not classified.</p> <p>Potential pollutant sources:</p> <ul style="list-style-type: none"> diffuse run-off of contaminants associated with A9 traffic; and diffuse rural sources including suspended sediment from forestry and biological pollutants from grazing livestock. <p>Due to the small catchment size, low and likely intermittent flow regime, limited contribution in terms of flows and habitat to the downstream SAC, and lack of intrinsically linked receptors such as water supplies or aquatic ecology, this watercourse is considered to exhibit a low quality on a local scale. In line with DMRB HD45/09, it is therefore assigned a low sensitivity for this attribute.</p>	Low

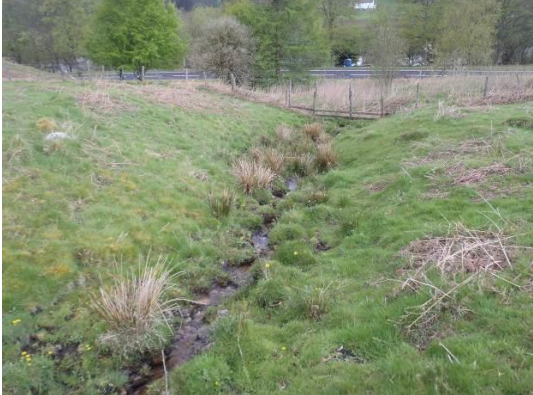
Table 5: WF20

Water feature type: Drainage channel
	Catchment Area: 0.31km ²
	Key hydraulic connections: Drains agricultural land/rough pasture downstream of General Wade's Military Road and discharges into the River Tay
	Surrounding land use: Agriculture/rough pasture.
Description of Specific Baseline Conditions	
Sensitivity	
Hydrology and Flood Risk	
<p>This watercourse has a catchment area less than 3km² so is not included in the SEPA Flood Map. Two properties are located within 100m of the watercourse.</p> <p>Stage 3 baseline modelling of the 0.5% AEP (200-year) plus CC flood extent from the River Tay indicates that the watercourse culvert under the A9 is outside the modelled flood extents.</p> <p>Stage 3 assessment of the A9 culvert indicates that the watercourse is in bank in the 0.5% AEP (200-year) plus CC event with a freeboard of 0.51m to the existing A9 road level.</p>	Very High
Fluvial Geomorphology

<p>WFD hydromorphology status: not classified.</p> <p>The watercourse is an ephemeral channel flowing into the River Tay and is culverted beneath the existing A9.</p> <p>The channel has gravel and pebble substrate, channel width is approximately 0.2-0.3m with a straight planform, and a step-pool section (7m in length) immediately upstream of the River Tay.</p>	Low
Water Quality	
<p>SEPA physico-chem/specific pollutants status: not classified.</p> <p>Potential pollutant sources:</p> <ul style="list-style-type: none"> diffuse run-off of contaminants associated with A9 traffic; and diffuse rural sources including suspended sediment from forestry and biological pollutants from grazing livestock. <p>Due to the small catchment size, low and likely intermittent flow regime, limited contribution in terms of flows and habitat to the downstream SAC, and lack of intrinsically linked receptors such as water supplies or aquatic ecology, this watercourse is considered to exhibit a low quality on a local scale. In line with DMRB HD45/09, it is therefore assigned a low sensitivity for this attribute.</p>	Low

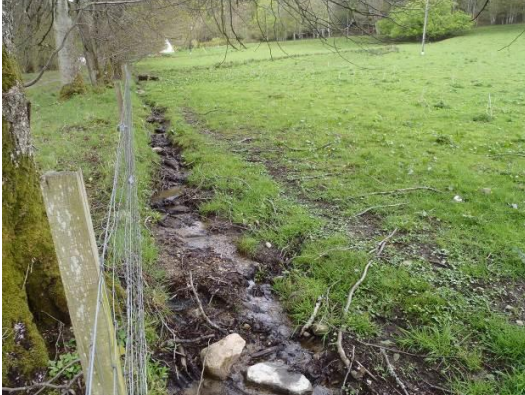
Table 6: WF21

Water feature type: Drainage channel
	Catchment Area: 0.16km ²
	Key hydraulic connections: Drains agricultural land/rough pasture downstream of General Wade's Military Road and discharges into the River Tay
	Surrounding land use: Agriculture/rough pasture
Description of Specific Baseline Conditions	
Sensitivity	
Hydrology and Flood Risk	
<p>This watercourse has a catchment area less than 3km² so is not included in the SEPA Flood Map. No properties fall within 100m of the watercourse.</p> <p>Stage 3 baseline modelling of the 0.5% AEP (200-year) plus CC flood extent does not include WF21.</p> <p>The watercourse connects into a manhole and is understood to then connect into existing road drainage.</p>	Low
Fluvial Geomorphology	
<p>WFD hydromorphology status: not classified.</p> <p>Above the existing A9, the watercourse is a shallow channel through agricultural fields. The substrate is predominantly silt with some gravels. Poaching of the banks is evident along the entire length of the channel. The watercourse flows into a manhole south of the existing A9.</p>	Low

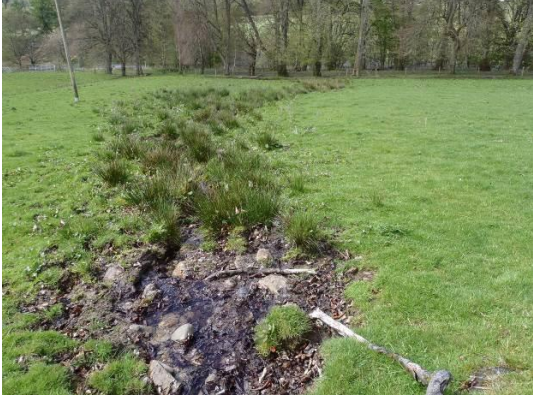
Table 7: WF22

Water feature type: Minor watercourse
	Catchment Area: 0.07km ²
	Key hydraulic connections: Drains agricultural land/rough pasture downstream of General Wade's Military Road and discharges into the River Tay
	Surrounding land use: Agriculture/rough pasture
Description of Specific Baseline Conditions	
Sensitivity	
Hydrology and Flood Risk	
<p>This watercourse has a catchment area less than 3km² so is not included in the SEPA Flood Map. One property is located within 90m of the watercourse.</p> <p>Stage 3 baseline modelling of the 0.5% AEP (200-year) plus CC flood extent does not include WF22.</p> <p>The watercourse is considered to provide field drainage and is believed to connect into road drainage. The very small catchment area means risk of flooding from this watercourse to receptors is considered low.</p>	Low
Fluvial Geomorphology	
<p>WFD hydromorphology status: not classified.</p> <p>The watercourse has a shallow channel with a straight planform flowing through an agricultural field. The predominant substrate is silt, and poaching of the banks is present along the length of channel. The watercourse flows into a manhole south of the existing A9.</p>	Low

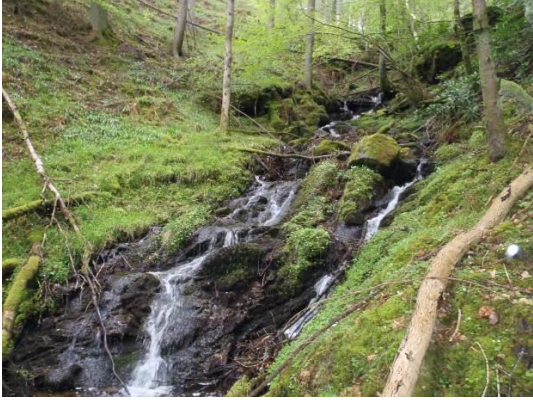
Table 8: WF23

<p>Photograph 8: WF23 – view of cascades in woodland upstream of existing A9.</p>	Water feature type: Minor watercourse
	Catchment Area: 0.60km ²
	Key hydraulic connections: Issues in forestry upstream of General Wade's Military Road and discharges into the River Tay
	Surrounding land use: Uplands/forestry
Description of Specific Baseline Conditions	
Hydrology and Flood Risk	
<p>This watercourse has a catchment area less than 3km² so is not included in the SEPA Flood Map. Warren Lodge is within 100m of the watercourse. General Wade's Military Road crosses the watercourse but is not shown to be at risk, however the SEPA flood extents do not take account minor watercourses with a catchment area <3km² and therefore could be under-predicting fluvial flood risk.</p> <p>Stage 3 baseline modelling of the 0.5% AEP (200-year) plus CC flood extent associated with the River Tay indicates that the culvert under the A9 is flooded to upstream of the road from the River Tay. Stage 3 hydraulic modelling and culvert assessment of the minor watercourse indicates that the road and other sensitive receptors are outside of flood extents in the design event and therefore flood risk is considered low.</p> <p>The watercourse flows through an area of ancient woodland upstream of the A9 and is considered to have minimal hydrological importance to the woodland and therefore the sensitivity is considered low.</p>	Low

Fluvial Geomorphology	
<p>WFD hydromorphology status: not classified.</p> <p>The source of the watercourse is in Rotmell Wood and flows into River Tay. The channel has step-pool sequences with some large rock cascade features. The channel is approximately 1.2m wide with pebble and cobble substrate.</p> <p>The channel flows through a bridge beneath General Wade's Military Road and is culvert beneath the existing A9 and forestry/farm tracks.</p> <p>The planform is relatively straight and largely unchanged since 1867.</p>	Medium
Water Quality	
<p>SEPA physico-chem/specific pollutants status: not classified.</p> <p>Potential pollutant sources:</p> <ul style="list-style-type: none"> • diffuse run-off of contaminants associated with A9 traffic; and • diffuse rural sources including suspended sediment from forestry and biological pollutants from grazing livestock. 	Medium
Dilution and Removal of Waste Products

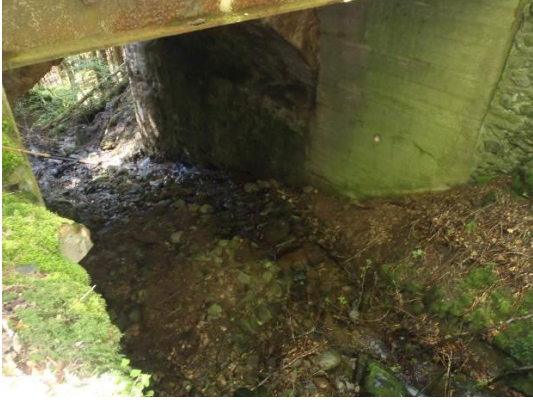
Table 9: WF24

<p>Photograph 9: WF24 – view downstream of bridge under General Wade’s Military Road.</p>	Water feature type: Minor watercourse
	Catchment Area: 0.16km ²
	Key hydraulic connections: Issues in upland agriculture land/rough pasture upstream of General Wade’s Military Road and discharges into the River Tay
	Surrounding land use: Agriculture/rough pasture, forestry
Description of Specific Baseline Conditions	Sensitivity
Hydrology and Flood Risk	
<p>This watercourse has a catchment area less than 3km² so is not included in the SEPA Flood Map. No properties fall within 100m of the watercourse.</p> <p>Stage 3 baseline modelling of the River Tay 0.5% AEP (200-year) plus CC flood extent indicates that the culvert under the A9 is flooded upstream (west) of the road. Hydraulic modelling and culvert assessment both indicate that the watercourse is in bank in the design event. Flood risk to the A9 or other receptors is therefore considered low.</p> <p>The watercourse flows through an area of ancient woodland upstream of the A9 and is considered to have minimal hydrological importance to the woodland and therefore the sensitivity is considered low.</p>	Low

Fluvial Geomorphology	
<p>WFD hydromorphology status: not classified.</p> <p>The watercourses source is in a clearing of Rotmell Wood and flows into the River Tay. A step-pool sequence is present; the channel has predominantly cobble and sand substrate, an incised channel, and is culverted under the existing A9 and forestry/farm tracks. A bridge crossing is present for General Wade’s Military Road.</p> <p>The planform is largely unchanged since 1867.</p>	Medium
Water Quality	
<p>SEPA physico-chem/specific pollutants status: not classified.</p> <p>Potential pollutant sources:</p> <ul style="list-style-type: none"> diffuse run-off of contaminants associated with A9 traffic; and diffuse rural sources including suspended sediment from forestry and biological pollutants from grazing livestock. 	Medium
Dilution and Removal of Waste Products	
CAR discharges: none	Low
Biodiversity	
SEPA overall ecological status: not classified. Considered to exhibit ‘Moderate’ ecosystem quality due to well-established bed and riparian habitat in upper reach.	Medium

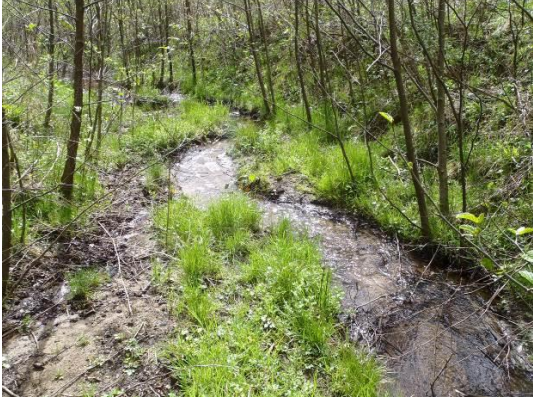
Table 10: WF25

Water feature type: Minor watercourse
	Catchment Area: 0.14km ²
	Key hydraulic connections: Issues in upland forestry upstream of General Wade's Military Road and discharges into the River Tay
	Surrounding land use: Forestry
Description of Specific Baseline Conditions	
Sensitivity	
Hydrology and Flood Risk	
<p>This watercourse has a catchment area less than 3km² so is not included in the SEPA Flood Map.</p> <p>Stage 3 baseline modelling of the River Tay 0.5% AEP (200-year) plus CC flood event indicates that the culvert under the A9 is flooded to upstream of the road. Stage 3 analysis of the A9 culvert and hydraulic modelling indicate that the watercourse is in bank at the culvert in the 0.5% AEP (200-year) plus CC event. Flood risk to the A9 or other receptors is therefore considered low.</p> <p>The watercourse flows through an area of ancient woodland upstream of the A9 and is considered to have minimal hydrological importance to the woodland and therefore the sensitivity is considered low.</p>	Low

Fluvial Geomorphology	
<p>WFD hydromorphology status: not classified.</p> <p>The watercourse has its source in Rotmell Wood (180m AOD) and flows into the River Tay.</p> <p>It has a straight planform, with predominantly step-pool sequences, incised channel with a cobble substrate. The channel is culverted beneath the existing A9 and General Wade's Military Road.</p> <p>The planform is largely unchanged since 1867.</p>	Medium
Water Quality	
<p>SEPA physico-chem/specific pollutants status: not classified.</p> <p>Potential pollutant sources:</p> <ul style="list-style-type: none"> • diffuse run-off of contaminants associated with A9 traffic; and • diffuse rural sources including suspended sediment from forestry and biological pollutants from grazing livestock. 	Medium
Dilution and Removal of Waste Products	
CAR discharges: none	Low
Biodiversity	
SEPA overall ecological status: not classified. Considered to exhibit 'Moderate' ecosystem quality due to well-established bed and riparian habitat in upper reach.	Medium

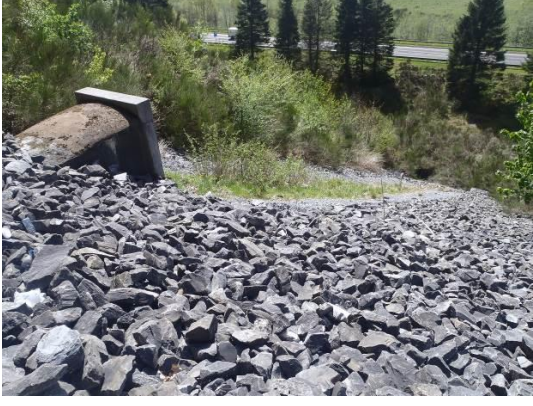
Table 11: WF28

<p>Photograph 11: WF28 – view downstream towards existing A9 culvert, flow discharges from culvert outlet shown in left centre of photograph.</p>	Water feature type: Minor watercourse
	Catchment Area: 0.06km ²
	Key hydraulic connections: Issues in forestry upstream of General Wade's Military Road. Discharges into an artificial channel (lower section of WF31) which connects WF28, WF29, WF30 and WF31 to the River Tay.
	Surrounding land use: Forestry
Description of Specific Baseline Conditions	Sensitivity
Hydrology and Flood Risk	
<p>This watercourse has a catchment area less than 3km² so is not included in the SEPA Flood Map. No properties fall within 100m of the watercourse.</p> <p>Stage 3 baseline modelling of the River Tay 0.5% AEP (200-year) plus CC flood event indicates that the culvert under the A9 is flooded to upstream of the road but does not indicate flood risk to the A9.</p> <p>Stage 3 analysis of the A9 culvert indicates that the watercourse is out of bank upstream of the culvert in the 0.5% AEP (200-year) plus CC event, however, hydraulic modelling of the watercourse indicates low flood risk to the A9 or other sensitive receptors.</p> <p>The watercourse flows through an area of ancient woodland upstream of the A9 and is considered to have minimal hydrological importance to the woodland and therefore the sensitivity is considered low.</p>	Low

Fluvial Geomorphology	
<p>WFD hydromorphology status: not classified.</p> <p>The watercourse is culverted beneath the existing A9 and General Wade's Military Road. It has step-pool sequences, cobble substrate and large woody material present upstream of the Military Road. Very steep artificial rock aggregate banks, held in place by netting, conveys flow between Military Road and existing A9 culverts.</p> <p>The planform is largely unchanged since 1867; however, the historical channel course was direct to the River Tay and is now diverted to the downstream reach of WF31 (historical secondary channel of the River Tay).</p>	Low
Water Quality	
<p>SEPA physico-chem/specific pollutants status: not classified.</p> <p>Potential pollutant sources:</p> <ul style="list-style-type: none"> • diffuse run-off of contaminants associated with A9 traffic; and • diffuse rural sources including suspended sediment from forestry and biological pollutants from grazing livestock. <p>Due to the very small catchment size, low and likely intermittent flow regime, limited contribution in terms of flows and habitat to the downstream SAC, and lack of intrinsically linked receptors such as water supplies or aquatic ecology, this watercourse is considered to exhibit a low quality on a local scale. In line with DMRB HD45/09, it is therefore assigned a low sensitivity for this attribute.</p>	Low

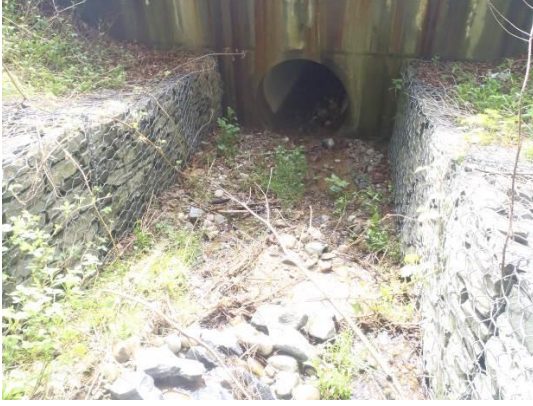
Table 12: WF29

<p>Photograph 12: WF29 – view of culvert under General Wade’s Military Road. Downstream reach similar to WF28 above.</p>	Water feature type: Minor watercourse
	Catchment Area: 0.17km ²
	Key hydraulic connections: Issues in upland forestry upstream of General Wade’s Military Road. Discharges into an artificial channel (lower section of WF31) which connects WF28, WF29, WF30 and WF31 to the River Tay.
	Surrounding land use: Forestry
Description of Specific Baseline Conditions	Sensitivity
Hydrology and Flood Risk	
<p>This watercourse has a catchment area less than 3km² so is not included in the SEPA Flood Map. No properties fall within 100m of the watercourse. The existing A9 crosses the watercourse but is not shown to be at risk.</p> <p>Stage 3 baseline modelling of the River Tay 0.5% AEP (200-year) plus CC event from the River Tay indicates that the culvert under the A9 is flooded to upstream of the road but that there is no risk to the A9.</p> <p>Stage 3 analysis of the A9 culvert indicates that the watercourse is in bank at the culvert in the 0.5% AEP (200-year) plus CC event and flood risk to the A9 or other sensitive receptors is therefore considered low.</p> <p>The watercourse flows through an area of ancient woodland upstream of the A9 and is considered to have minimal hydrological importance to the woodland and therefore the sensitivity is considered low.</p>	Low

Fluvial Geomorphology	
<p>WFD hydromorphology status: not classified.</p> <p>The watercourse is culverted beneath the existing A9 and General Wade’s Military Road. It has a step-pool sequence, cobble substrate and large woody material present upstream of the Military Road. Very steep artificial rock aggregate banks, held in place by netting, conveys flow between the Military Road and existing A9 culverts.</p> <p>The planform is largely unchanged since 1867; however, the historical channel was direct to the River Tay and is now diverted to WF31 (historical secondary channel).</p>	Low
Water Quality	
<p>SEPA physico-chem/specific pollutants status: not classified.</p> <p>Potential pollutant sources:</p> <ul style="list-style-type: none"> • diffuse run-off of contaminants associated with A9 traffic; and • diffuse rural sources including suspended sediment from forestry and biological pollutants from grazing livestock. <p>Due to the small catchment size, low and likely intermittent flow regime, limited contribution in terms of flows and habitat to the downstream SAC, and lack of intrinsically linked receptors such as water supplies or aquatic ecology, this watercourse is considered to exhibit a low quality on a local scale. In line with DMRB HD45/09, it is therefore assigned a low sensitivity for this attribute.</p>	Low

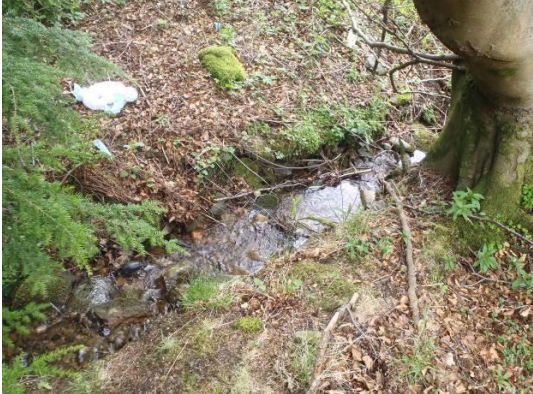
Table 13: WF30

Water feature type: Minor watercourse
	Catchment Area: 0.14km ²
	Key hydraulic connections: Issues in agricultural land/rough pasture upstream of General Wade’s Military Road. Discharges into an artificial channel (lower section of WF31) which connects WF28, WF29, WF30 and WF31 to the River Tay.
	Surrounding land use: Forestry and agriculture (rough pasture)
Description of Specific Baseline Conditions	
Hydrology and Flood Risk	
<p>This watercourse has a catchment area less than 3km² so is not included in the SEPA Flood Map. No properties fall within 100m of the watercourse.</p> <p>Stage 3 baseline modelling of the River Tay 0.5% AEP (200-year) plus CC event indicates that the culvert under the A9 is flooded upstream of the road, but that there is no flood risk to the A9.</p> <p>Stage 3 analysis of the A9 culvert and hydraulic modelling of the watercourse indicate that the watercourse is in bank at the culvert in the 0.5% AEP (200-year) plus CC event and therefore flood risk to the A9 or sensitive receptors is considered low.</p> <p>The watercourse flows through an area of ancient woodland upstream of the A9 and is considered to have minimal hydrological importance to the woodland and therefore the sensitivity is considered low.</p>	Low

Fluvial Geomorphology	
<p>WFD hydromorphology status: not classified.</p> <p>The watercourse is culverted beneath the existing A9 and General Wade’s Military Road. It is characterised by a step-pool sequence, predominantly fine gravel and silt substrate, and is approximately 0.6m wide. Large gabion mattresses which span the entire channel (approximately 8m wide and 3m high) are present immediately downstream of General Wade’s Military Road culvert.</p> <p>The planform largely unchanged since 1867; however, the historical channel course was direct to River Tay, the current flow is diverted to WF31 (historical secondary channel of the River Tay).</p>	Low
Water Quality	
<p>SEPA physico-chem/specific pollutants status: not classified.</p> <p>Potential pollutant sources:</p> <ul style="list-style-type: none"> • diffuse run-off of contaminants associated with A9 traffic; and • diffuse rural sources including suspended sediment from forestry and biological pollutants from grazing livestock. <p>Due to the small catchment size, low and likely intermittent flow regime, limited contribution in terms of flows and habitat to the downstream SAC, and lack of intrinsically linked receptors such as water supplies or aquatic ecology, this watercourse is considered to exhibit a low quality on a local scale. In line with DMRB HD45/09, it is therefore assigned a low sensitivity for this attribute.</p>	Low

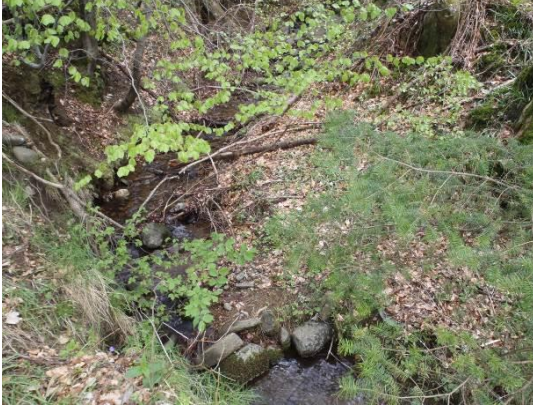
Table 14: WF31

Water feature type: Minor watercourse
	Catchment Area: 1.16km ²
	Key hydraulic connections: Issues in forestry upstream of General Wade's Military Road, culverted under existing A9, flows parallel downstream to existing A9 within an artificial channel which receives flows from WF28, WF29 and WF30 before discharging into the River Tay.
	Surrounding land use: Agriculture (rough pasture) and forestry
Description of Specific Baseline Conditions	
Hydrology and Flood Risk	
<p>This watercourse has a catchment area less than 3km² so is not included in the SEPA Flood Map. No properties fall within 100m of the watercourse.</p> <p>Stage 3 baseline modelling of the 0.5% AEP (200-year) plus CC flood event for the River Tay indicates that the culvert under the A9 is flooded downstream of the road. Hydraulic modelling indicates that there is a risk of flooding to the foot of the A9 embankment from a 0.5% AEP (200-year) plus CC flood event for the minor watercourse, but flood risk to the road itself is considered low.</p> <p>The watercourse flows through an area of ancient woodland upstream of the A9 and is considered to have minimal hydrological importance to the woodland and therefore the sensitivity is considered low.</p>	Low

Fluvial Geomorphology	
<p>WFD hydromorphology status: not classified.</p> <p>The source of the watercourse is in Rotmell Wood. The watercourse is culverted beneath the existing A9, General Wade's Military Road and forestry/farm tracks. The channel is highly incised with a slightly meandering planform. It has step-pool sequences with predominantly cobble and gravel substrate.</p> <p>After being culverted, the channel then becomes a straight road drainage ditch flowing south along the existing A9 to the River Tay, the planform of which is within a historical secondary channel of the River Tay (historically very active). It is characterised by a uniform channel, silt bed, and low energy flow types. The channel is approximately 1m wide. Several areas are choked with terrestrial vegetation.</p>	Low
Water Quality	
<p>SEPA physico-chem/specific pollutants status: not classified.</p> <p>Potential pollutant sources:</p> <ul style="list-style-type: none"> • diffuse run-off of contaminants associated with A9 traffic; and • diffuse rural sources including suspended sediment from forestry and biological pollutants from grazing livestock. 	Medium

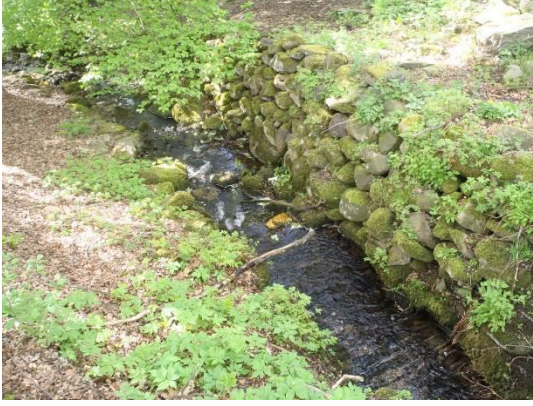
Table 15: WF32

<p>Photograph 15: WF32 – view upstream of existing A9 parallel to Rotmell Farm.</p>	Water feature type: Minor watercourse
	Catchment Area: 0.37km ²
	Key hydraulic connections: Issues in forestry upstream of General Wade's Military Road and discharges into the River Tay
	Surrounding land use: Forestry, agriculture improved grassland/rough pasture
Description of Specific Baseline Conditions	Sensitivity
Hydrology and Flood Risk	
<p>This watercourse has a catchment area less than 3km² so is not included in the SEPA Flood Map. Three buildings fall within 50m of the watercourse, namely Cottage No 1. Rotmell Farm, Cottage No 2. Rotmell Farm and Rotmell Farm & Farmhouse. The building at Cottage No 1. Rotmell Farm is a Category B listed building.</p> <p>Stage 3 baseline modelling of the 0.5% AEP (200-year) plus CC flood extent from the River Tay indicates that the culvert under the A9 is flooded downstream of the road. Stage 3 analysis of the A9 culvert indicates that the watercourse is in bank at the culvert in the 0.5% AEP (200-year) plus CC event on WF32 and therefore the risk of flooding to the A9 or other sensitive receptors is considered low.</p> <p>The watercourse lies partially within native woodland which is a conservation area. Although the watercourse flows directly into the River Tay SAC, it is considered to have minimal influence on these receptors and therefore the sensitivity is low.</p>	Low

Fluvial Geomorphology	
<p>WFD hydromorphology status: not classified.</p> <p>The watercourse source is in Rotmell Wood. It has a relatively straight planform in the upper catchment; upstream of Cottage No 1. Rotmell Farm and Cottage No 2. Rotmell Farm, erosion and deposition processes were observed along with some channel incision. The channel has a straight planform and extensive culverting in vicinity of Rotmell Farm & Farmhouse. Sluice gates are present along with culverting under existing A9 and General Wade's military Road.</p> <p>The channel is characterised by step-pool sequences with cobble and gravel substrate. Depositional features are present adjacent to the existing A9. The planform is largely unchanged since 1867.</p>	Medium
Water Quality	
<p>SEPA physico-chem/specific pollutants status: not classified.</p> <p>Potential pollutant sources:</p> <ul style="list-style-type: none"> diffuse run-off of contaminants associated with A9 traffic; and diffuse rural sources including suspended sediment from forestry and biological pollutants from grazing livestock. 	Medium

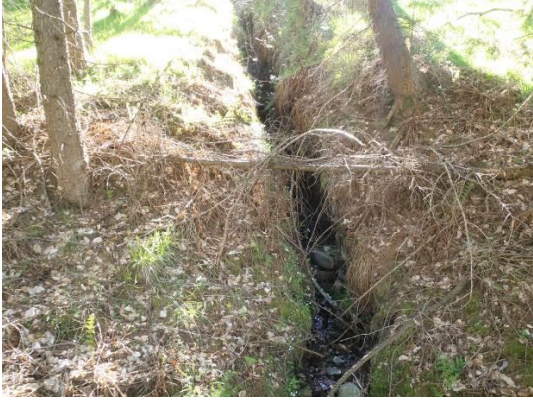
Table 16: WF33

<p>Photograph 16: WF33 – view upstream in forestry upslope of existing A9.</p>	Water feature type: Drainage channel
	Catchment Area: 0.12km ²
	Key hydraulic connections: Issues in improved grassland upstream of General Wade's Military Road and discharges into the River Tay
	Surrounding land use: Agriculture (improved grassland) and forestry
Description of Specific Baseline Conditions	
Sensitivity	
Hydrology and Flood Risk	
<p>This watercourse has a catchment area less than 3km² so is not included in the SEPA Flood Map. No properties fall within 100m of the watercourse.</p> <p>Stage 3 baseline modelling of the 0.5% AEP (200-year) plus CC flood extent from the River Tay indicates that the culvert under the A9 is flooded downstream of the road. Stage 3 analysis of the A9 culvert indicates that the watercourse is in bank at the culvert in the 0.5% AEP (200-year) plus CC event and therefore the risk of flooding to the A9 or other sensitive receptors is considered low.</p> <p>The watercourse lies partially within native woodland which is a conservation area, however the watercourse is considered to have minimal influence on the woodland and the sensitivity is therefore considered low.</p>	Low

Fluvial Geomorphology	
<p>WFD hydromorphology status: not classified.</p> <p>The watercourse is a straight ditch approximately 180m long and flows into the River Tay.</p> <p>The channel is highly incised, likely due to the steep gradient and downward angled culvert under the existing A9. The channel is narrow channel (0.5m) comprising step-pool sequences. Channel substrate is predominantly earth and clay.</p>	Low
Water Quality	
<p>SEPA physico-chem/specific pollutants status: not classified.</p> <p>Potential pollutant sources:</p> <ul style="list-style-type: none"> • diffuse run-off of contaminants associated with A9 traffic; and • diffuse rural sources including suspended sediment from forestry and biological pollutants from grazing livestock. <p>Due to the small catchment size, low and likely intermittent flow regime, limited contribution in terms of flows and habitat to the downstream SAC, and lack of intrinsically linked receptors such as water supplies or aquatic ecology, this watercourse is considered to exhibit a low quality on a local scale. In line with DMRB HD45/09, it is therefore assigned a low sensitivity for this attribute.</p>	Low

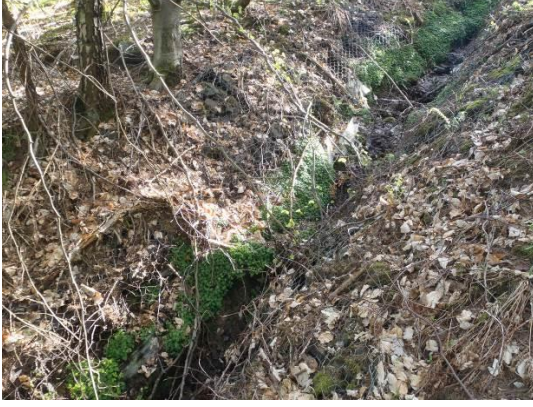
Table 17: WF34

<p>Photograph 17: WF34 – view upstream of existing A9 culvert.</p>	Water feature type: Drainage channel
	Catchment Area: 0.25km ²
	Key hydraulic connections: Issues in forestry upstream of existing A9 and discharges into the River Tay
	Surrounding land use: Agriculture (improved grassland) and forestry
Description of Specific Baseline Conditions	
Sensitivity	
Hydrology and Flood Risk	
<p>This watercourse has a catchment area less than 3km² so is not included in the SEPA Flood Map. No properties fall within 100m of the watercourse.</p> <p>Stage 3 baseline modelling of the 0.5% AEP (200-year) plus CC flood extent from the River Tay indicates that the culvert under the A9 is not flooded by the River Tay. Stage 3 analysis of the A9 culvert indicates that the watercourse is in bank at the culvert in the 0.5% AEP (200-year) plus CC event and therefore the risk of flooding to the A9 or other sensitive receptors is considered low.</p> <p>The watercourse lies partially within native woodland which is a conservation area, however the watercourse is considered to have minimal influence on the woodland and the sensitivity is therefore considered low.</p>	Low

Fluvial Geomorphology	
<p>WFD hydromorphology status: not classified.</p> <p>The watercourse is a straight ditch approximately 120m long and flows into the River Tay.</p> <p>The channel is highly incised, likely due to steep gradient and downward angled culvert under the existing A9. It has a narrow channel (0.5m) comprising step-pool sequences. Channel substrate is predominantly earth and clay.</p>	Low
Water Quality	
<p>SEPA physico-chem/specific pollutants status: not classified.</p> <p>Potential pollutant sources:</p> <ul style="list-style-type: none"> diffuse run-off of contaminants associated with A9 traffic; and diffuse rural sources including suspended sediment from forestry and biological pollutants from grazing livestock. <p>Due to the small catchment size, low and likely intermittent flow regime, limited contribution in terms of flows and habitat to the downstream SAC, and lack of intrinsically linked receptors such as water supplies or aquatic ecology, this watercourse is considered to exhibit a low quality on a local scale. In line with DMRB HD45/09, it is therefore assigned a low sensitivity for this attribute.</p>	Low

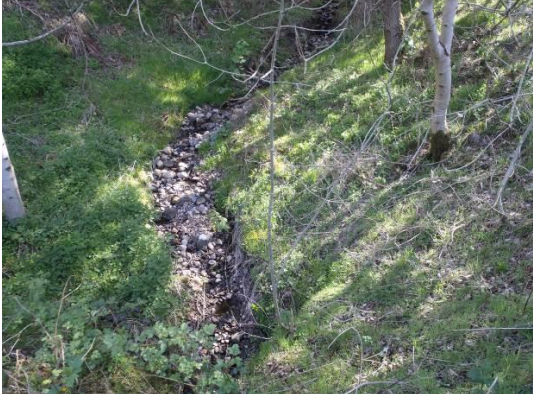
Table 18: WF35

Water feature type: Minor watercourse
	Catchment Area: 0.26km ²
	Key hydraulic connections: Issues in forestry upstream of existing A9 and discharges into the River Tay
	Surrounding land use: Rough pasture and forestry
Description of Specific Baseline Conditions	
Sensitivity	
Hydrology and Flood Risk	
<p>This watercourse has a catchment area less than 3km² so is not included in the SEPA Flood Map. No properties fall within 100m of the watercourse.</p> <p>Stage 3 baseline modelling of the 0.5% AEP (200-year) plus CC flood extent from the River Tay indicates that the culvert under the A9 is not flooded. Stage 3 analysis of the A9 culvert indicates that the watercourse is in bank at the culvert in the 0.5% AEP (200-year) plus CC event and flood risk is therefore considered low.</p> <p>The watercourse flows through an area of ancient woodland upstream of the A9 and is considered to have minimal hydrological importance to the woodland and therefore the sensitivity is considered low.</p>	Low

Fluvial Geomorphology	
<p>WFD hydromorphology status: not classified.</p> <p>The watercourse has a relatively straight planform, is highly incised with a narrow channel (0.5m), and comprising a step-pool sequences with predominantly gravel and pebble substrate.</p> <p>The channel is culverted beneath the existing A9.</p> <p>The planform is largely unchanged since 1867.</p>	Low
Water Quality	
<p>SEPA physico-chem/specific pollutants status: not classified.</p> <p>Potential pollutant sources:</p> <ul style="list-style-type: none"> • diffuse run-off of contaminants associated with A9 traffic; and • diffuse rural sources including suspended sediment from forestry and biological pollutants from grazing livestock. <p>Due to the small catchment size, low and likely intermittent flow regime, limited contribution in terms of flows and habitat to the downstream SAC, and lack of intrinsically linked receptors such as water supplies or aquatic ecology, this watercourse is considered to exhibit a low quality on a local scale. In line with DMRB HD45/09, it is therefore assigned a low sensitivity for this attribute.</p>	Low

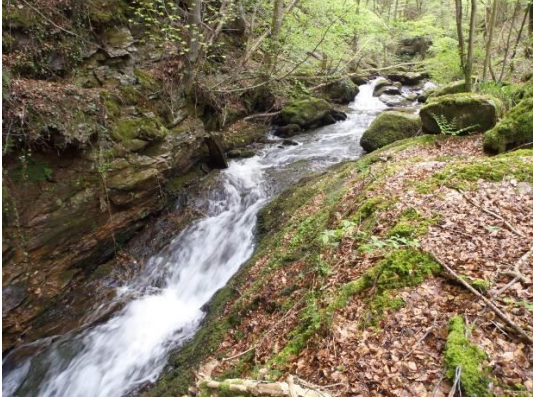
Table 19: WF36 Dowally Burn

<p>Photograph 19: WF36 (Dowally Burn) – view upstream of Dowally.</p>	Water feature type: Medium watercourse
	Catchment Area: 17.14km ²
	Key hydraulic connections: Issues from Loch Ordie, receives multiple inputs from small drains on its course downstream, and discharges into the River Tay downstream of the Dowally and existing A9.
	Surrounding land use: Uplands, agriculture rough pasture, forestry
	SEPA overall status: Moderate (2016).
Description of Specific Baseline Conditions	Sensitivity
Hydrology and Flood Risk	
<p>SEPA Flood Maps indicate seven properties at fluvial flood risk in the 0.5% AEP (200-year) event from overtopping along Dowally Burn including one non-residential property downstream of the existing A9 and Dowally Craft Centre and residential properties upstream of the existing A9. The SEPA extents do not take account of engineering structures; therefore, the indicative flood risk is likely to be conservative (over-estimated). The mapping shows a small area of flood risk to the A9 at its crossing of the Dowally Burn.</p> <p>The SEPA mapping suggests that overtopping of the A9 upstream (near WF38) spreads southward filling up a topographic depression bounded by the A9 embankment to the west and higher ground east of the access road to the Dowally Craft Centre.</p> <p>Stage 3 baseline modelling of the 0.5% AEP (200-year) event plus CC confirms that the A9 is at low risk from Dowally Burn. However, the River Tay flows back up into the lower section of the watercourse leading to the flooding of Dowally Farm located on the left bank of Dowally Burn. The hydraulic model suggests that the flooding to the east of the A9 does not reach as far south as Dowally as indicated by the SEPA mapping.</p> <p>A9 Stage 3 baseline modelling of the 0.5% AEP (200-year) plus CC flood extent indicates that the culvert under the A9 is flooded to upstream of the road, but that there is low flood risk to the road or to property upstream of the A9 as these are outside of the modelled flood events.</p> <p>The watercourse flows through an area of ancient woodland upstream of the A9 that is considered to have minimal hydrological importance to the woodland. SEPA Surface Water (pluvial) Flood Maps indicate a small area at risk of surface water flooding in a 10% AEP (10-year) event immediately upstream of the A9. However, no properties are shown to be at risk of flooding and the A9 and local access roads are shown not to be affected.</p>	High

Fluvial Geomorphology	
<p>WFD hydromorphology status: Moderate (2016).</p> <p>The watercourse flows from Lochan Oisinneach Beag (approx. NGR NO 038 557) for 0.9km to Lochan Oisinneach Mor. It continues south for 5km to Loch Ordie then south-east for 5km (drop in elevation of 230m) to the River Tay.</p> <p>The watercourse has an irregular meandering planform to Dowally; with the upstream section (upstream of residential buildings) comprising of large step-pool sequences and bedrock cascades. The channel gradient decreases through Dowally, where the channel becomes more uniform with riffle-pool sequences. Channel substrate is predominantly cobble and pebble. The channel is approximately 3m wide with high embankments (approximately 1.5m) either side of the channel downstream of the existing A9. The channel has been historically straightened through Dowally; planform is otherwise unchanged since 1867.</p> <p>The burn is culverted beneath the existing A9 and several access tracks.</p> <p>Historical map shows channel modification from wandering gravel-bed to a straight channel between 1900 and 1977 immediately upstream of River Tay. This alteration is likely to be the result of the southerly migration of the meander bend on the River Tay during this period and maintaining hydraulic connectivity of Dowally Burn with the River Tay.</p>	Medium

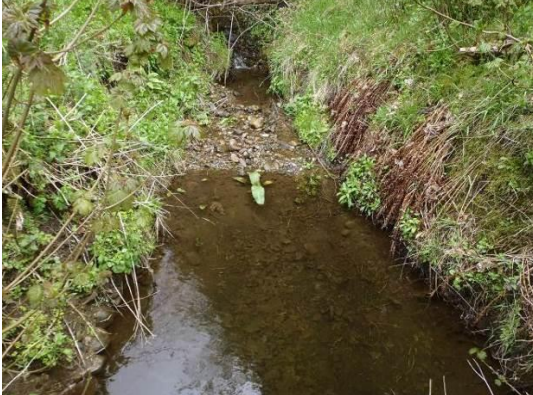
Table 20: WF37

Water feature type: Minor watercourse
	Catchment Area: 0.30km ²
	Key hydraulic connections: Issues in forestry upstream of existing A9 and discharges into the River Tay (WF06) via WF38 and WF36.
	Surrounding land use: Arable agriculture, rough pasture/improved pasture and forestry.
Photograph 20: WF37 – view upstream of Dowally side road.	
Description of Specific Baseline Conditions	Sensitivity
Hydrology and Flood Risk	
<p>This watercourse has a catchment area less than 3km² so is not included in the SEPA Flood Map. No properties fall within 100m of the watercourse. However, the SEPA mapping suggests that overtopping of the A9 upstream near WF38 spreads southward filling up a topographic depression bounded by the A9 embankment to the west and higher ground to the east of the access road to the Dowally Craft Centre which WF37 passes underneath. Stage 3 baseline modelling of the 0.5% AEP (200-year) plus CC flood extent from the River Tay indicates that the culvert under the A9 is flooded to upstream of the road. Flood extents to the east of the A9 near WF38 are not as extensive as indicated by the SEPA mapping but do extend as far as WF37. The Stage 3 modelling indicates that this is due to flooding from the River Tay through the culverts in the area rather than overtopping of the A9. Stage 3 analysis of the A9 culvert indicates that the watercourse is in bank at the culvert in the 0.5% AEP (200-year) plus CC event on WF37.</p> <p>The watercourse flows through an area of ancient woodland upstream of the A9 and is considered to have minimal hydrological importance to the woodland. . Hydraulic modelling indicates flooding from WF37 to fields downstream of the A9 in the AEP (200-year) plus CC event.</p>	Medium

Fluvial Geomorphology	
<p>WFD hydromorphology status: not classified.</p> <p>The watercourse is a small meandering channel flowing for 750m before being culverted under General Wade's Military Road and the existing A9. Upstream of the existing A9, the channel consists of step-pool sequences with sand and cobble substrate. The channel is largely incised at this section.</p> <p>Downstream of the existing A9, the channel is straightened with silt and fine gravel substrate and is approximately 0.4m wide. The channel ends within the arable field in a soakaway drain.</p> <p>The planform is largely unchanged since 1867.</p>	Low
Water Quality	
<p>SEPA physico-chem/specific pollutants status: not classified.</p> <p>Potential pollutant sources:</p> <ul style="list-style-type: none"> • diffuse run-off of contaminants associated with A9 traffic; and • diffuse rural sources including suspended sediment from forestry and biological pollutants from grazing livestock. <p>Due to the small catchment size, low and likely intermittent flow regime, limited contribution in terms of flows and habitat to the downstream SAC, and lack of intrinsically linked receptors such as water supplies or aquatic ecology, this watercourse is considered to exhibit a low quality on a local scale. In line with DMRB HD45/09, it is therefore assigned a low sensitivity for this attribute.</p>	Low

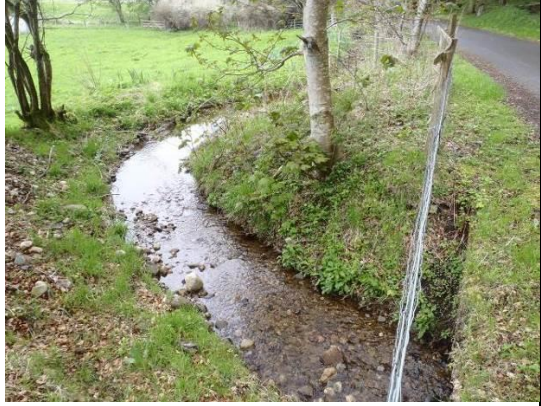
Table 21: WF38

Water feature type: Minor watercourse
	Catchment Area: 0.68km ²
	Key hydraulic connections: Issues in agricultural land upstream of the existing A9 and discharges into WF36 and subsequently the River Tay (WF6)
	Surrounding land use: Arable agriculture and rough pasture
Description of Specific Baseline Conditions	
Hydrology and Flood Risk	
<p>This watercourse has a catchment area less than 3km² so is not included in the SEPA Flood Map. No properties fall within 100m of the watercourse. However, the mapping shows the existing A9 to be at risk, suggesting that overtopping of the A9 upstream near WF38 spreads southward filling up a topographic depression bounded by the A9 embankment to the west and higher ground to the east of the access road to the Dowally Craft Centre (WF36).</p> <p>The SEPA extents however do not take account of minor watercourses (WF37 and WF38) with a catchment area <3km² which therefore could be under-predicting fluvial flood risk levels.</p> <p>Stage 3 baseline modelling of the 0.5% AEP (200-year) plus CC flood extent from the River Tay indicates that the culvert under the A9 is flooded to upstream of the road.</p> <p>Stage 3 analysis of the A9 culvert indicates that the watercourse is out of bank at the culvert in the 0.5% AEP (200-year) plus CC event, indicating a degree of flood risk from the watercourse, although hydraulic modelling indicates that there is no risk of flooding to the A9 despite flood depths of approximately 1m in places. Flooding is however predicted to the Dowally side road, with depths of over 0.5m in places and to arable land downstream of the A9.</p> <p>The watercourse flows through an area of ancient woodland upstream of the A9 and is considered to have minimal hydrological importance to the woodland. The watercourse flows through agricultural fields downstream of the A9.</p>	Medium

Fluvial Geomorphology	
<p>WFD overall hydromorphology status: not classified.</p> <p>The watercourse has four sources: three sinuous burns with uniform geomorphological features; one straight uniform drainage channel (historically modified).</p> <p>The watercourses converge and are culverted under General Wade's Military Road and the existing A9. The watercourse is straightened through fields west of existing A9 and terminated approximately 220m to the east of the River Tay, entering a soakaway drain.</p> <p>The channel is approximately 0.8m wide upstream of the existing A9, with step-pool sequences with cobble and pebble substrate.</p> <p>The channel downstream of the existing A9 is straightened and uniform with fine gravel substrate. Embankments (0.3m high) are present on both banks.</p> <p>The watercourse is shown on historical mapping in the 1900s with the same planform as the present day. The channel appears to be non-natural for drainage purposes.</p>	Medium

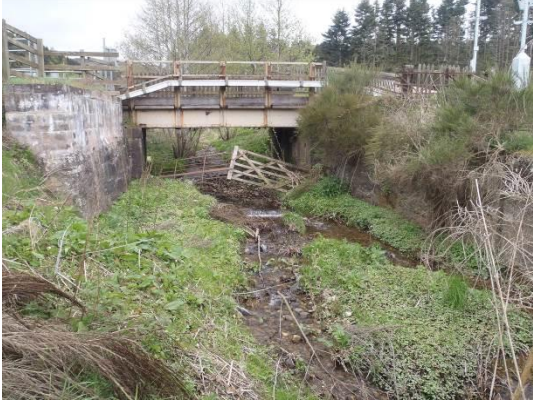
Table 22: WF39 Sloggan Burn

Water feature type: Medium watercourse
	Catchment Area: 2.12km ²
	Key hydraulic connections: Issues in the uplands and discharges into the River Tay downstream of Guay and the existing A9
	Surrounding land use: Uplands, agriculture - rough pasture, mixed forestry, residential
Description of Specific Baseline Conditions	
Hydrology and Flood Risk	
<p>This watercourse has a catchment area less than 3km² so is not included in the SEPA Flood Map. There are a number of residential properties in Guay located in close proximity to Sloggan Burn.</p> <p>Stage 3 baseline modelling of the 0.5% AEP (200-year) plus CC flood extent from the River Tay indicates that the culvert under the A9 is flooded to upstream of the road. The model predicts that the A9 will be overtopped over an approximately 50m length just south of the watercourse, with a more extensive area of overtopping approximately 200m long just to the north. The model indicates that Guay Farmhouse. The Highland Mainline Railway and agricultural land downstream of the A9 are at risk of flooding in the 0.5% AEP (200-year) plus CC flood on the watercourse. The watercourse lies partially within ancient woodland upstream of the A9. Guay Farmhouse is listed as a Category B listed building.</p>	Very High

Fluvial Geomorphology	
<p>WFD overall hydromorphology status: not classified.</p> <p>The source of the watercourse is in the Forest of Clunie. It has a sinuous planform upstream of the existing A9, step-pool sequences, cobble and gravel substrate, and the channel is approximately 0.7m wide. It is culverted under the existing A9, Highland Main Line railway and under an agricultural field before discharging into the River Tay. Historical mapping from 1867 shows a slightly more sinuous planform near Guay. Straightening of the lower reach is possibly due to construction of the Highland Main Line railway.</p>	Medium
Water Quality	
<p>SEPA physico-chem/specific pollutants status: not classified.</p> <p>Potential pollutant sources:</p> <ul style="list-style-type: none"> • diffuse run-off of contaminants associated with A9 traffic and Highland Main Line railway; • diffuse rural sources including suspended sediment from forestry and biological pollutants from grazing livestock; • TB-C5 former Guay Station (1867 to 1900) with potential contamination from hydrocarbons, polychlorinated biphenyls (PCBs) and other toxic chemicals –within 100m of the watercourse; • TB-C4 disused sand pit (1978). It is unknown whether this has been subsequently infilled - potential for contaminants associated with infill material; • TB-C6 disused sand and gravel opencast mine. It is unknown if the opencast mine has been subsequently infilled - potential for contaminants associated with infill material; and • TB-C7 former Smithy at Guay (1867 to 1900) with potential contamination from metals and polyaromatic hydrocarbons. 	Medium
