Appendix A11.1 Baseline Conditions

1 Introduction

- 1.1.1 This Appendix provides a detailed description of the baseline conditions of the water features (WF) referred to in Chapter 11 (Road Drainage and the Water Environment) and as shown on Figures 11.1 and 11.2.

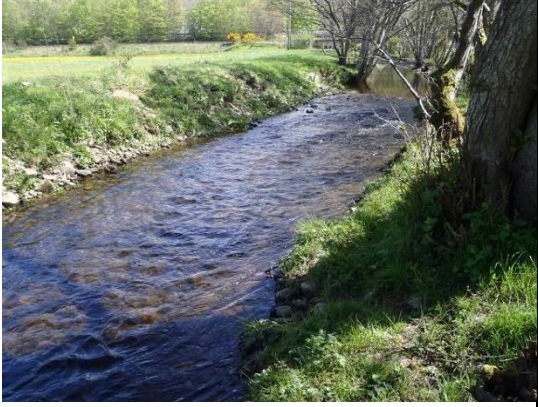
Table 23: WF40 Kindallachan Burn (WFD water body name: Tulliemet Burn)

<p>Photograph 23: WF40 (Kindallachan Burn) – view downstream from existing A9 bridge crossing.</p>	Water feature type: Medium watercourse
	Catchment Area: 19.2km ²
	Key hydraulic connections: Issues in the uplands and discharges into the River Tay downstream of Kindallachan and the existing A9
	Surrounding land use: Arable agriculture, rough pasture and improved grassland, residential and mixed forestry
	SEPA overall status: Good (2016).
Description of Specific Baseline Conditions	Sensitivity
Hydrology and Flood Risk	
<p>SEPA Flood Maps indicate that there are 12 residential properties at fluvial flood risk in Kindallachan in a 0.5% AEP (1 in 200) event. The existing A9 crosses the watercourse but is not shown to be at risk. However, the SEPA extents do not take account of engineering structures; therefore, the indicative flood risk is likely to be conservative (over-estimated). General Wade's Military Road crosses the watercourse and is shown to be at risk.</p> <p>Stage 3 baseline modelling of the 0.5% AEP (200-year) plus CC flood extent from the River Tay indicates that there is flooding of the A9 over approximately 50m lengths both north and south of the watercourse. Flooding on both banks is also indicated between the A9 and General Wade's Military Road. The model indicates reduced flood extents on the watercourse through Kindallachan, with no properties predicted to be at risk. The watercourse lies partially within native woodland which is a conservation area.</p> <p>Hydraulic modelling of a 0.5% AEP (200-year) plus CC event on WF40 indicates approximately a 20m length of the A9 would be flooded in a 0.5% AEP (200-year) plus CC event. There would also be flooding to farmland downstream of the A9 and to the Highland Mainline Railway embankment. Kindallachan Standing Stone and Kindallachan Cairn Scheduled Monuments are both within 100m of the channel but are not located in the 0.5% AEP (200-year) plus CC flood extent.</p>	Very High

Fluvial Geomorphology	
<p>WFD overall hydromorphology status: Good (2016).</p> <p>The watercourse source is in hills north of Ballinluig.</p> <p>The upstream section is sinuous with areas of deposition and erosion suggesting the burn is geomorphologically active.</p> <p>The middle section is more built-up and straightened and flows through Kindallachan to the River Tay. A number of waterfalls are present in this location suggesting it is bedrock controlled with a steep gradient and high stream power. The watercourse has predominantly cobble, pebble and gravel substrate.</p> <p>The gradient decreases towards the existing A9 and forms a riffle-pool sequence with some cobble side bars present. An embankment is present on the right bank measuring up to 0.5m high. The downstream section (west of a pooled area) is straightened and uniform with reinforced banks; the channel approximately 3.5m wide.</p> <p>The watercourse has a bridge over the existing A9 and General Wade's Military Road and culvert beneath access tracks.</p> <p>The planform has remained relatively consistent since 1867. The burn flowed into a secondary channel of the River Tay until 1980; it currently flows into a lake feature that drains via a straightened channel to the River Tay.</p>	High

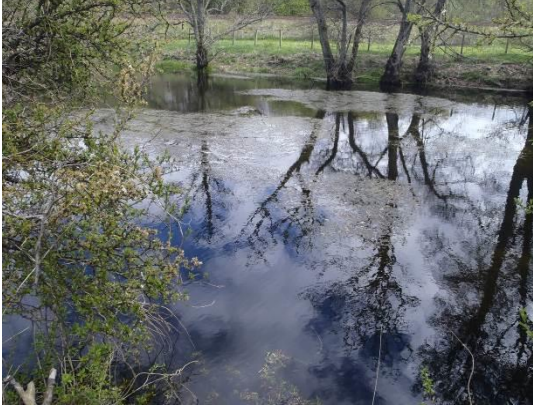
Table 24: WF41

<p>Photograph 24: WF41 – view across water feature (note: wide channel).</p>	Water feature type: Palaeochannel
	Catchment Area: 0.77km ²
	Key hydraulic connections: WF41 and WF42 represent the same interconnected palaeochannel feature. WF42 receives flows from WF45, WF46, WF47 and WF49 before discharging into WF41 after crossing the existing A9. WF41 discharges into WF40 prior to reaching the River Tay
	Surrounding land use: Arable agriculture, rough pasture and improved grassland
Description of Specific Baseline Conditions	Sensitivity
Hydrology and Flood Risk	
<p>WF41 to WF49 are intrinsically linked and located in an area of boggy marshland. WF47 and WF49 cross the existing A9 and flow towards WF41 on the west side of the A9. WF45 and WF46 converge into WF42 on the east side of the existing A9. Culverts exist at WF42 and WF41 to pass any flows under the existing A9 into the wide channel at WF41. SEPA Flood Maps indicate that there are no properties at fluvial flood risk. No properties fall within 100m of the watercourse.</p> <p>Stage 3 baseline modelling of the 0.5% AEP (200-year) plus CC flood extent indicates that the A9 is overtopped in this location by flooding from the River Tay over approximately a 300m length, resulting in the watercourse being flooded between the A9 and General Wade’s Military Road. However, hydraulic modelling of a 0.5% AEP (200-year) plus CC flood event on the watercourse indicates low flood risk to the A9 or other sensitive receptors, with small areas of flooding to farmland downstream of the A9 and in the wetland areas upstream of the a9.</p> <p>The watercourse lies partially within native woodland. Flows from the watercourses in this area discharge into the Kindallachan Burn upstream of the confluence with the River Tay.</p>	Medium

Fluvial Geomorphology	
The water feature is a historical secondary channel (palaeochannel) to the River Tay which has remained with a wide channel, approximately 15m, located within forestry. The water feature now has standing water.	Low
Water Quality	
<p>SEPA physico-chem/specific pollutants status: not classified.</p> <p>Potential pollutant sources:</p> <ul style="list-style-type: none"> • diffuse runoff including contaminants associated with A9 traffic and Highland Main Line railway; and • diffuse rural sources including suspended sediment from forestry and biological pollutants from grazing livestock. <p>Due to the small catchment size, limited contribution in terms of flows and habitat to the downstream SAC, and lack of intrinsically linked receptors such as water supplies or aquatic ecology, this watercourse is considered to exhibit a low quality on a local scale. In line with DMRB HD45/09, it is therefore assigned a low sensitivity for this attribute.</p>	Low

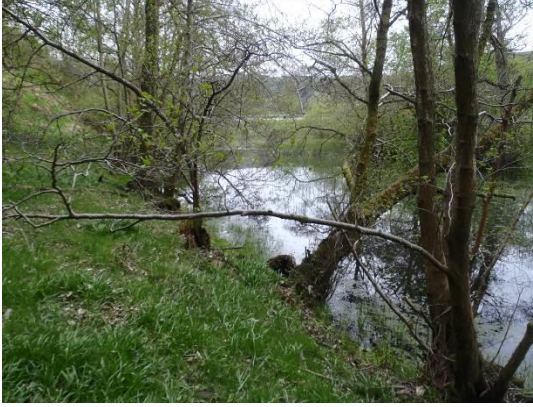
Table 25: WF42

<p>Photograph 25: WF42 – view across water feature towards existing A9.</p>	Water feature type: Palaeochannel
	Catchment Area: 0.77km ²
	Key hydraulic connections: WF41 and WF42 represent the same interconnected palaeochannel feature. WF42 receives flows from WF45, WF46, WF47 and WF49 before discharging into WF41 after crossing the existing A9. WF41 discharges into WF40 prior to reaching the River Tay
	Surrounding land use: Arable agriculture, rough pasture and improved grassland
Description of Specific Baseline Conditions	Sensitivity
Hydrology and Flood Risk	
<p>WF41 to WF49 are intrinsically linked and located in an area of boggy marshland. WF47 and WF49 cross the existing A9 and flow towards WF41 on the west side of the A9. WF45 and WF46 converge into WF42 on the east side of the existing A9. Culverts exist at WF42 and WF41 to pass any flows under the existing A9 into the wide channel at WF41.</p> <p>SEPA Flood Maps indicate that there are no properties at fluvial flood risk. No properties fall within 100m of the water feature.</p> <p>Stage 3 baseline modelling of the 0.5% AEP (200-year) plus CC flood extent indicates that the A9 is overtopped in this location by flooding from the River Tay over approximately a 300m length, resulting in the water feature being flooded between the A9 and General Wade’s Military Road. However, hydraulic modelling of a 0.5% AEP (200-year) plus CC flood event on the watercourse indicates low flood risk to the A9 or other sensitive receptors, with small areas of flooding to farmland downstream of the A9 and in the wetland areas upstream of the A9.</p> <p>The water feature lies partially within native woodland. Flows from the water features in this area discharge through agricultural land into the Kindallachan Burn upstream of the confluence with the River Tay.</p>	Medium

Fluvial Geomorphology	
<p>The standing water feature is approximately 13m wide. It has a silt substrate and no perceptible flow. Reeds present within the pool and it is surrounded by trees.</p> <p>The water feature appears historically as a secondary channel to the River Tay.</p>	Low
Water Quality	
<p>SEPA physico-chem/specific pollutants status: not classified.</p> <p>Potential pollutant sources:</p> <ul style="list-style-type: none"> diffuse run-off of contaminants associated with A9 traffic and railway use (TB-C2 Highland Main Line railway – crosses watercourse); and diffuse rural sources including suspended sediment from forestry and biological pollutants from grazing livestock. <p>Due to the small catchment size, limited contribution in terms of flows and habitat to the downstream SAC, and lack of intrinsically linked receptors such as water supplies or aquatic ecology, this watercourse is considered to exhibit a low quality on a local scale. In line with DMRB HD45/09, it is therefore assigned a low sensitivity for this attribute.</p>	Low

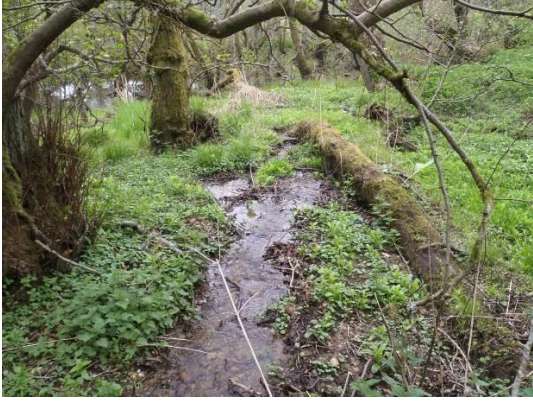
Table 26: WF45/WF46

<p>Photograph 26: WF45 – view downstream prior to discharge to WF42.</p>	Water feature type: Small watercourses
	Catchment Area: 0.194km ²
	Key hydraulic connections: WF45 and WF46 are minor watercourses which discharge into the WF41/WF42 palaeochannel feature
	Surrounding land use: Deciduous woodland and agriculture - rough pasture
Description of Specific Baseline Conditions	Sensitivity
Hydrology and Flood Risk	
<p>WF41 to WF49 are intrinsically linked and located in an area of boggy marshland. WF47 and WF49 cross the existing A9 and flow towards WF41 on the west side of the A9. WF45 and WF46 converge into WF42 on the east side of the existing A9. Culverts exist at WF42 and WF41 to pass any flows under the existing A9 into the wide channel at WF41.</p> <p>SEPA Flood Maps indicate that there are no properties at fluvial flood risk.</p> <p>SEPA Flood Maps indicate that there are no properties at fluvial flood risk. No properties fall within 100m of the watercourse.</p> <p>Stage 3 baseline modelling of the 0.5% AEP (200-year) plus CC flood extent indicates that the A9 is overtopped in this location by flooding from the River Tay over approximately a 300m length, resulting in the watercourse being flooded between the A9 and General Wade's Military Road. However, hydraulic modelling of a 0.5% AEP (200-year) plus CC flood event on the watercourse indicates that the A9 or other sensitive receptors are outside of the flood extents and therefore flood risk is considered low.</p> <p>The watercourse lies within native woodland, however this is upstream of the A9 and the hydrological importance of the watercourse to the woodland is considered low. Flows from the water features in this area flow through agricultural land into the Kindallachan Burn upstream of the confluence with the River Tay.</p>	Low

Fluvial Geomorphology	
<p>WFD overall hydromorphology status: not classified.</p> <p>WF45 flows from the wooded area east of the existing A9. The channel consists of step-pool sequences with predominantly cobble and gravel substrate; it is approximately 0.7m wide and the channel spreads before entering WF42.</p>	Low
Water Quality	
<p>SEPA physico-chem/specific pollutants status: not classified.</p> <p>Potential pollutant sources:</p> <ul style="list-style-type: none"> diffuse run-off of contaminants associated with A9 traffic and Highland Main Line railway; and diffuse rural sources including suspended sediment from forestry and biological pollutants from grazing livestock. <p>Due to the small catchment size, low and likely intermittent flow regime, limited contribution in terms of flows and habitat to the downstream SAC, and lack of intrinsically linked receptors such as water supplies or aquatic ecology, this watercourse is considered to exhibit a low quality on a local scale. In line with DMRB HD45/09, it is therefore assigned a low sensitivity for this attribute.</p>	Low

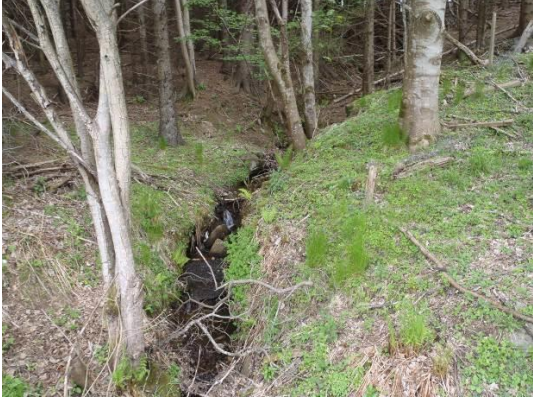
Table 27: WF47

<p>Photograph 27: WF47 – view upstream of existing A9 culvert.</p>	Water feature type: Minor watercourse
	Catchment Area: 0.16km ²
	Key hydraulic connections: Issues upstream of existing A9, is culverted beneath existing A9 and discharges into WF49, then subsequently WF42, WF41, WF40 and the River Tay.
	Surrounding land use: Agriculture - rough pasture and forestry
Description of Specific Baseline Conditions	
Hydrology and Flood Risk	
<p>This watercourse has a catchment area less than 3km² so is not included in the SEPA Flood Map. No properties fall within 100m of the watercourse. The A9 crosses the watercourse but is not shown to be at risk.</p> <p>Stage 3 baseline modelling of the 0.5% AEP (200-year) plus CC flood extent indicates that the A9 culvert is flooded downstream of the road.</p> <p>Stage 3 analysis of the A9 culvert indicates that the watercourse is out of bank immediately upstream of the A9 culvert in the 0.5% AEP (200-year) plus CC event, however the head water level is only 1mm above bank level and given the 1m freeboard to the A9 in this location, the flood risk is considered low.</p> <p>The watercourse lies partially within ancient woodland upstream of the A9, however the hydrological importance of the watercourse to the woodland is considered low. The watercourse flows into WF49 upstream of its confluence with the River Tay.</p>	Low

Fluvial Geomorphology	
<p>WFD overall hydromorphology status: not classified.</p> <p>WF47 flows from the wooded area to the east of the existing A9. Flows under the existing A9 in a culvert to join WF49.</p> <p>Upstream of the existing A9, the channel is highly incised (up to 3m deep in some locations) with several areas of mass failure and undercutting along the banks. The watercourse has predominantly step-pool sequences with gravel and pebble substrate. It flows through a culvert under the existing A9 into WF49.</p>	Low
Water Quality	
<p>SEPA physico-chem/specific pollutants status: not classified.</p> <p>Potential pollutant sources:</p> <ul style="list-style-type: none"> • diffuse run-off of contaminants associated with A9 traffic; and • diffuse rural sources including suspended sediment from forestry and biological pollutants from grazing livestock. <p>Due to the small catchment size, low and likely intermittent flow regime, limited contribution in terms of flows and habitat to the downstream SAC, and lack of intrinsically linked receptors such as water supplies or aquatic ecology, this watercourse is considered to exhibit a low quality on a local scale. In line with DMRB HD45/09, it is therefore assigned a low sensitivity for this attribute.</p>	Low

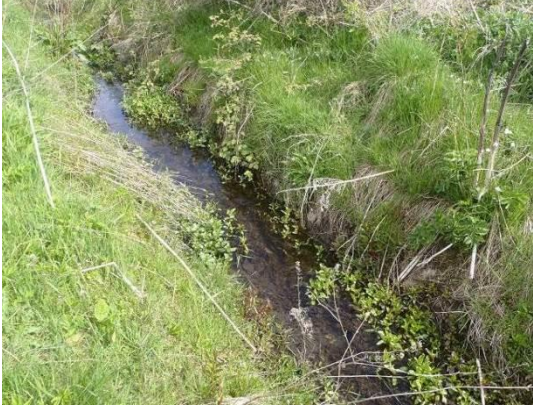
Table 28: WF49

<p>Photograph 28: WF49 – view upstream running parallel with existing A9 northbound carriageway embankment.</p>	Water feature type: Minor watercourse
	Catchment Area: 0.22km ²
	Key hydraulic connections: Issues upstream, is culverted under the existing A9, and runs parallel to the existing A9 within an artificial ditch before discharging into WF41 (subsequently WF40 and the River Tay).
	Surrounding land use: Agriculture - rough pasture and forestry
Description of Specific Baseline Conditions	Sensitivity
Hydrology and Flood Risk	
<p>This watercourse has a catchment area less than 3km² so is not included in the SEPA Flood Map. One residential property falls within approximately 10m of the watercourse but is outside of modelled 0.5% AEP (200-year) plus CC event flood extents.</p> <p>Stage 3 baseline modelling of the 0.5% AEP (200-year) plus CC flood extent on the River Tay includes the majority of the watercourse on the downstream side of the A9; however, does not extend as far as the culvert outlet under the A9. Stage 3 analysis of the A9 culvert indicates that the watercourse is in bank at the culvert in the 0.5% AEP (200-year) plus CC event and flood risk to the A9 is therefore considered low.</p> <p>The watercourse lies partially within ancient woodland upstream of the A9. The watercourse flows alongside agricultural land into WF41 prior to its confluence with the Kindallachan Burn.</p>	Medium

Fluvial Geomorphology	
<p>WFD overall hydromorphology status: not classified.</p> <p>WF49 flows from the wooded area to the east of the existing A9. Upstream of the existing A9, the channel consists mainly of step-pool sequences with some areas of riffles with increasing distance upstream. Channel substrate is predominantly gravel and cobble substrate with several sand bars along the course of the channel. The watercourse is overgrown with terrestrial vegetation in the upstream section. Downstream of the existing A9, the channel is straight and uniform with reinforced bed and banks. The channel is approximately 0.7m wide and is culverted beneath the existing A9. Historical maps (1900s-1987) only show WF49 to be present in an open corridor with no woodland cover. The burn appears to be man-made for land drainage purposes.</p>	Low
Water Quality	
<p>SEPA physico-chem/specific pollutants status: not classified.</p> <p>Potential pollutant sources:</p> <ul style="list-style-type: none"> • diffuse run-off of contaminants associated with A9 traffic; • diffuse rural sources including suspended sediment from forestry and biological pollutants from grazing livestock; • TB-C18 potential contaminants from septic tank at Haugh of Kilmorich; • TB-C10 site of former Gravel Pit (1900). It is unknown if the gravel pit has been subsequently infilled potential for contaminants associated with infill material; and • TB-C11 disused sand and gravel opencast mine. It is unknown if the opencast mine has been subsequently infilled. The ground investigation (2015/16) did not record any soil chemistry exceedance values. <p>Due to the small catchment size, low and likely intermittent flow regime, limited contribution in terms of flows and habitat to the downstream SAC, and lack of intrinsically linked receptors such as water supplies or aquatic ecology, this watercourse is considered to exhibit a low quality on a local scale. In line with DMRB HD45/09, it is therefore assigned a low sensitivity for this attribute.</p>	Low

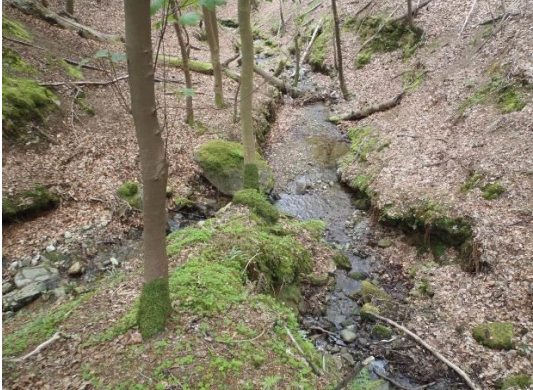
Table 29: WF50

<p>Photograph 29: WF50 – view within forestry upstream of existing A9</p>	Water feature type: Minor watercourse
	Catchment Area: 0.21km ²
	Key hydraulic connections: Issues upstream of existing A9, is culverted beneath the road and completely infiltrates to groundwater (i.e. no watercourse channel downstream) within a wooded area 100m south west of the A9.
	Surrounding land use: Forestry, arable agricultural land, rough pasture and improved pasture
Description of Specific Baseline Conditions	Sensitivity
Hydrology and Flood Risk	
<p>This watercourse has a catchment area less than 3km² so is not included in the SEPA Flood Map. No properties fall within 100m of the watercourse.</p> <p>Stage 3 baseline modelling of the 0.5% AEP (200-year) plus CC flood extent indicates that flooding from the River Tay is likely to affect the downstream end of the watercourse, but does not extend to the culvert outlet from the A9. Stage 3 hydraulic modelling indicates a risk of flooding to the A9 from this watercourse, with overtopping predicted over a 50m length of the road in the 0.5% AEP (200-year) plus CC flood event. Flooding is also predicted to agricultural land downstream of the A9 and against the Highland Mainline Railway embankment.</p> <p>The watercourse lies partially within ancient woodland which is a conservation area.</p>	Very High

Fluvial Geomorphology	
<p>WFD overall hydromorphology status: not classified.</p> <p>The watercourse is an irregularly meandering channel until it meets the existing A9, where the channel is shown to 'sink'. Upstream of the existing A9, the channel is incised and consists of step-pool sequences with predominantly cobble and pebble substrate. The channel is approximately 0.8m wide, relatively active with areas of erosion (mass failure and undercutting) and deposition (cobble bars). The channel downstream of the existing A9 is straightened and runs parallel to the existing A9. Channel substrate consists of fine gravel and silt. The watercourse spreads and sinks approximately 100m west of the existing A9.</p> <p>This watercourse is only present in historical maps after 1977; with the same planform as presently shown on OS map.</p>	Medium
Water Quality	
<p>SEPA physico-chem/specific pollutants status: not classified.</p> <p>Potential pollutant sources:</p> <ul style="list-style-type: none"> diffuse run-off of contaminants associated with A9 traffic and railway use (TB-C2 Highland Main Line railway – crosses watercourse); and diffuse rural sources including suspended sediment from forestry and biological pollutants from grazing livestock. <p>Due to the infiltration of flows to groundwater upon reaching the River Tay floodplain, the small catchment size, limited contribution in terms of flows and habitat to the downstream SAC, and lack of intrinsically linked receptors such as water supplies or aquatic ecology, this watercourse is considered to exhibit a low quality on a local scale. In line with DMRB HD45/09, it is therefore assigned a low sensitivity for this attribute.</p>	Low

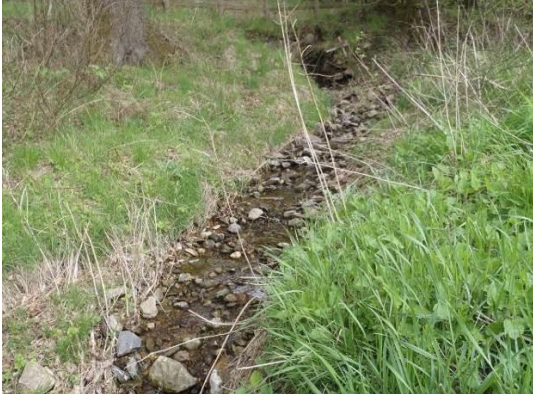
Table 30: WF52

Water feature type: Minor watercourse
	Catchment Area: 0.30km ²
	Key hydraulic connections: Issues as two tributaries in forestry upslope of A9. The tributaries merge in a single channel running upstream and parallel to existing A9. The single channel is culverted beneath the A9 and railway line, and infiltrates completely to groundwater approximately 400m to the south west of the A9.
	Surrounding land use: Arable agricultural land, rough pasture, improved grassland and mixed forestry
Photograph 30: WF52 – view upstream of existing A9 culvert.	
Description of Specific Baseline Conditions	Sensitivity
Hydrology and Flood Risk	
<p>This watercourse has a catchment area less than 3km² so is not included in the SEPA Flood Map. No properties fall within 100m of the watercourse.</p> <p>Stage 3 baseline modelling of the 0.5% AEP (200-year) plus CC flood extent indicates that the downstream end of the watercourse is within the River Tay flood extents, but the culvert under the A9 is further upstream. Stage 3 analysis of the A9 culvert indicates that the watercourse is out of bank at the culvert during the 0.5% AEP (200-year) plus CC event, indicating a degree of flood from this watercourse, although the freeboard to the A9 is over 1.2m so flood risk to the A9 is considered low. Flooding is predicted to local access roads. Downstream of the A9 there is flooding to agricultural land and at the base of the Highland Mainline Railway embankment. Upstream of the A9 the watercourse flows through ancient woodland.</p> <p>The watercourse flows through agricultural land downstream of the A9.</p>	Medium

Fluvial Geomorphology	
<p>WFD overall hydromorphology status: not classified.</p> <p>The watercourse has two sources that join and are culverted under the existing A9, then straightened to form a boundary between two fields. Upstream of the existing A9, both channels are highly incised and consist of step-pool sequences with cobble and gravel substrate. Channels are approximately 0.8m wide and have areas of erosion and deposition.</p> <p>The watercourse sinks in a field south of the Highland Main Line railway. The channel at this location is straightened and uniform and was dry at time of survey. The channel is not present on historical maps until the 1900s; the planform is the same as the present day and appears to be man-made for land drainage purposes.</p>	Low
Water Quality	
<p>SEPA physico-chem/specific pollutants status: not classified.</p> <p>Potential pollutant sources:</p> <ul style="list-style-type: none"> diffuse run-off of contaminants associated with A9 traffic and railway use (TB-C2 Highland Main Line railway – crosses watercourse); and diffuse rural sources including suspended sediment from forestry and biological pollutants from grazing livestock. <p>Due to the infiltration of flows to groundwater upon reaching the River Tay floodplain, the small catchment size, limited contribution in terms of flows and habitat to the downstream SAC, and lack of intrinsically linked receptors such as water supplies or aquatic ecology, this watercourse is considered to exhibit a low quality on a local scale. In line with DMRB HD45/09, it is therefore assigned a low sensitivity for this attribute.</p>	Low

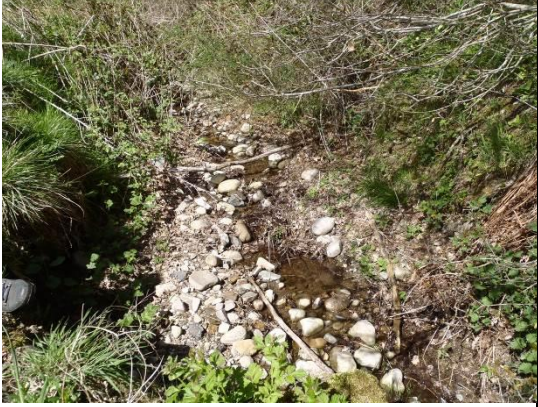
Table 31: WF53

Water feature type: Minor watercourse
	Catchment Area: 0.20km ²
	Key hydraulic connections: Issues within forestry upslope of existing A9 and infiltrates into groundwater downstream of existing A9. Potential connectivity with WF52 via existing road drainage (pre-earthwork drains).
	Surrounding land use: Arable agricultural land, rough pasture, improved grassland and mixed forestry
Description of Specific Baseline Conditions	
Hydrology and Flood Risk	
<p>This watercourse has a catchment area less than 3km² so is not included in the SEPA Flood Map. One property (Inch Cottage) falls within approximately 10m of the watercourse.</p> <p>Stage 3 baseline modelling of the 0.5% AEP (200-year) plus CC flood extent indicates that the flood extents from the River Tay and River Tummel extend under the Highland Main Line railway via culverts and back up the watercourse. The culvert under the A9 is flooded on the upstream side. The floodwaters associated with the hydraulic modelling from the River Tay extend under the Highland Main Line railway via drain culverts and underpasses towards the A9. The Highland Main Line railway and the A9 are not shown to be at fluvial flood risk in this location.</p> <p>Stage 3 analysis of the A9 culvert indicates some flooding on either side of the A9 culvert in the 0.5% AEP (200-year) plus CC event on WF53, but that the A9 and other sensitive receptors are outside of the predicted flood extents and therefore are considered to be at low risk. Agricultural land and the foot of the Highland Mainline Railway embankment are at risk of flooding in this event.</p> <p>The watercourse lies partially within ancient woodland upstream of the A9 and passes through agricultural land downstream of the A9.</p>	Medium

Fluvial Geomorphology	
<p>WFD hydromorphology status: not classified.</p> <p>The watercourse source in a wooded area to north-east of existing A9 and is culverted under an access track to Inch Cottage. The channel is a straight, uniform drainage channel with cobble substrate and was dry at the time of survey. Historically, it was a sinuous channel up to the Highland Main Line railway and a straightened channel downstream to the River Tummel. Between 1980 and the latest OS maps, the burn has been culverted or disconnected and is shown to end at the existing A9.</p>	Low
Water Quality	
<p>SEPA physico-chem/specific pollutants status: not classified.</p> <p>Potential pollutant sources:</p> <ul style="list-style-type: none"> diffuse run-off of contaminants associated with A9 traffic; and diffuse rural sources including suspended sediment from forestry and biological pollutants from grazing livestock. <p>Due to the infiltration of flows to groundwater upon reaching the River Tay floodplain, the small catchment size, limited contribution in terms of flows and habitat to the downstream SAC, and lack of intrinsically linked receptors such as water supplies or aquatic ecology, this watercourse is considered to exhibit a low quality on a local scale. In line with DMRB HD45/09, it is therefore assigned a low sensitivity for this attribute.</p>	Low

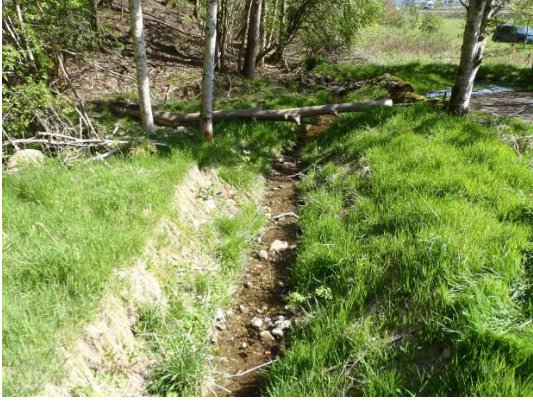
Table 32: WF55

Water feature type: Minor watercourse/palaeochannel
	Catchment Area: 0.38km ²
	Key hydraulic connections: Issues as three tributaries upstream of the A9. The tributaries merge into a single channel that is culverted beneath the A9. Downstream of the A9 it becomes ephemeral/infiltrates to groundwater as it crosses the floodplain, feeds into a palaeochannel and collects upstream of an impoundment.
	Surrounding land use: Arable agricultural land, rough pasture, improved grassland and mixed forestry.
Description of Specific Baseline Conditions	
Hydrology and Flood Risk	
<p>This watercourse has a catchment area less than 3km² so is not included in the SEPA Flood Map. Station Cottages and Inch Farm fall within 80m of the watercourse.</p> <p>Stage 3 baseline modelling of the 0.5% AEP (200-year) plus CC flood event indicates that downstream of the A9 culvert the watercourse is within the flood extents of the River Tummel. The floodwaters from the River Tummel extend under the Highland Main Line railway via drain culverts and underpasses towards the A9 and show Station Cottages and Inch Farm (House of Bruar) to be at risk. Flooding is also shown on the upstream side of the A9, due to floodwater overtopping the A9 north of the Ballinluig junction and flowing south towards the watercourse. However, there is no flood risk predicted to the A9, the railway or to the buildings due to a flood event from the watercourse. Upstream of the A9 the watercourse flows partially through ancient woodland however the hydrological influence is considered low. Downstream of the A9 the watercourse flows through agricultural land. Stage 3 culvert analysis indicates that flows are in bank and therefore flood risk from WF55 is considered low.</p>	Medium

Fluvial Geomorphology	
<p>WFD overall hydromorphology status: not classified.</p> <p>The watercourse had three sources, east of Port of Tummel Farm, which join to flow under the existing A9 in a culvert. It reappears as a straightened channel to the west of the existing A9.</p> <p>Upstream of the existing A9, the channels consist of step-pool sequences with gravel and cobble substrate. As they flow into the drainage ditches, the channels are uniform, straight and consist of silt substrate. The channel is culverted under the land between the existing A9 and the Highland Main Line railway. Downstream of the Highland Main Line railway, the channel is over-wide, embanked and lacks any geomorphological features.</p>	Low
Water Quality	
<p>SEPA physico-chem/specific pollutants status: not classified.</p> <p>Potential pollutant sources:</p> <ul style="list-style-type: none"> diffuse run-off of contaminants associated with A9 traffic and railway use (TB-C2 Highland Main Line railway – crosses watercourse); diffuse rural sources including suspended sediment from forestry and biological pollutants from grazing livestock; and point source sewage discharge from septic tank effluent to soakaway at 1-4 Station Cottages. <p>Due to the infiltration of flows to groundwater upon reaching the River Tay floodplain, the small catchment size, limited contribution in terms of flows and habitat to the downstream SAC, and lack of intrinsically linked receptors such as water supplies or aquatic ecology, this watercourse is considered to exhibit a low quality on a local scale. In line with DMRB HD45/09, it is therefore assigned a low sensitivity for this attribute.</p>	Low

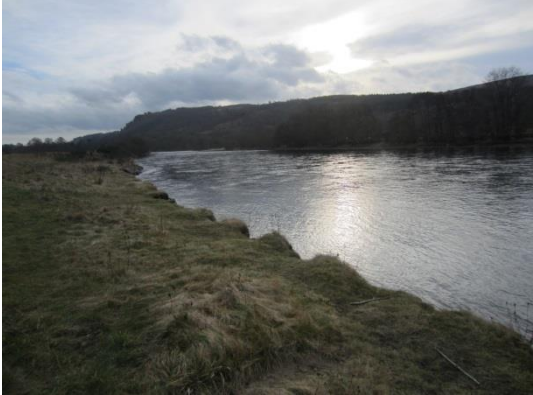
Table 33: WF70 River Tummel (Reach Loch Faskally to River Tay confluence)

<p>Photograph 33: River Tummel looking downstream towards confluence with River Tay</p>	Water feature type: Major watercourse
	Catchment Area: 1,715km ²
	Key hydraulic connections: Major tributary of the River Tay, which converge within the study site and to the east of the existing A9.
	Surrounding land use: Arable agricultural land, rough pasture, improved grassland, mixed forestry, and urban (immediately downstream of Loch Faskally)
	SEPA overall status: Good ecological potential (2016).
Description of Specific Baseline Conditions	Sensitivity
Hydrology and Flood Risk	
<p>The confluence between the River Tay and the River Tummel is located at the upstream extent of the study area. The River Tummel flows in a southerly direction with a catchment area of 1,715km² and does not cross the existing A9 within the study area. The River Tummel passes in close proximity to a number of settlements including Ballinluig and Dalnabo. The River Tummel itself is part of the River Tay SAC and the Shingle Islands within the river are an SSSI and SAC.</p> <p>SEPA Flood Maps indicate no flood risk to properties, the Highland Main Line railway or the A9 within the study area. Stage 3 baseline modelling of the 0.5% AEP (200-year) plus CC flood extent predicts the floodwaters from the River Tummel impact the A9 immediately upstream of the A827. The flows then extend southwards along a path towards WF56. There are two properties predicted to be at risk in Ballinluig, as well as Station Cottages on the flood plain west of the A9 and the House of Bruar Warehouse complex between the Highland Main Line railway and the A9.</p> <p>SEPA Surface Water (pluvial) Flood Maps indicate that there are small areas of surface water flood risk in the River Tummel floodplain, however none of these impact on property.</p>	Very High

Fluvial Geomorphology	
<p>WFD overall hydromorphology status: Moderate (2016).</p> <p>The River Tummel has a wandering gravel-bed river planform, with a multi-thread planform at the confluence with the River Tay. Large cobble/pebble depositional features are characteristic of the River Tummel in the form of point bars, side bars and mid-channel bars. Both un-vegetated and vegetated depositional features are present; the latter providing an indicator of recent stability, albeit still prone to future channel adjustment. A riparian zone consisting of established trees and shrubs is present on both banks. The channel is approximately 50m wide, with variety of geomorphological features, including large riffle sequences, side-arms, secondary channels and palaeochannels.</p> <p>The River Tummel has a long history of channel change over the past 275 years. Historical maps show evidence of a braided river system with six to seven channel threads and several large mid-channel bars at confluence with River Tay. The River Tummel maintains a wandering gravel-bed river planform downstream of Pitlochry dam at Loch Faskally, with notable channel change, in particular around Tomdachoille Island, Ballinluig Island and Richard's Island (at the confluence with the River Tay) during the 20th Century since the abandonment of embankment maintenance in 1903.</p> <p>Existing pressures: river regulation, in particular the impacts of the Pitlochry dam at Loch Faskally. Impacts include modification to the natural flow regime, including reduced flow variation, peak flows and a less flashy regime. The Pitlochry dam structure also inhibits the downstream movement of sediment; thus the river is impacted by sediment depletion. The existing sediment is now re-worked during high flow events, along with some zones of channel incision being present. This, in combination with regulated flow, has impacted upon the morphological dynamics of the River Tummel. This has resulted in a more stable regime where channel change, including channel avulsion, is less frequent. Prior to the construction of the Pitlochry dam, the shingle islands were typically mobile and provided the habitat template for the species rich communities that are designated under the Shingle Islands SSSIs. The reduced fluvial disturbance regime has enabled vegetation colonisation of the shingle islands, including dense scrub and wet woodlands. Morphological change on the River Tummel is now more likely to occur only during high magnitude flood events.</p>	High
