## **Appendix A11.5: Fluvial Geomorphology**

- 1.1.1 This technical appendix informs Chapter 11 (Road Drainage and the Water Environment) of the Environmental Statement (ES). It focuses on the fluvial geomorphology aspects of the study, providing a detailed understanding of the baseline environment and the assessment of impacts of the proposed scheme. The appendix focuses only on those water features that have been given a medium, high or very high sensitivity. Low sensitivity water features are not included in the appendix; these are discussed in Appendix A11.1 (Baseline conditions) and Appendix A11.7 (Impact Assessment).

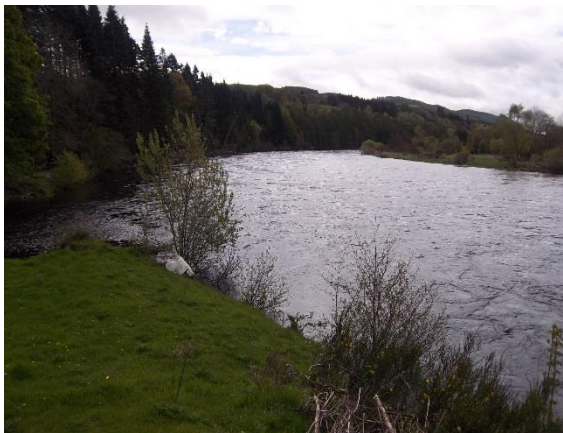
**Photograph 1a: The River Tay looking downstream at Dowally**

- 3.1.2 The River Tay within the study area has a meandering planform and a predominantly single-thread channel. The channel exhibits signs of a previously wandering gravel-bed system with palaeochannels and side-arms present within the floodplain, and active erosion and deposition at several locations. The channel has numerous large pebble/cobble deposits throughout the study area including point bars, side bars and mid-channel bars (both vegetated and unvegetated) (Photograph 1). A combination of flow regulation and river training, such as embankments, river realignment and localised bank protection, has resulted in the river being confined primarily within a single-thread channel. Given the discharge and energy of this river system, it retains the power to re-activate former river channels and adjust its course during high flow events.

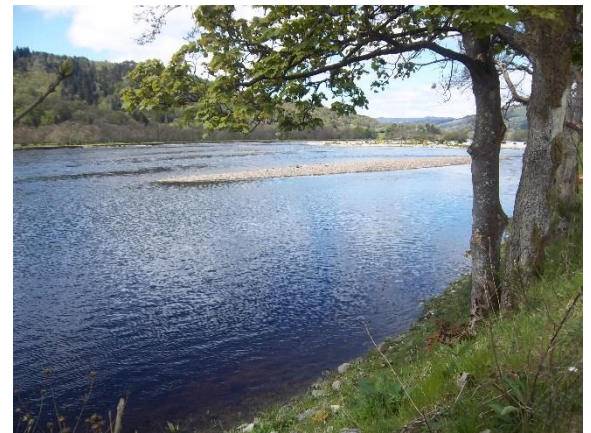
**Photograph 1b: The River Tay looking upstream at Kindallachan**

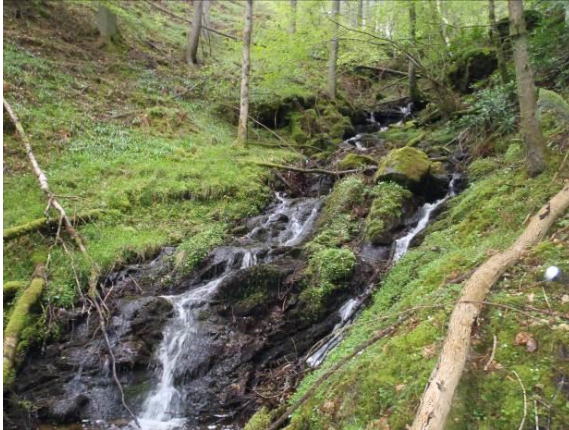
**Photograph 2a: Bedrock cascade looking upstream of Rotmell Wood forestry track**

- 3.1.8 WF23 is a medium watercourse which has its source in Rotmell Wood approximately 350m east of General Wade's Military Road. The channel has a steep gradient and is confined at the base of two steep valley sides, with an average width of approximately 1m upstream of Rotmell Wood forestry track and approximately 2m downstream of the road. The catchment land use consists predominantly of coniferous woodland with a small section of marshland in the centre of the catchment area.

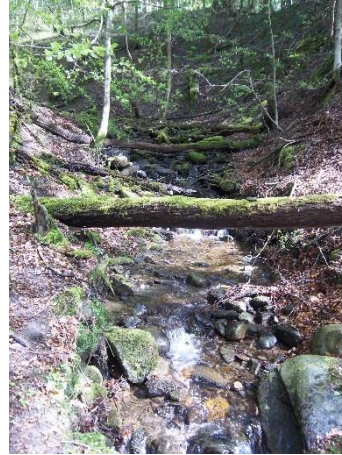
**Photograph 2b: Step-pool sequence upstream of General Wade's Military Road**

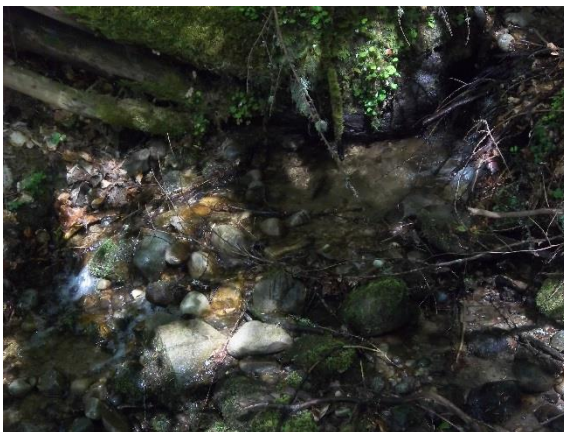
**Photograph 3a: Downstream of forestry track (looking downstream)**

- 3.1.11 WF24 is a medium watercourse which has its source in a clearing of Rotmell Wood. The water feature flows west for approximately 630m before flowing into the River Tay north west of Warren Lodge. The channel has a steep gradient and is confined within the valley sides. Catchment land use consists of open moorland in the upper section and coniferous woodland in the downstream section.
- 3.1.12 The channel predominantly has a step-pool sequence with cobble and sand substrate. The water feature is crossed by a bridge structure for the forestry track and General Wade's Military Road, and is culverted under the existing A9.
- 3.1.13 Historical map analysis shows minimal change with the planform remaining consistent since 1867. The water feature was culverted under the existing A9 between 1900 and 1977.

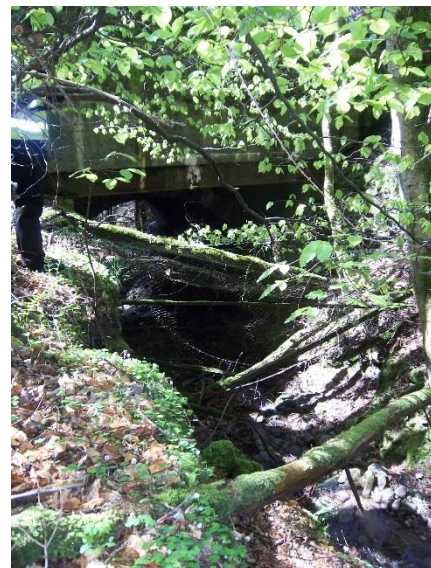
**Photograph 3b: Riffle-pool sequence upstream of existing A9 (looking upstream)**

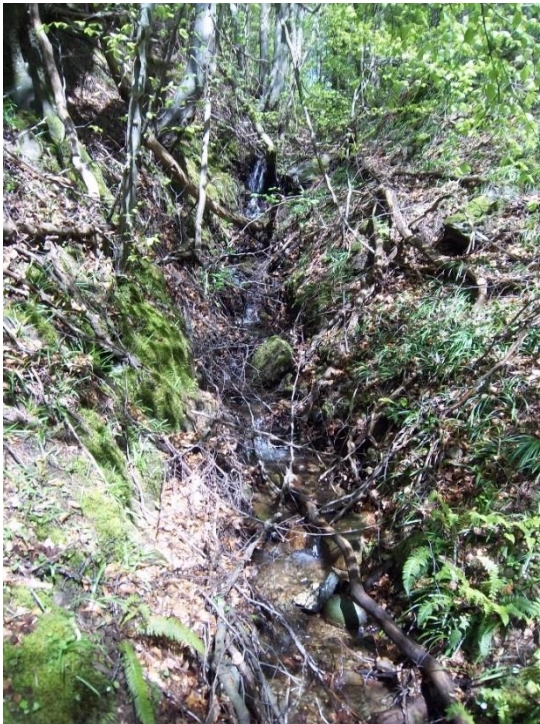
**Photograph 4a: WF25 upstream of General Wade's Military Road (looking upstream)**

- 3.1.15 WF25 has a predominantly straight planform with a step-pool sequence and cobble and sand substrate, measuring approximately 0.7m in width upstream of the existing A9 and 1.5m downstream of the road. The channel appeared to be incised along several reaches and woody material (including fallen trees and broken branches) created a variety of flow types in several locations, particularly upstream of General Wade's Military Road.

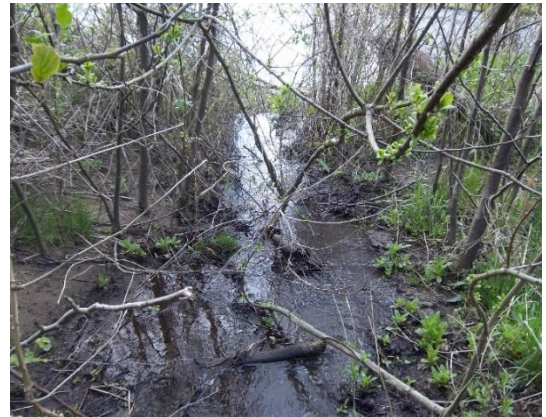
**Photograph 4b: Looking downstream of the existing A9 crossing towards the Tay**

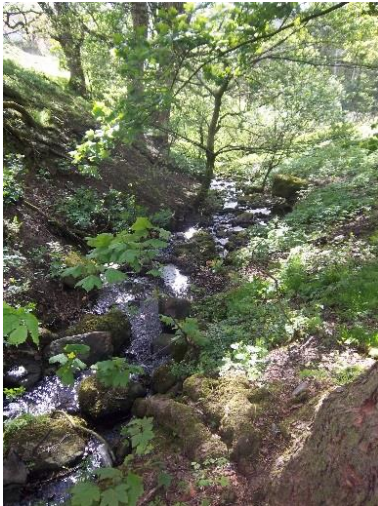
**Photograph 5a: Step-pool sequence (looking upstream)**

- 3.1.17 WF32 is a medium watercourse which has its source in Rotmell Wood. The water feature flows north-west for approximately 1.65km before flowing into the River Tay west of Cottage No 2. Rotmell Farm. Catchment land use consists of coniferous woodland in the upstream reach and open moorland and pastoral agricultural land in the downstream reach. The channel has a steep gradient and, from available mapping, appears to be culverted under several access roads, forestry tracks and for approximately 100m under Rotmell Farm and Farmhouse. The water feature is also culverted under General Wade's Military Road and the existing A9.

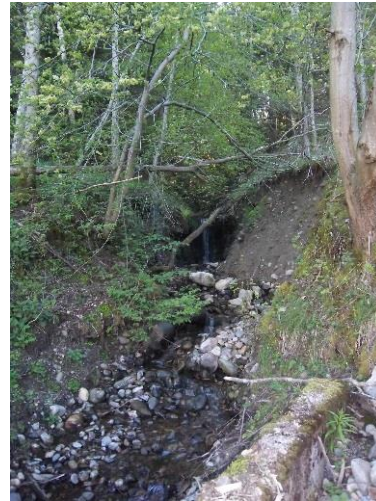
**Photograph 5b: Knickpoint migration immediately upstream of General Wade's Military Road (looking upstream)**

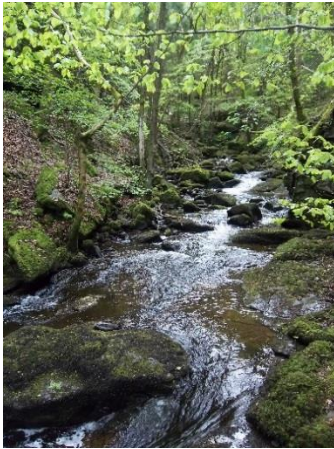
**Photograph 6a: Typical channel character upstream of Dowally (looking upstream)**

- 3.1.20 Dowally burn is a large watercourse which flows from Lochan Oisineach Beag (approx. NGR NO 038 557) for 0.9km to Lochan Oisineach Mor. The water feature continues south for 5km to Loch Ordie before flowing south-east for a further 5km (drop in elevation of 230m) to the River Tay west of Dowally. Catchment land use consists predominantly of open moorland in the upstream section and mixed coniferous and deciduous woodland in the downstream section (west of Raor Lodge) with a small section of pastoral agricultural land downstream of the existing A9.

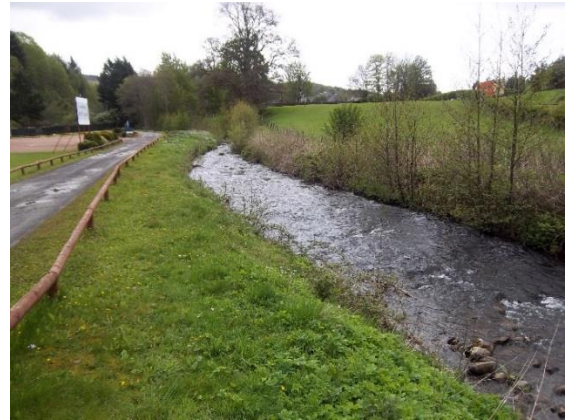
**Photograph 6b: Channel downstream of Dowally, immediately upstream of the existing A9 (looking upstream)**

- 3.1.22 Analysis of historical mapping shows that Dowally Burn historically has a sinuous planform downstream of Dowally with woodland land use and mid channel bars. Between 1900 and 1977 the channel was modified to become straightened at this location. With the exception of this, the channel is largely unchanged since 1867.

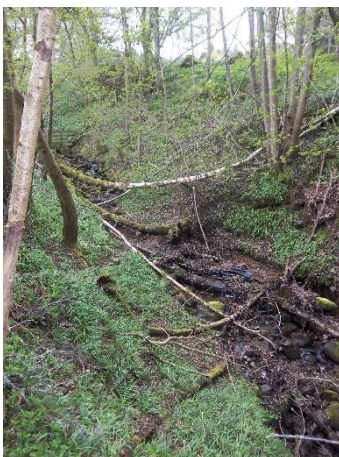
**Photograph 7a: Typical channel cross-section with step-pool sequence upstream of General Wade's Military Road (looking upstream)**

- 3.1.24 WF38 comprises of three sinuous channels and one straight uniform drainage channel (historically modified). All four watercourses join east of General Wade's Military Road to form one channel under the road and the existing A9.

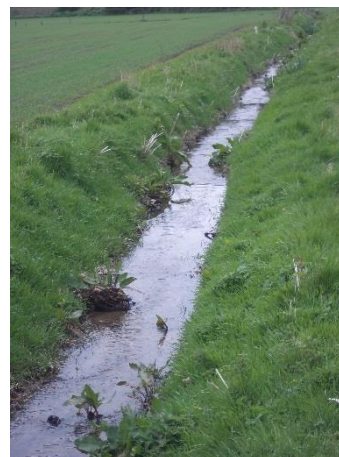
**Photograph 7b: Straight planform and embankment downstream of the existing A9 (looking downstream)**

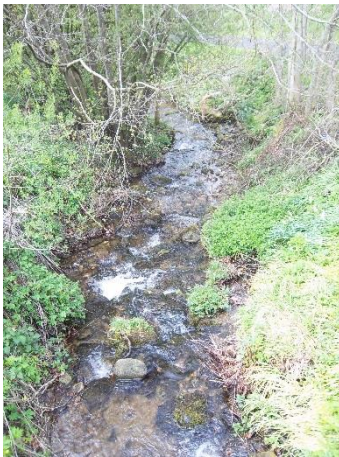
**Photograph 8a: Typical channel cross-section upstream of the existing A9 (looking downstream)**

- 3.1.28 Within the upstream sections, the channel measures approximately 1.2m wide and has step-pool sequences with cobble and gravel substrate. Downstream of the existing A9, Sloggan Burn appeared to be overwidened (approximately 4m wide) and the river had deposited material to create a low flow channel of approximately 0.7m wide, which split into two channels west of the railway.
- 3.1.29 Historical mapping from 1867 shows that the channel was slightly more sinuous in planform near Guay, than the current channel. The channel also appears to have been straightened in the lower reach, most likely due to the construction of the railway.

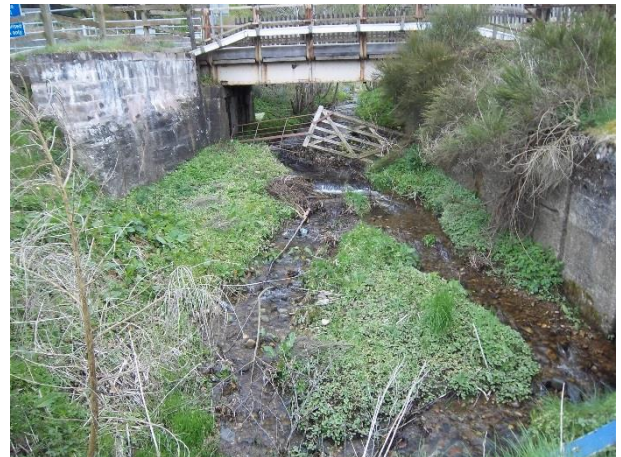
**Photograph 8b: Section of bank reinforcement immediately downstream of the highland railway (looking upstream)**

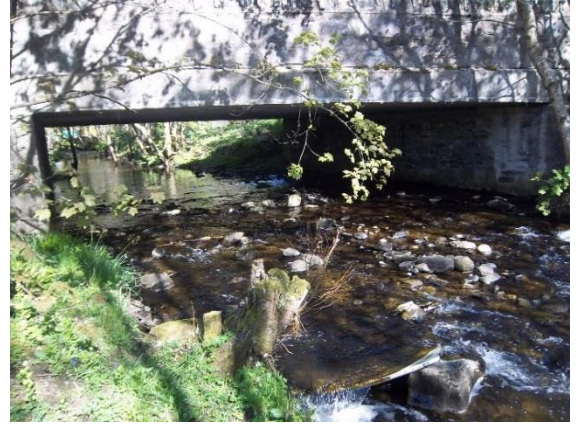
**Photograph 9b: Typical channel cross-section downstream of the existing A9 (looking downstream)**

- 3.1.30 Kindallachan Burn (WF40) has its source north of Baledmund Farm, approximately 2km north-east of Kindallachan village. The water feature flows south for 2km to West Balnald and west for a further 1.35km to its confluence with the River Tay. The channel has a sinuous planform within the upper sections and a straightened, more modified planform in the downstream section, particularly downstream of the existing A9 crossing. The water feature is crossed by several access tracks and roads, including General Wade's Military Road and the existing A9. Catchment land use consists of pastoral agricultural land in the upper catchment and mixed deciduous and coniferous woodland in the downstream section. The water feature has a continuous tree lining which is likely to provide channel shading and bank stability.

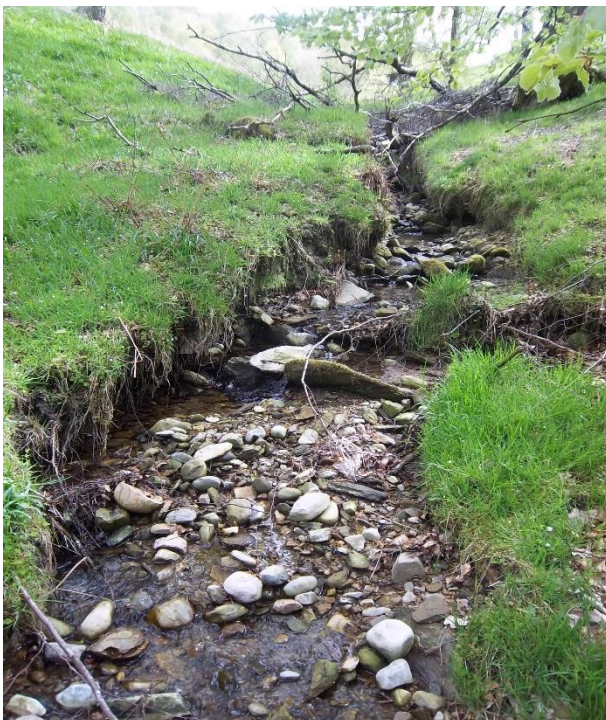
**Photograph 10a: Looking upstream south of the existing A9**

- 3.1.34 WF50 has its source south of Cuil-an-Duin and flows south for approximately 250m before flowing under the existing A9. Downstream of the road, the burn is shown to 'sink' a further 200m downstream, potentially via a culvert. The watercourse has an irregularly meandering planform in the upper catchment and the channel is incised consisting of a step-pool sequence with predominantly cobble and pebble substrate. The channel measures approximately 0.8m in width and is relatively active with areas of erosion (mass failure and undercutting) and deposition (cobble bars). The channel downstream of the existing A9 is artificially straightened with fine gravel and silt substrates.
- 3.1.35 Analysis of historical maps shows that the channel is only visible on maps after 1977. After this date the channel appears to have the same planform currently shown on contemporary OS maps.

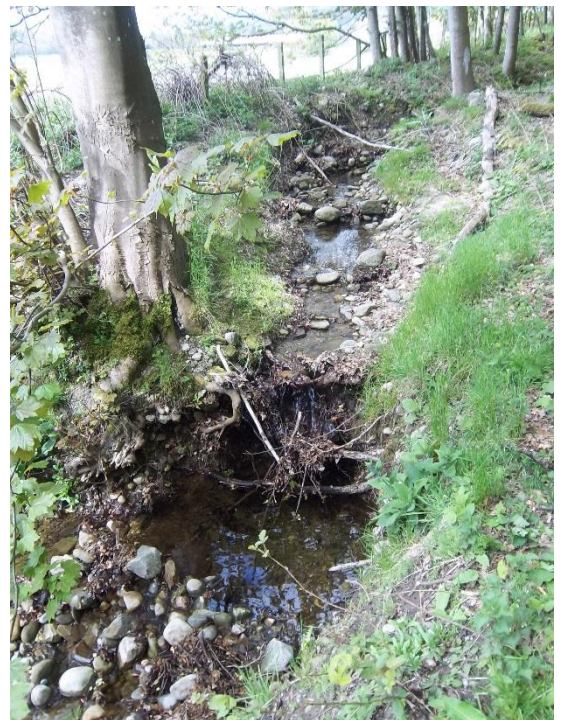
**Photograph 10b: Looking upstream north of the existing A9**

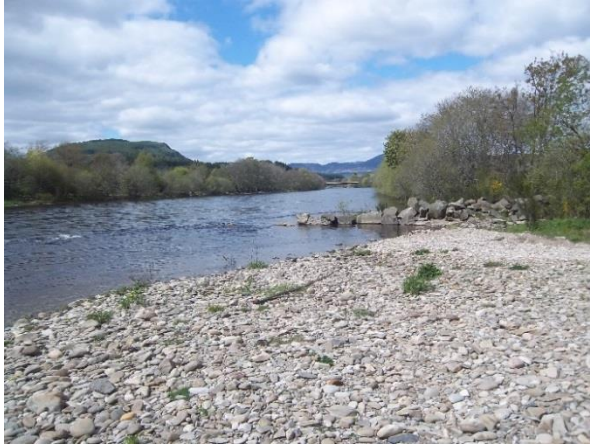
**Photograph 11a: Typical channel cross-section south of the existing A9 (looking downstream)**

- 3.1.36 The River Tummel (WF70) is a wandering gravel-bed river, with the localised planform from Ballinluig crossing to the confluence with the River Tay being relatively straight. Large cobble/pebble depositional features are characteristic of the Tummel in the form of point bars, side bars and mid-channel bars. Both unvegetated and vegetated depositional features are present; the latter providing an indicator of stability. A riparian zone, consisting of established trees and shrubs, is present on both banks. The river channel is approximately 50m wide, with a variety of geomorphological features, including large riffle sequences, secondary channels and palaeochannels.

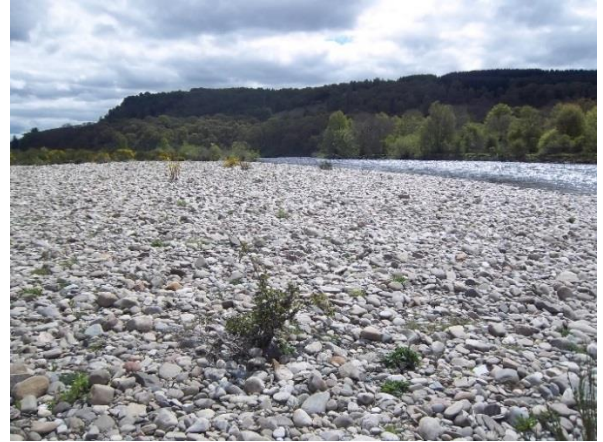
**Photograph 11b: Large gravel deposit observed north of the existing A9 (looking upstream)**

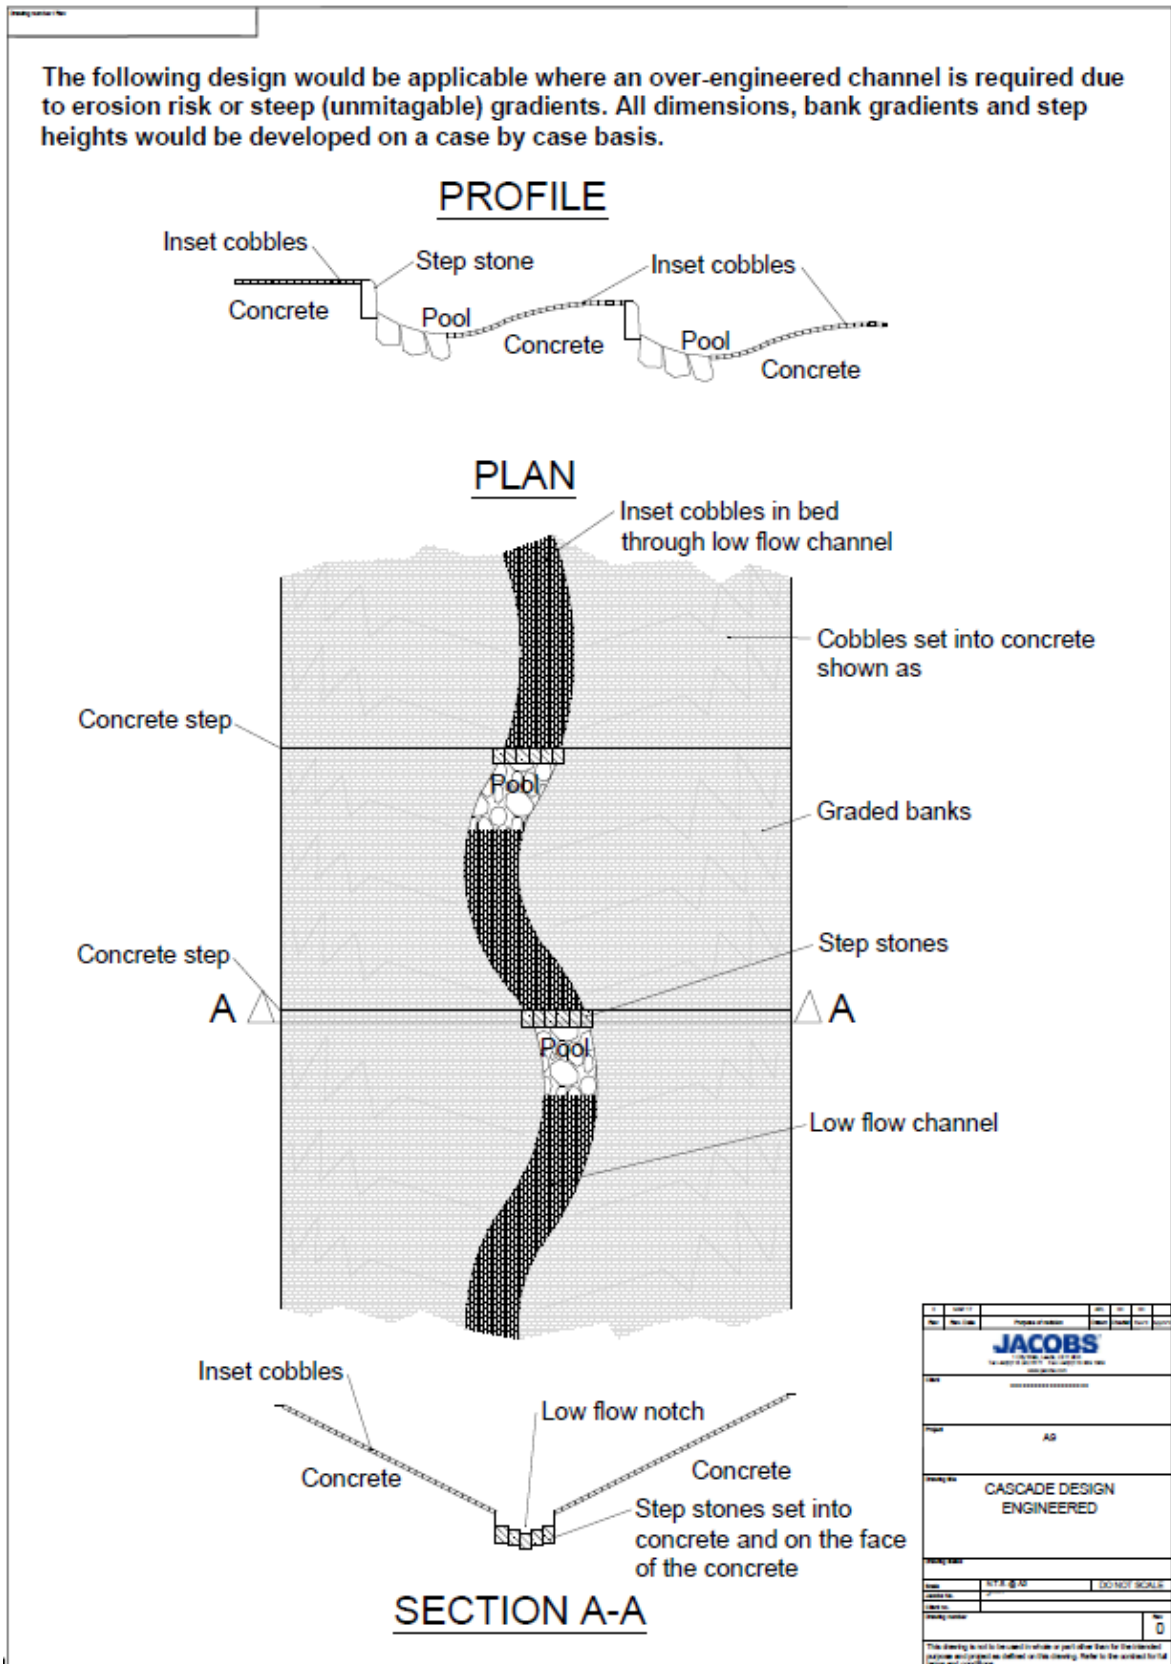
Diagram 4: Conceptual diagram illustrating, in profile, plan view and cross-section, the constituents of a step-pool bed morphology for an engineered design for high erosion risk sites

5.1.5 Diagrams 2, 3 and 4 provide an indicative conceptual design illustrating the potential design and layout of the proposed natural cascade (step-pool sequence) detailed above. The design replicates the natural bed (i.e. gravel or cobble) and uses large boulders to form the steps that check the gradient in a steepened length that requires a cascade. Between each step, a pool is created, proportional to channel geometry, acting to slow flows and dissipate energy. The conceptual design provides a cascade that would be closer to mimicking existing channel characteristics and would therefore, would provide benefits for the morphology of the water features. The design would need to be developed during detailed design and made specific to each water feature to ensure it functions effectively.

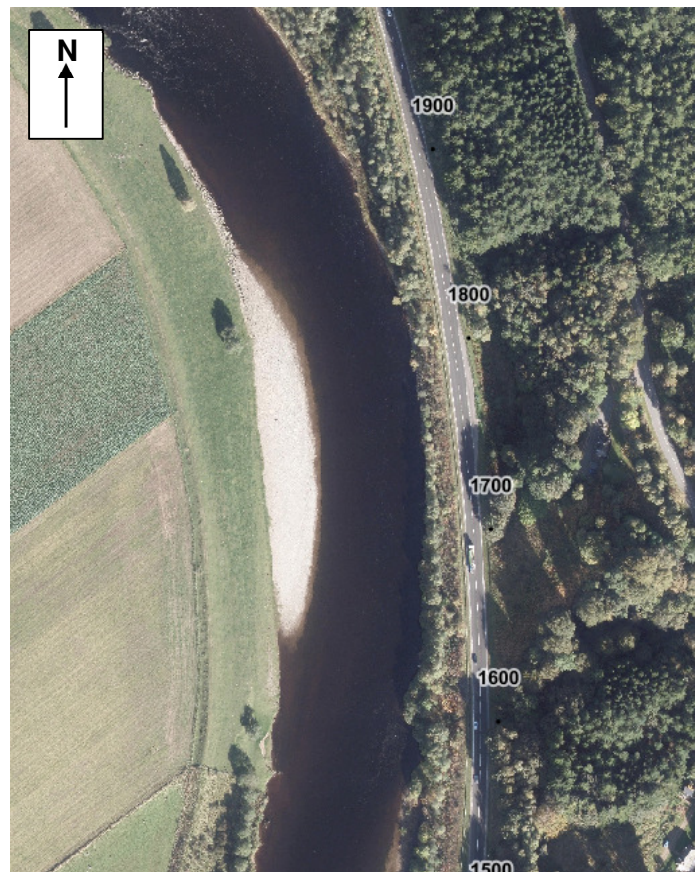
Figure 1. Aerial view of erosion risk site.

The bank between the existing A9 carriageway and the River Tay consists of a thin strip of broadleaved woodland in this area (see Figure 1).
